Identification and Mitigation of Subsidence in Karstic Areas with Sustainable Geotechnical Structures: A Case Study in Gallur (Spain)

Posted Date: 19 February 2024

Alberto Gracia ^{1,*}, Francisco Javier Torrijo ², Julio Garzón-Roca ³ and Miguel Pérez-Picallo ¹

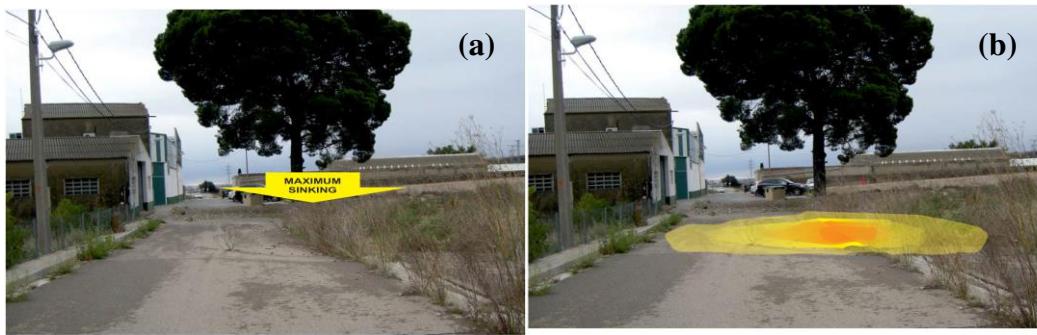
Figure 1. Panoramic image of the apparent subsidence of the road surface of the access to Gallur along the Camino Real (2015). The most depressed area is highlighted in color. This access had remained closed for several years.

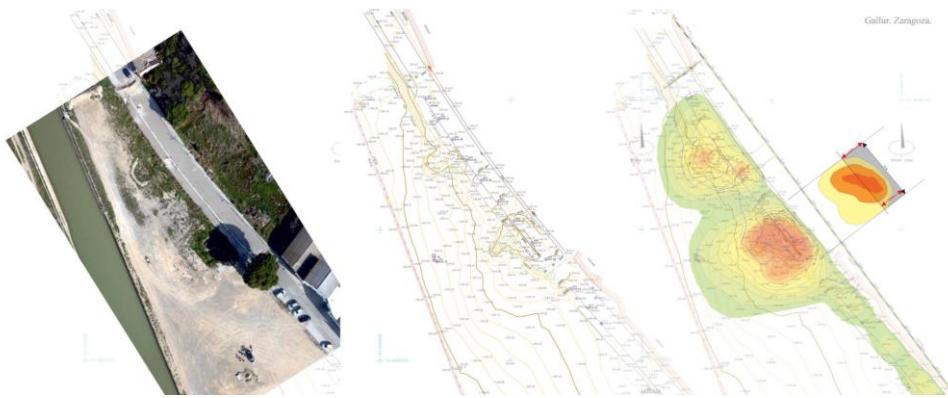
Figure 2. Topography on aerial photography (year 2015). The area affected by land subsidence is marked in colour. The layout of the contour lines shows the subsidence edges and defined areas affected by structural changes.

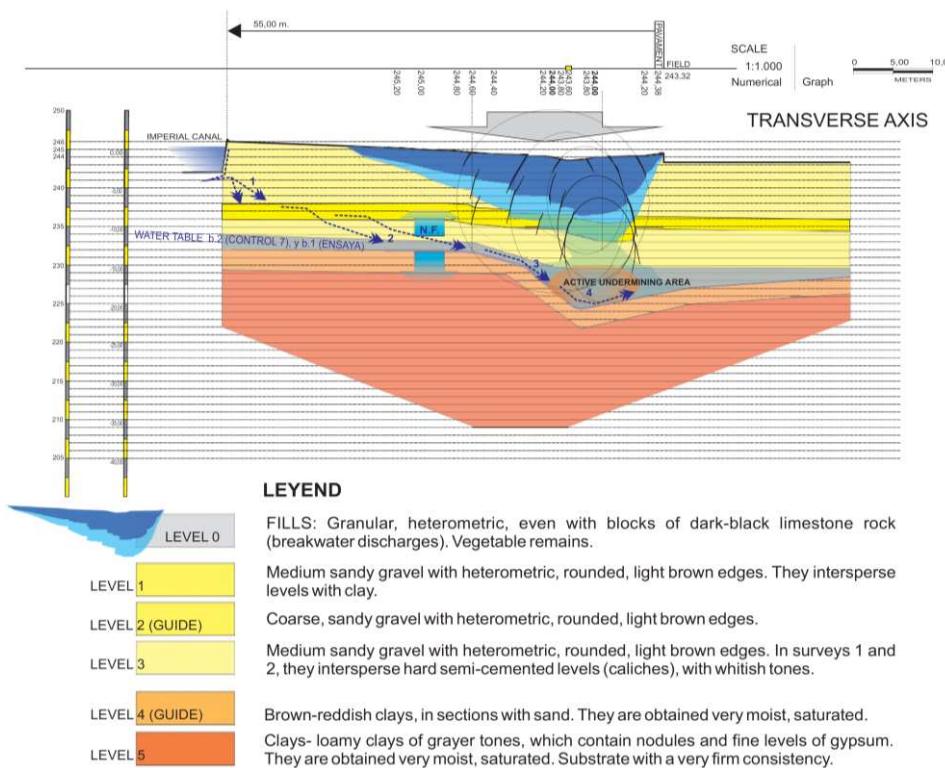
1. In the area of oscillation of the water table and in the contact between the deposit of granular material (gravels and sands) and the clay-marl substratum (with gypsum), there is an anomalous differential concentration of a sub-valve flow in the direction of the river Ebro.
2. A higher velocity flow is generated in this area and, consequently, a greater dragging capacity (scour) of both the fines in the granular deposit and those displaced due to the alteration of the substratum.
3. For this reason, the gravels of level 3, in the zone of contact with the clayey substrate, have a low fines content, which results in a higher relative permeability and abnormally low strength.
4. Hence, the process can be likened to a large hourglass with lateral expansion, favoring the preferential flow line toward the base level of the entire aquifer system, situated in the direction of the Ebro river.

Figure 6. Geological-geotechnical cross-sectional profile established based on previous existing data.

- There is no nearby catchment basin that could justify a process of this magnitude. The unusual influx of water into the system might be attributed to the nearby Canal Imperial de Aragón. In recent history, it is widely known that repairs were necessary on a section located immediately to the west, merely 30-40 meters away. The same issue that prompted the aforementioned repair could have influenced the emergence of the new subsidence observed in this access area to Gallur.

- These inputs have been infiltrating for a long time through the gravel deposit that makes up the soil in the area. The infiltrated flow was incorporated into a system of high relative porosity (levels 1 and 2), taking advantage of levels where the proportion of fines is lower (level 3), incorporating itself into the phreatic. The natural, preferential direction of this flow is in the direction of the river Ebro, towards the west.

- Taking into account the correlation among the boreholes surveyed, it is conceivable that there was a reduction in the relief corresponding to the Tertiary substratum. In this relative difference in elevation, there is a shift in the speed of the phreatic flow, which also integrates infiltrated contributions from the nearby channel, likely accumulating over the years. This contact gives rise to a flow with higher velocity and, consequently, an enhanced capacity for dragging (scour) of both fines from the granular deposit itself and those displaced due to the alteration of the substratum.

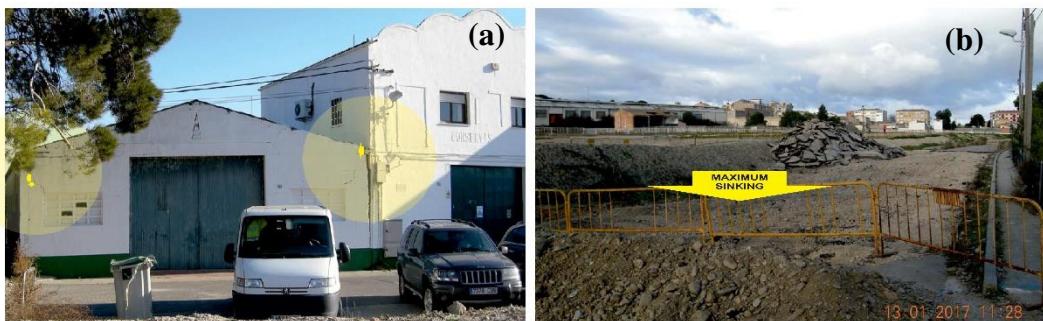
Figure 7. (a) Damage to an adjacent building is evident, highlighting points where deformations (cracks) are most pronounced, along with their indicated direction. (b) View of the street affected by the subsidence where the maximum subsidence is marked.

Finally, the solution adopted consisted of consolidating the ground in the section where the settlements were located by injecting low-mobility mortar in the center of the sunken area (Figure 7), and the construction of an embankment reinforced with high tensile strength geogrids along the entire section of the affected street.

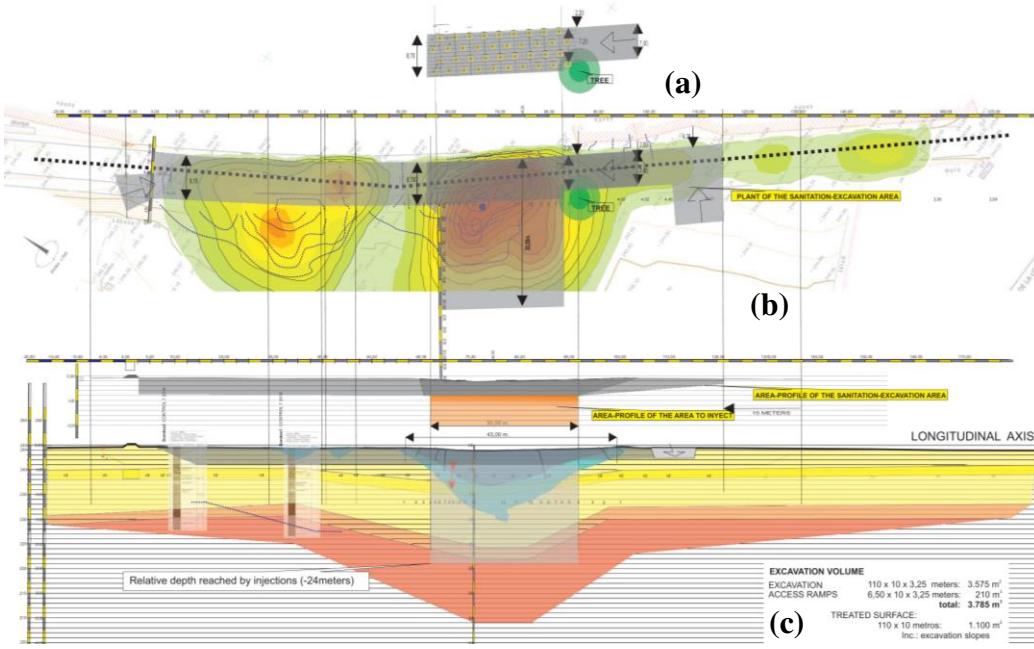
Figure 8. Location in plan view and profile of the consolidation works. (a) Initial excavation (in plan view) to carry out the consolidation mortar injections. (b) Excavation in the second phase, for the rehabilitation and placement of a reinforced-compacted embankment using high tensile strength geogrids. The relative depth reached by the B.M. mortar injections is included in the diagram that serves as a geotechnical model.

1. Installation on site and restoration of pavements. Trench excavation, up to -3.00 m, of the area (section of street) in which the consolidation injections were subsequently carried out. In point (a) of Figure 8 the specific area is included in plan view.

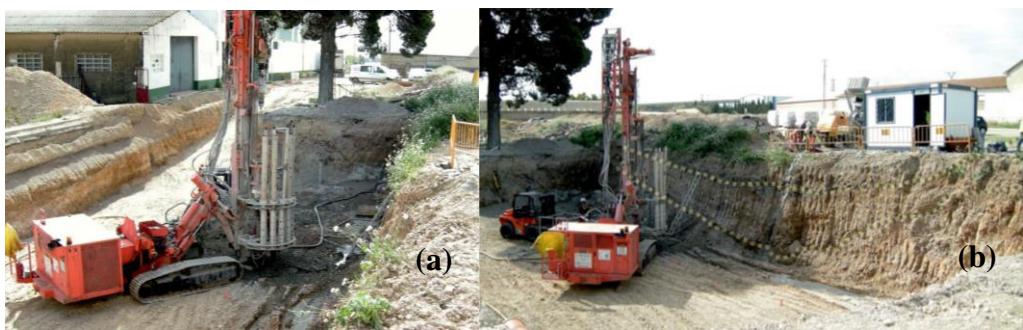
Figure 9. (a) Drilling equipment located in the excavation (at -3.00 m). (b) Excavation slope with the apparent arrangement of the ground levels in the shape of a trough, indicating the point of maximum subsidence.

2. Access and staking out of the injection equipment campaign (Figure 9), a test section was carried out to define the spacing of the injections and to evaluate the injection pressures. DPSH tests were carried out to verify the situation.

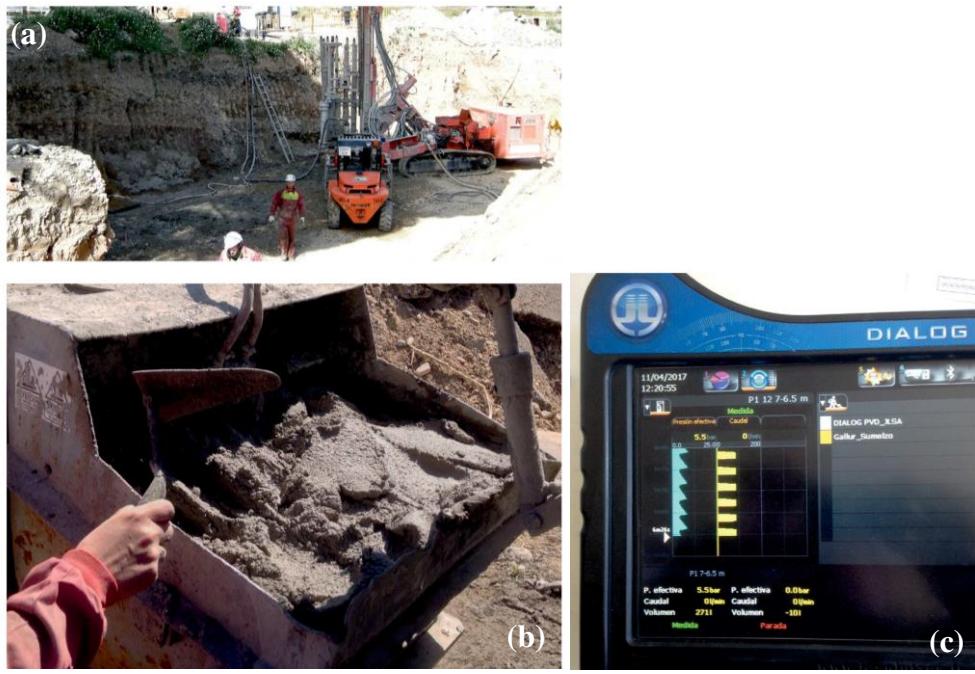
Figure 10. (a) Drilling equipment located in the excavation made at -3.00 m from the original street surface; (b) Appearance (texture and consistency) of the injection mortar in the injection pump hopper; (c) Injection control equipment: Injection in the interval between -7.00 and -6.50m; Effective pressure at that time 5.5 bar; mortar intake volume, after 6.26 minutes: 271 l.

3. Execution of low mobility mortar injections (compaction grouting), in the excavation made (Figure 10), at -3.00 m from the current street level. Maximum planned consumption of 150 l/m, including drilling into the ground. The mortar was injected at a pressure up to 20 bar and with an Abrams cone value of less than 8 to 12 cm. The pumping speed was limited to less than 60 l/m in order to produce infiltration-displacement of the soil without breaking its structure.

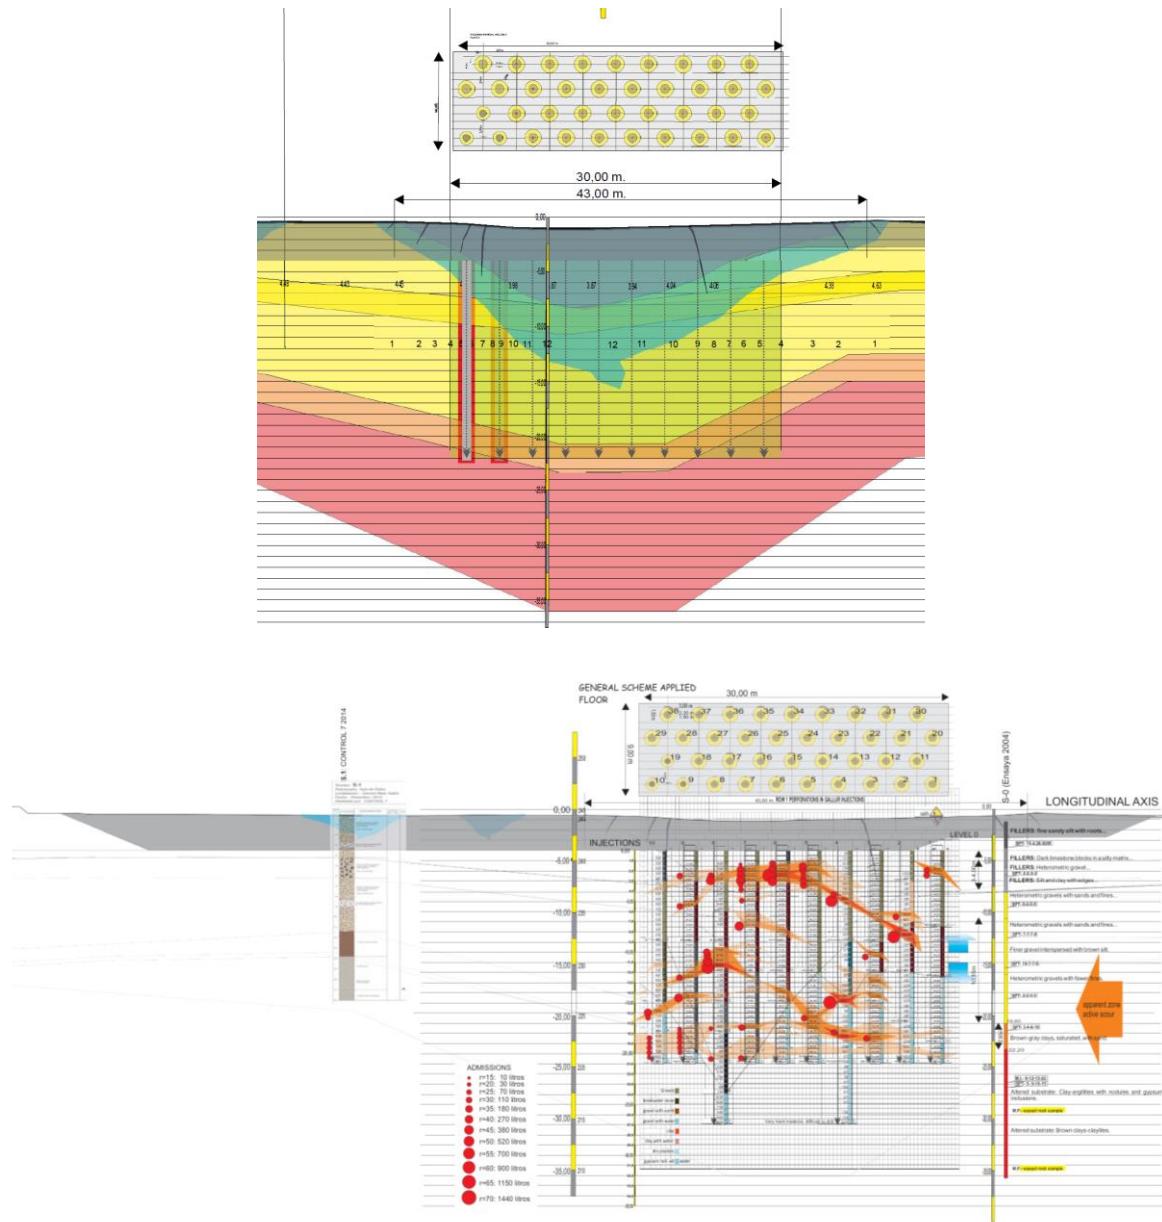
Figure 11. Profile showing the arrangement of the injections in the section with the highest apparent subsidence-subsidence at the surface, where the correlation model showed the largest deformations.

The work was carried out in the arrangement shown in Figure 11, and to previously determined depths at each injection point, initially assessed to be -21.00 m deep from the excavation grade, at -3.00 m from the current street.

In order to improve the information on the ground situation at depth, 7 of the 38 injections of 29 m were extended to -27 m (Tables 1 and 2).

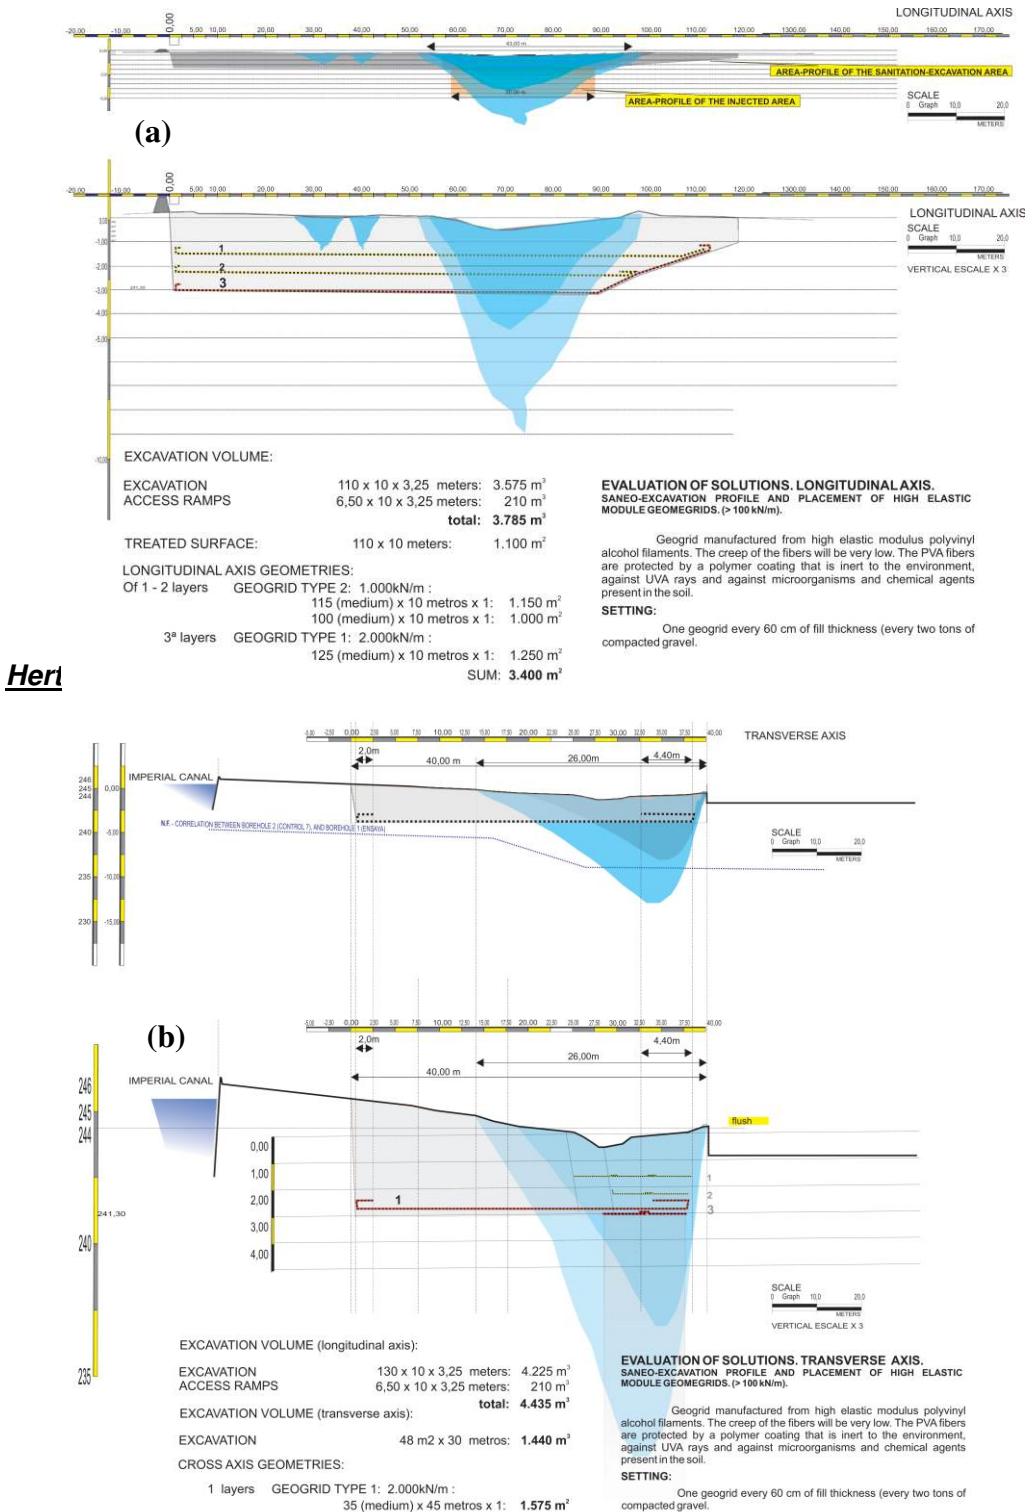
Figure 12. Profile of the reinforced backfill solution: (a) Longitudinal profile; (b) Transverse profile. A series of photographs showing this treatment are attached in Figure 13.

In the area where the settlements reflected a greater subsidence, a deeper treatment was carried out (Figure 12) consisting of a 3 m soil remediation, injections, a bidirectional reinforcement (two uniaxial layers) and subsequent reconstruction by means of reinforced fill and a lighter treatment on both sides of this area of greater deformation (following the route of the road).

From a geometrical point of view, for this treatment the voids between injections were considered voids of a certain diameter, using of one or more layers of geogrid to bridge them. These geogrids can bridge the differential settlements that occur, anchoring themselves in fixed areas. The solution adopted was based on this concept. In the case of a generalised settlement in the backfill, where no fixed points existed, the geogrid simply descended solidarity with the backfill. Therefore, the design was made on the assumption that the area of differential settlement had a defined direction.

The tensile and deformational characteristics of the geogrid was set based on the thickness of the drainage (3 m) and the diameter of the possible cavity (space between injections), which was considered 2 m.

As $H/D < 1$ (being H the infill thickness and D the diameter), the British standard [24] was used, although considering the method established by Giroud [25], usually used when $H/D > 1$. This distinction is due to the fact that the British standard [24] does not consider the arch effect produced in the infill for H/D ratios > 1 , so if the design is carried out with this standard, the results obtained are exaggeratedly on the side of safety. On the other hand, for $H/D < 1$, as the effect of the discharge arc does not occur, this standard gives solutions that are in line with reality. The method of Giroud [25] takes into account the effect of the unloading arch, which substantially reduces the vertical pressure that the geogrid must bridge, which for H/D ratios > 1 is quite close to reality.

In terms of acceptable surface deformation, following the indications of the British standard [24] for the case of secondary roads, this was set at 2%. It is of great importance in this type of application to use materials whose raw material has a low nominal deformation, for this reason Polyvinyl Alcohol (PVA) was chosen, which has a nominal deformation $< 6\%$.

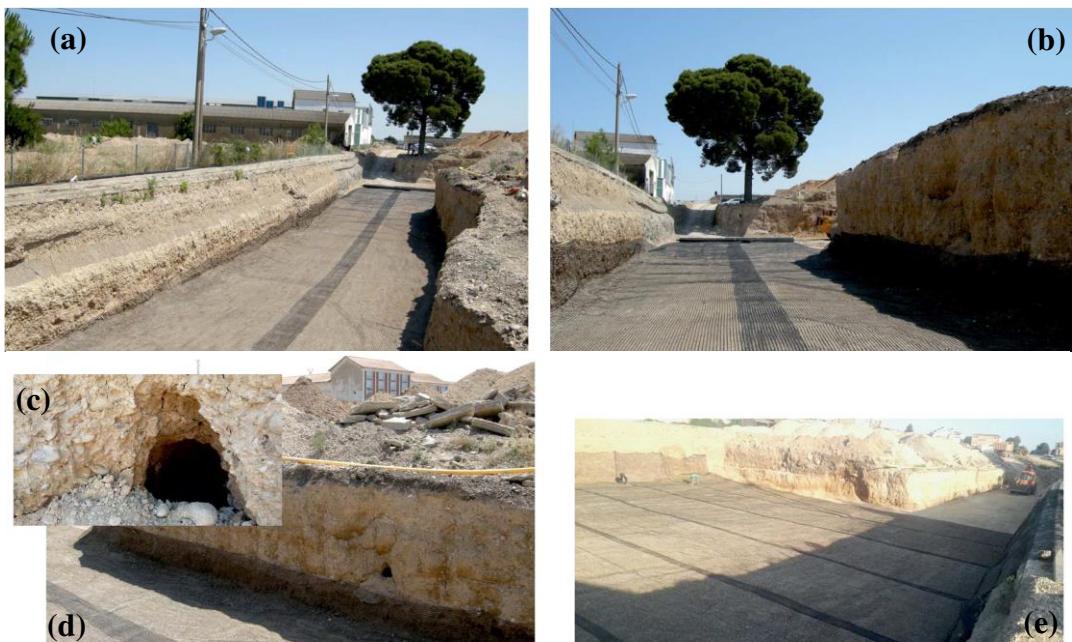
Figure 13. Photographs showing part of the reinforced backfill solution shown in Figure 12: (a) and (b) Longitudinal profile area; (c), (d) and (e) Transverse profile area. Figure (c) shows in detail a karstic cavity detected during the treatment.

- Positioned at the base of the excavation (at -3.00 m; layer 5): GEOMALLA woven geotextile based on polypropylene, type FORTRAC (HUESKER brand), made of PVA and with a combined modulus of 2,000 kN/m.
- Positioned in 60 cm intervals (layers 1 to 4): GEOMALLA woven geotextile based on polypropylene, type FORTRAC (HUESKER brand), made of PVA and with a combined modulus of 1,000 kN/m.

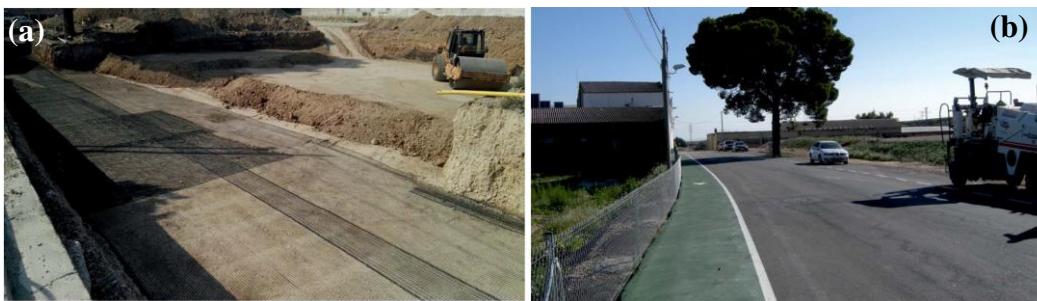
Figure 14. (a) Construction of the backfill with granular material; (b) Final state of the area after treatment and asphalting.

Finally, the construction of the backfill was carried out with selected granular material, spread, moistened and compacted in 20-30 cm thick layers (compaction degree 95% of the modified proctor), up to -3,00 m. (Figure 14).
