Impacts of a Moderate-Sized Earthquake: The 2023 Magnitude (M_w) 4.7 Leyte, Leyte Earthquake, Philippines

Abstract: On 15 January 2023, a shallow, moderate earthquake with a magnitude (M_w) of 4.7 and a depth of one kilometer struck the northern part of Leyte Island in the central Philippines. Originating along the northern Leyte segment of the Philippine Fault, a well-established creeping fault, the earthquake caused significant geologic, structural, and socio-economic impacts despite its low magnitude. Probable surface rupture and landslides were reported, leading to a comprehensive field investigation. Our investigation revealed an ~8 km discontinuous surface rupture along the northern Leyte segment of the Philippine Fault, with a maximum left-lateral displacement of 2 cm—the first documented occurrence of such a phenomenon associated with an earthquake of magnitude less than 6, particularly along a creeping fault segment. The maximum ground shaking felt was reported at PHIVOLCS Earthquake Intensity Scale (PEIS) VI (very strong), equivalent to Modified Mercalli Intensity (MMI) VI along the fault strike. However, strong motion accelerographs recorded a peak ground acceleration (

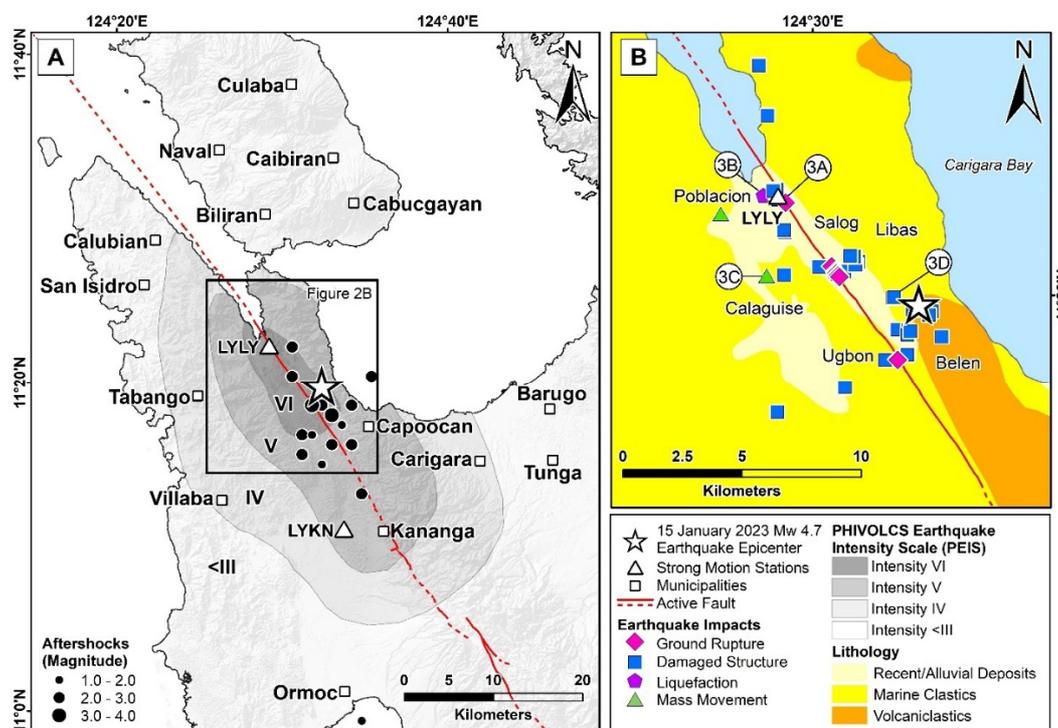
Figure 2. The 2023 M_w 4.7 Leyte, Leyte Earthquake isoseismal, aftershock distribution, and earthquake impact maps. (A) The isoseismal map was based on the latest earthquake information from DOST-PHIVOLCS [18] and the detailed intensity survey and impact assessment conducted in this study. Aftershock distribution (black circle) from 15 to 23 January 2023 was recorded by the Philippine Seismic Network [18]. (B) Spatial distribution of documented damages and geologic impacts (ground rupture, liquefaction, and mass movement). The geologic map was modified from Aurelio and Peña [26]. Circles with letters and numbers show the location of photos in Figure 3. The active fault trace (red line) is from Tsutsumi and Perez [11].

The PSN recorded 26 aftershocks from 15-23 January 2023, of which 15 were plotted and 12 were felt (Figure 2A) [18]. The magnitudes of recorded aftershocks range from 1.7 to 3.9 (Fig. 2) and the highest magnitude was felt at PEIS III (weak), equivalent to MMI III, in Leyte, Leyte. The recorded aftershocks were relatively few with abrupt decay from 16 on the 1st day, five (5) on the 2nd day, and less than three (3) to zero from the 3rd to 9th day [18]. The distribution of the aftershocks also indicates that the earthquake generator for this earthquake is the Philippine Fault – Leyte Segment.

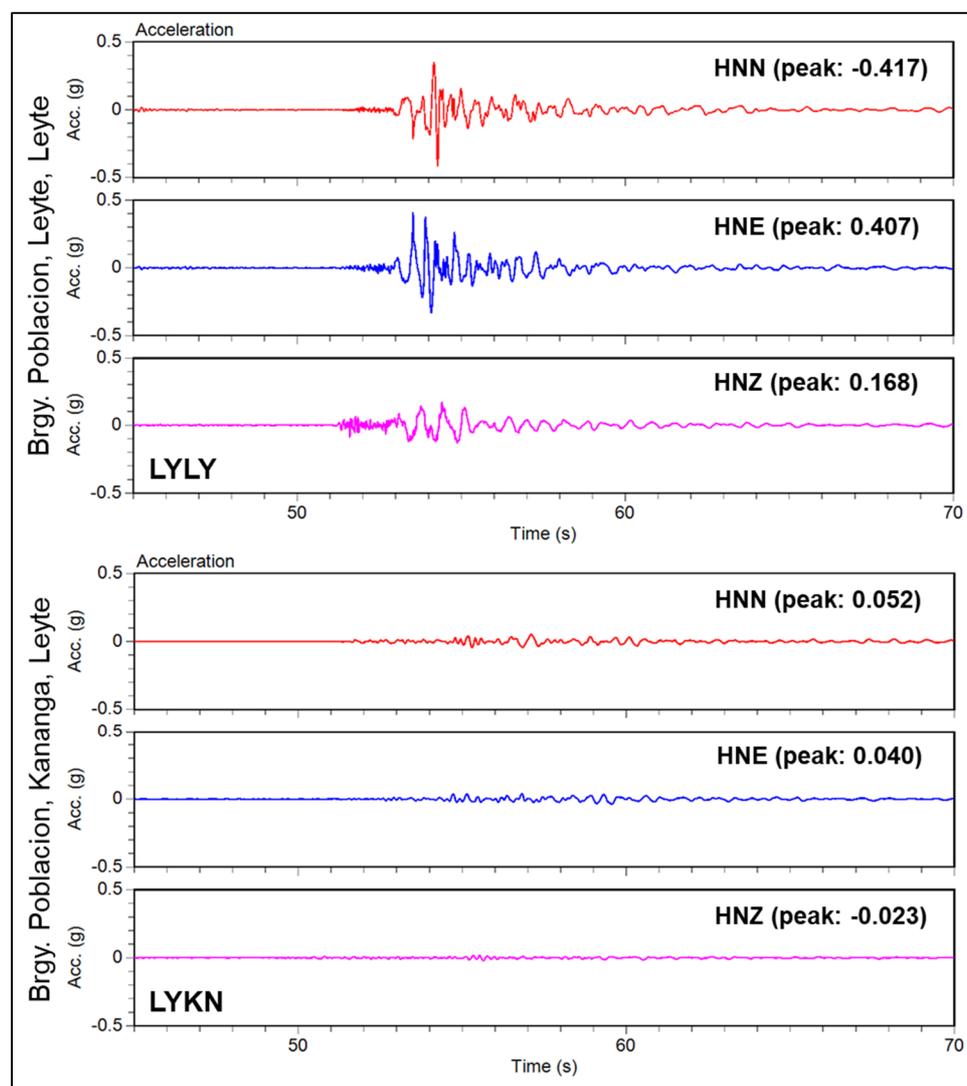
Figure 3. Peak ground acceleration (PGA) record from the Philippine Strong Motion Network (PSMNet) stations in Brgy. Poblacion, Leyte (Station code: LYLY) and Brgy. Poblacion, Kananga (Station code: LYKN). PGA value for the two sites corresponds to the expected ground shaking felt in the area and is influenced by the soft sediment subsurface as manifested by the geology and geomorphology of the area. Refer to Figure 2 for the location of the two (2) accelerographs.

For a more detailed assessment of the ground motion, data from two (2) accelerographs positioned near the epicenter were examined, both belonging to the PSMNet (refer to Figures 2 and 3). The first accelerograph (station code: LYLY) is located in Brgy. Poblacion, Leyte, and ~7 km NW of the epicenter recorded a peak ground acceleration (PGA) of 0.407 g equivalent to PEIS VIII (very destructive) [22] while the second accelerograph (station code: LYKN) located in Brgy. Poblacion, Kananga and ~16 km southeast of the epicenter has recorded a much smaller PGA, 0.052 g, equivalent to PEIS V (strong) [22].

The PGA value recorded in Brgy, Poblacion, Leyte (station code: LYLY) is relatively high (0.407 g) and is equivalent to PEIS VIII (MMI VIII) (Figure 2A and 3) [22]. This value seems to contradict the maximum earthquake intensity, PEIS VI (very strong), felt in areas along the trace of the fault based on reports and intensity surveys (Figure 2A). In some cases, recorded PGA value may be affected by local site amplification of the ground motion which may have been influenced by the subsurface geology of the area. LYLY is located in an area that is mainly overlain by thick sediments which is consistent with the geology (alluvial deposits) and geomorphology (marshland) (Figure 2) [26]. Thus, site amplification is the reason why there was a relatively high PGA value recorded in Brgy. Poblacion, Leyte. A PGA value of 0.052 g was recorded in Brgy. Poblacion, Kananga (station code: LYKN), which is located ~16 km southeast of the epicenter (Figures 2A and 3), is equivalent to PEIS V (strong). This recorded PGA corresponds to the observed earthquake intensity felt in the area based on the intensity survey we have conducted (Table 1 and Figure 2A).

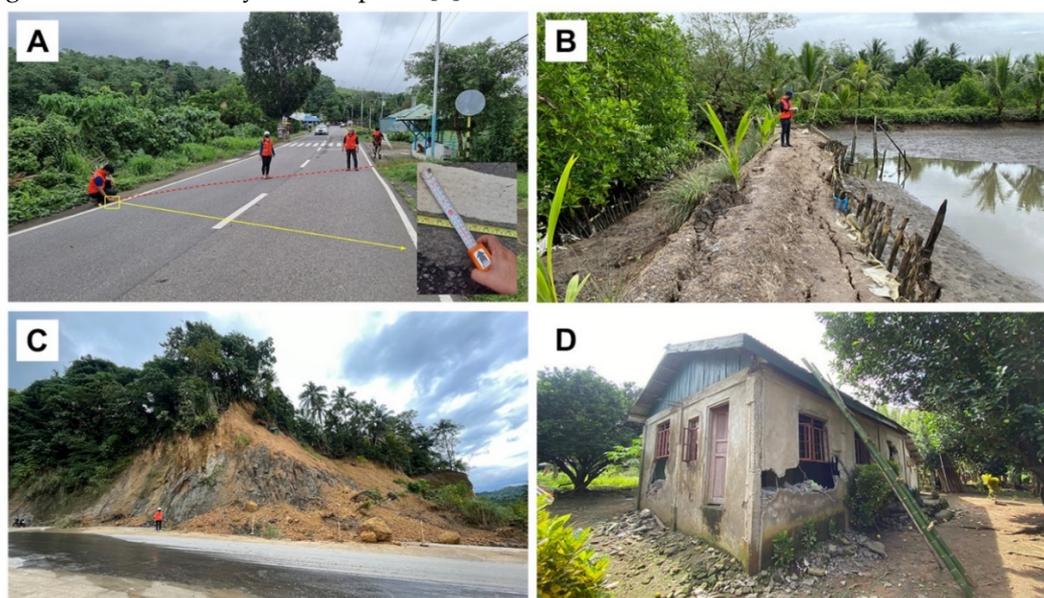
Figure 4. Geologic and structural impacts of the 2023 M_w 4.7 Leyte, Leyte Earthquake. (A) Observed road cracks (red line) along the national highway in Brgy. Poblacion, Leyte coinciding along the trace of the Philippine Fault – Leyte segment [11]. Inset: 2 cm left-lateral displacement measured along the offset road paint. (B) Lateral spreads (cracks) formed on the earth dikes beside fishponds in Palaypalay District, Brgy. Poblacion, Leyte. (C) A shallow landslide consisting of soil rock and debris partly covered a road in Brgy. Calaguise, Leyte. (D) Damaged house (concrete hollow block) in Brgy. Belen, Leyte. Refer to Figure 2B for the location of photos.

It is uncommon for a magnitude < 6 earthquake to have surface rupture [23,24]. However, our field investigation revealed an 8-km-long northwest-trending discontinuous rupture associated with the 2023 M_w 4.7 Leyte, Leyte Earthquake that occurred along the previously mapped Philippine Fault – Leyte segment [11,14,15]. Detailed ground and drone surveys conducted during the investigation showed that the surface rupture affected at least three barangays (Brgys. Poblacion, Salog, and Ugbon) in Leyte (Figures 2B and 4A). The surface rupture was manifested as a continuous crack with discernable left-lateral displacement or parallel *en-echelon* visible cracks identified as Riedel shear structures. Measured displacements range from 1.5 to 2 cm. Figure 4A shows a portion of the surface rupture manifested as hairline cracks along a road with 2 cm horizontal displacement coinciding with the previously mapped active fault. Eyewitness accounts verified that the hairline cracks were caused by the earthquake. It also affected residential houses traversed by the active fault. These residential houses were also previously identified to be damaged by fault creeping in the past studies [14,15]. A detailed discussion of this rare surface rupture is presented in Llamas et al. [25].

Documented liquefaction occurrences were limited to the marshlands with recent and alluvial deposits in the Palaypay District, Brgy. Poblacion, Leyte (Figure 2B) [26] and was near the epicentral area. In these sites, lateral spreads were observed along the earth dikes of a fishpond (Figure 4B). These dikes were made up of soil dug up from the adjacent fishponds. Ground cracks measuring up to 20 m in length and 4 cm of horizontal gaps were documented. These cracks are all nearly parallel to the length of the earth dikes and spread towards the fishponds. A house beside the fishpond was also damaged. Portions of the house sank in soil by 3 cm. According to the house owner, the house was built on top of the sandy fill dug out from the nearby fishpond. In other areas of the Palaypay District, ground failures also caused damage to some built-up structures. In two houses, the flooring of the houses is made up of concrete, sustained cracks, sank, and tilted towards the nearby marsh. In another two houses, the comfort rooms made of CHB also sank and tilted.

The municipality of Leyte is flanked by mountains on its eastern and western perimeters. Only two instances of landslides were observed, as illustrated in Figure 2B. A rockfall was recorded along a densely vegetated hill in Brgy. Palid Uno in Leyte, while a shallow landslide occurred in Brgy. Calaguise, Leyte (Figures 2B and 4C). The shallow landslide, composed of earth debris and rocks, partially covered sections of the Calaguise-Calubian Road. The landslide took place on the steeply sloping road cut of a highly jointed sedimentary bedrock. Fortunately, no casualties or damages were reported due to mass wasting.

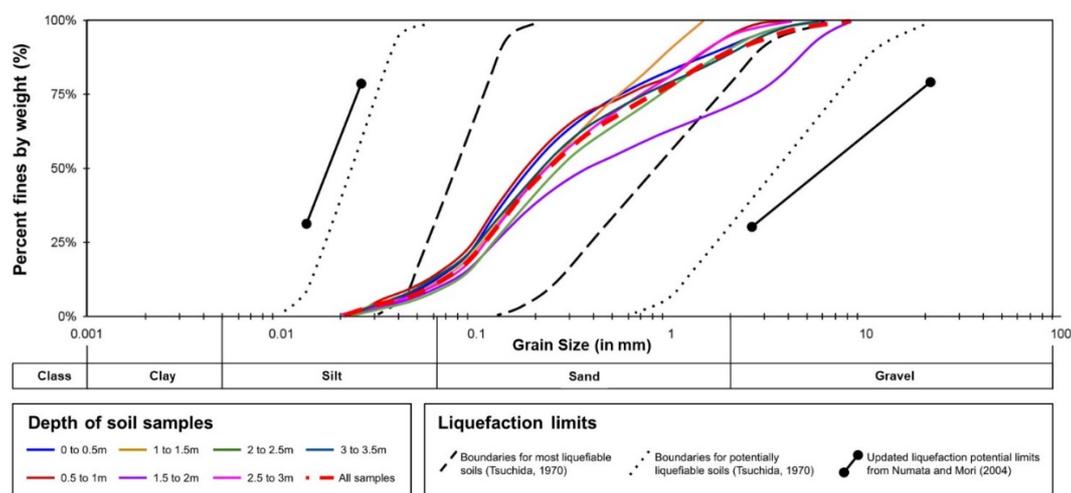
Figure 5 shows the summary of the grain size analysis of soil samples we have collected and compares it to liquefaction limits on grain sizes suggested by Tsuchida [27] and Numata and Mori [28]. The majority of the collected soil samples have grain sizes ranging from very fine to very coarse sand (0.0625 to 2.0 mm) and are within the boundaries of most liquefiable soils (Figure 5) [27–29]. While the soil sample collected from 1.5 to 2 m depth has 30% of its grains that are granule-pebble sized (2.0 to 8.0 mm), this is still within the boundary for potentially liquefiable soils. With these soil properties and geomorphology coupled with the measured PGA of 0.407 g (recorded by LYLY, 500m from Palaypay District) (Figure 2A and 3), and as evidenced by subsidence and tilting of some buildings and lateral spreads on some earth dikes, we are therefore more certain that liquefaction occurred in these soils.

Figure 5. Grain size analysis of soil samples taken on the earth dikes that liquefied in Palaypay District, Brgy. Poblacion, Leyte with liquefaction limits set by [27 and 28].
