A Study of Repair Mortars for Restoration of Wall Painted Plasters in a Hypogeum Rock-Cut Church of Matera (Southern Italy)

Keywords: air lime mortars; calcareous aggregate; silica aggregate; microstructure; physical-mechanical performance; salt ageing

Abstract: Several lime mortars for the repair of painted plasters of the rock cut church of Ss. Pietro and Paolo in Matera were studied. They were designed taking into account both aesthetic criteria that need to be fulfilled in the field of paintings restoration, and physical-mechanical compatibility with the original materials on site, i.e. the pre-existing plasters and the supporting rock. Mixes with calcareous and silica aggregates, based on different grain size proportions, were prepared for filling missing portions of the original painted plaster. The effects of the mineralogical nature and size of the aggregates on the characteristics and properties of the mixes were investigated in relation to the microstructure, physical-mechanical features and resistance to salt ageing. At the end of the experimental campaign, the overall performances were evaluated.

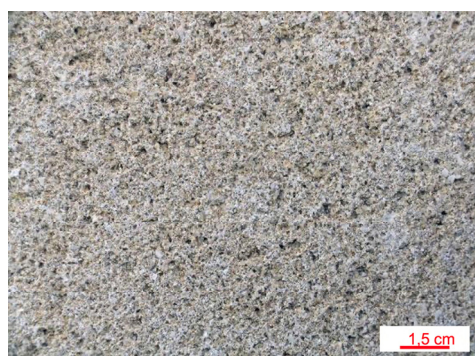
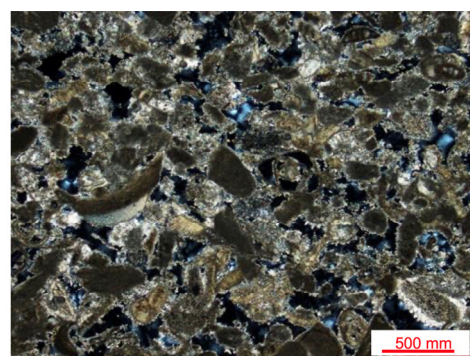
Figure 2. (a) Macroscopic appearance of the calcarenitic cut rock; (b) thin section micrograph under polarized light and cross nicols of the same cut rock.

The mediaeval crypt of Ss. Pietro and Paolo in Matera is a church excavated within a Plio-Pleistocenic calcarenite (Gravina Calcarenite geological formation), locally named “calcareous tuff”. The rock has pale yellow color and is almost exclusively made of fossil remains binded by poor calcite cement (Figure 2a,b). It is a soft rock and typically has a very high (from 40 to 50%, approximately) and coarse porosity, with prevailing pore radius sizes between 10 μm and some hundreds of micrometers, which promotes high capillary water absorption, up to about 700 mg/cm² [28,29].

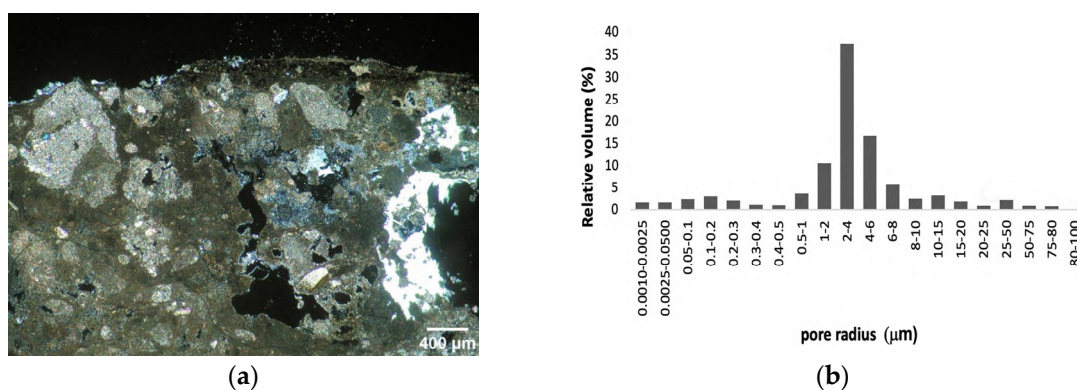
Figure 3. (a) Thin section micrograph under polarized light and cross nicols; (b) porosimetric distribution of the original plaster.

The frescoes are applied on a plaster having an average thickness of 1 cm, which covers the cut rock surface. The plaster is made of air hardening lime and calcareous aggregates coming from the grinded calcarenite of the rocky bank (Figure 3a). Clasts' dimensions range from 100 to 900 μm , with an average size mostly between 200 and 400 μm . The binder:aggregate ratio estimated on thin sections was 1:1.5 by volume. The plaster shows dissolution phenomena at the expense of the calcite matrix and the presence of fissures and vugs often occluded by gypsum. The pictorial layer, with a thickness of about 200 μm , consists of earth pigments and whitewash. The porosity of the plaster, as determined by MIP, is 45 %, with prevailing pore-size radii in the range 1-8 μm (Figure 3b) [30].

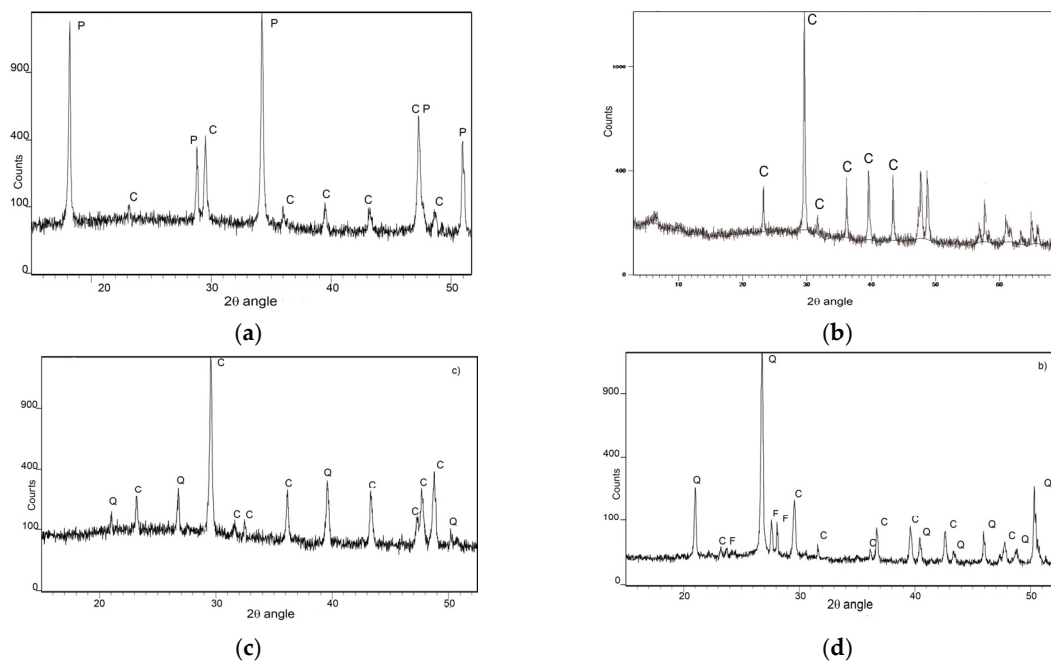
Figure 4. XRD spectra of: (a) lime putty; (b) whitish “tufina” aggregate (T); (c) orange colored calcarenite aggregate (C); (d) river sand (G). (C: Calcite; P: Portlandite; Q: Quartz; F: Feldspar).

approximately (Figure 4c); a river sand from Ginosa (G), near Matera (Figure 4d). T aggregate has the same provenance of the aggregate in the original plaster within the church, namely the calcarenite from the hosting rock bank belonging to the geological outcrop of Gravina calcarenite. C is a variety dating to Pleistocene of the soft and porous calcarenites outcropping in Southern Italy [29], while Ginosa sand comes from the Plio-Pleistocenic deposits in the area of Matera [34] and is mainly composed of quartz, chert, feldspars and a low amount of calcite. Mineralogical composition of T, C and G is shown in Figure 4b–d.

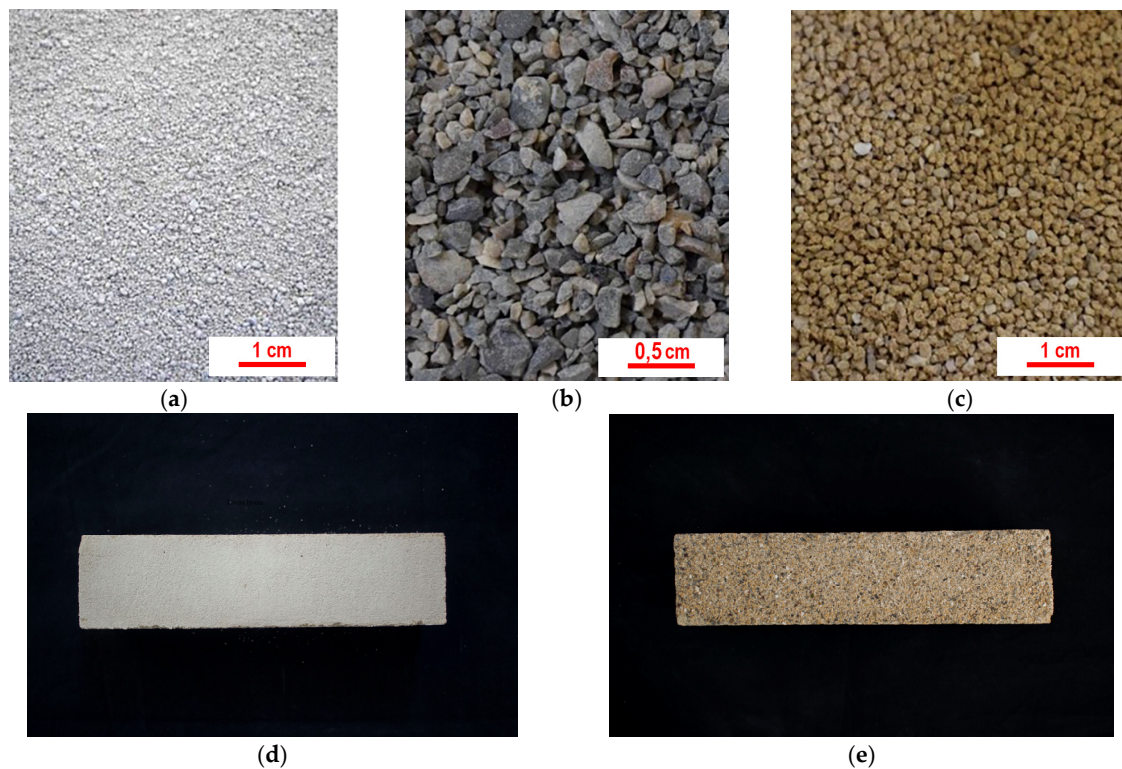
Figure 5. T, G and C aggregates (a, b and c, respectively); R and NR representative mortar samples (d and e, respectively).

Whitish colour required for the retouchable mortars was obtained by using pale yellow aggregate of T type (Figure 5a). Starting from the clast sizes microscopically observed in the pre-

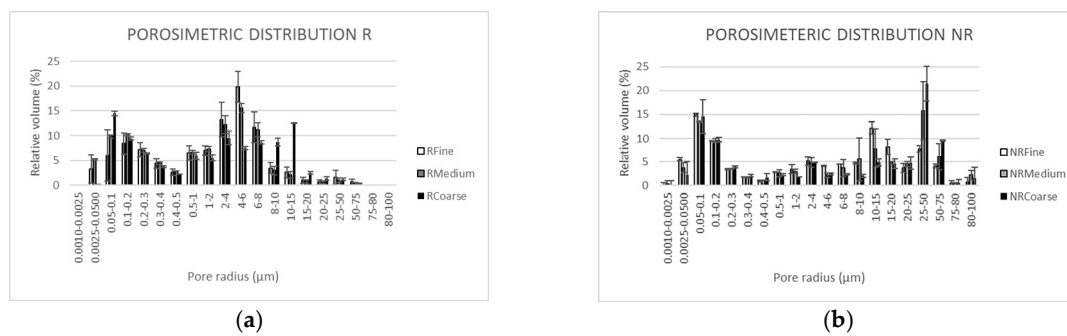
Figure 7. (a) Porosimetric distribution of R mixtures; (b) Porosimetric distribution of NR mixtures.

As illustrated in Table 3 and Figures 7 and 8, different mortars microstructures and porosity features, depending on the nature and sizes of the aggregates, were detected for the studied formulations. The accessible porosities measured by MIP (Table 3) show very close values among samples of each of the two R (from 36 to 39%) and NR groups (from 33 to 35%), but higher for the former. Apparent density values were higher for NR than R formulations.

Pore size distribution (Figure 7a) shows that mortars of the R group have pore radii mainly between 0.0025 and 15 μm, with a bimodal trend. In particular, RF and RM have the main peak in the range from 4 up to 6 μm and a second one between 0.1 and 0.2 μm. RC shows the main peak between 0.05 and 0.1 μm. Compared to RM and RF, it has a lower pore volume in the 2-8 μm range and a higher one from 8 up to 20 μm, with a second peak centered between 10 and 15 μm.

4 μm , it can be observed that NRF has a high pore concentration in the range of 10-20 μm while the maximum peak for NRM and NRC is set between 25 and 50 μm .

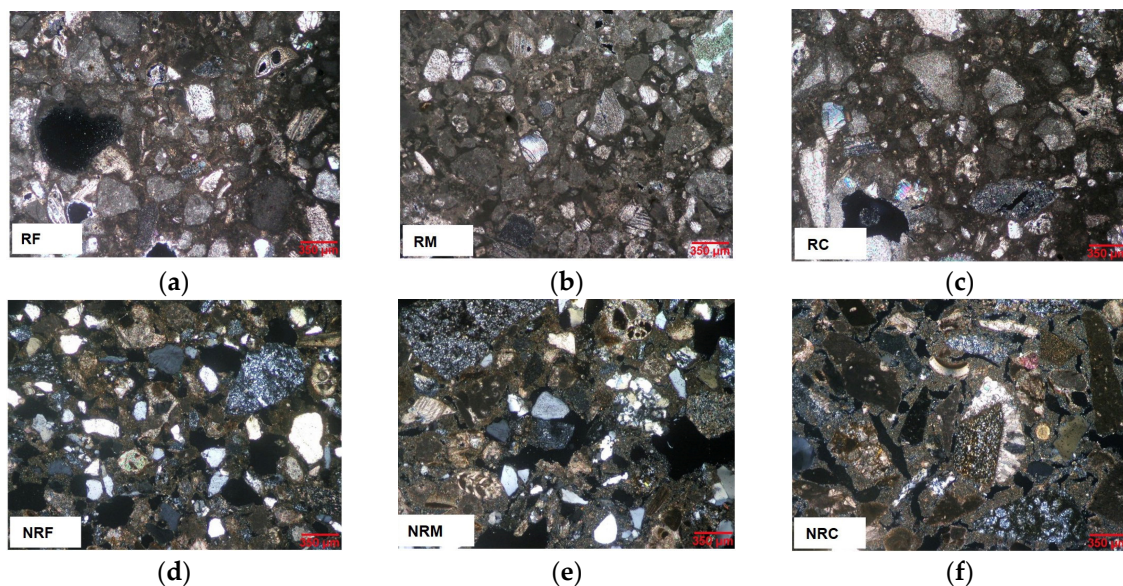
Figure 8. Mortars' microstructures as observed on thin section under polarized light, cross nicols: (a) RF; (b) RM; (c) RC; (d) NRF; (e) NRM; (f) NRC.

The notably different microstructures resulting for R and NR mortars, despite the same binder-aggregate ratio and mixing water, can be attributed to the nature of the aggregate. Indeed, in R mixtures, the aggregate is exclusively calcareous, while in NR mortars, only 20% is calcareous and the remaining 80% is silicate. The calcareous aggregate comes from a rock having a high open porosity (between 40% and 50%), including both intergranular and intragranular voids [29,48], part of which especially at the intragranular level are probably maintained in the grinded fraction. The porosity of the aggregate, being able to absorb the mixing water, could account for lower coarse shrinkage fissures observed in R mixtures. Conversely, such a type of contribution cannot be expected by the silicate aggregates, mainly composed of single quartz and chert grains or tightened poly-minerals fragments having an almost absent porosity. It is a fact that in R mortars, the porosity resolved microscopically, which is of both inter-granular and intra-granular types, mainly ranges from some micrometers to only a few tens of micrometers, and only sometimes ultra-large shrinkage pores were observed.

In addition, widespread discontinuities were found in NR samples along the silicate grains at the contact with the binder. The coarser the aggregate, the more extended these fissures along the grains, so that larger pores increase passing from formulations with prevailing fine grain sizes to coarser ones. The lower volume of large pores observed in R mortars compared to NR ones can be attributed to the higher cohesion between the matrix and the calcareous aggregates, due to their chemical affinity: this leads to a reduction in the content of the discontinuities between the lime and the aggregate [49]. According to the literature, the presence of calcareous aggregates in aerial lime mortars results in a better quality of the interfacial transition zone between the aggregate and the matrix [50]. During the carbonation of the lime, the calcite of the aggregates provides nucleating sites

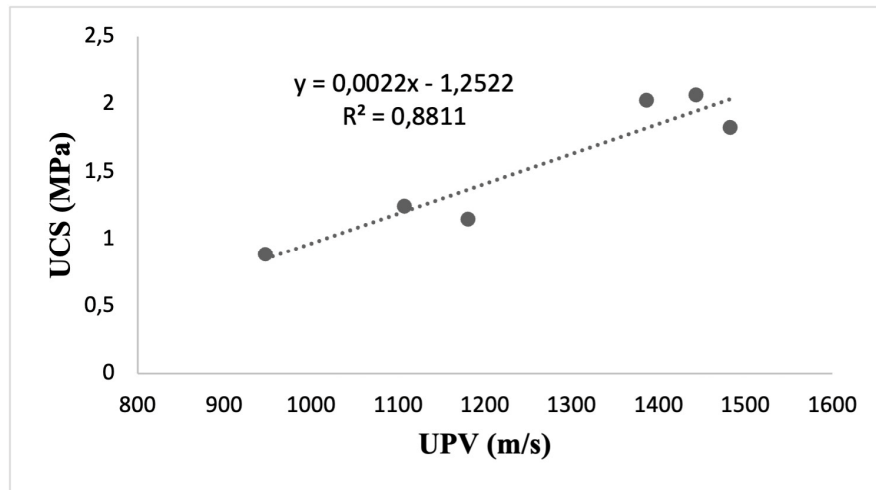
Figure 10. Correlation between UCS and UPV for R and NR formulations.

In a similar vein, higher compressive strengths were measured for R type. There is a good correlation (coefficient of correlation = 0.89) between the ultrasonic velocities and the compressive strengths (Figure 10), as higher mechanical strengths correspond to higher ultrasonic velocities.

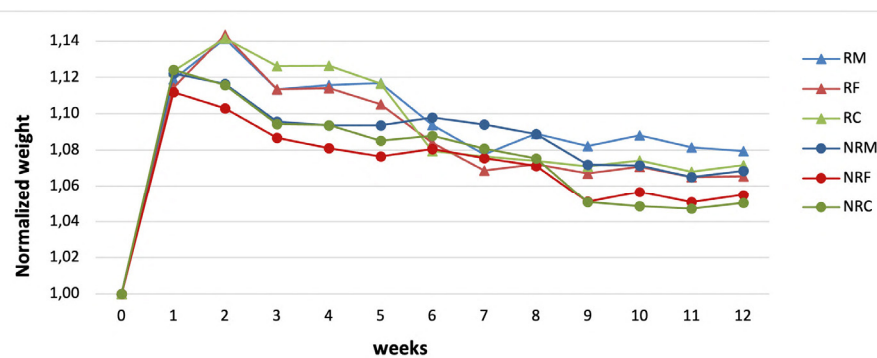
Figure 12. Weekly mean normalized weights for R and NR samples during salt ageing.

Weekly normalized mean weights for R samples (Figure 12) show an increase after the first two weeks, due to the salt accumulation within the porous structure. Starting from the third week, weight decreases were observed, meaning that loss of materials due to mortar decohesion, as an effect of salt damage, prevailed on the salt accumulation. It is worthy to note that for NR samples weight decreases took place earlier, namely starting from the second week.
