Structural Health Monitoring for Prefabricated Building Envelope under Stress Tests

Abstract: This paper details the comprehensive activities conducted in a laboratory setting to assess the Structural Health Monitoring (SHM) of prefabricated building envelopes. Integrating sensors into building components like curtain wall facades poses challenges but offers opportunities for monitoring structural health, requiring compliance with regulatory standards. The research investigates the possibility to define a kit of conventional and multi-parameters sensors integrated within the building envelope to monitor its behavior during performance test conducted following. The kit of sensors also includes Fiber Optic Sensors, for effective monitoring of building envelope behavior and structural integrity. In this context, the European project InComEss (H2020 - GA862597) aims at defining a stand-alone solution for SHM using Piezoelectric Energy Harvesting Systems (PE-EHS) for façade monitoring through FBG/FOS system. After having analysis the main façade structural stress, a series of FBGs, accelerometer and force washer were integrated within a 1:1 scale façade prototype and tested in a labora

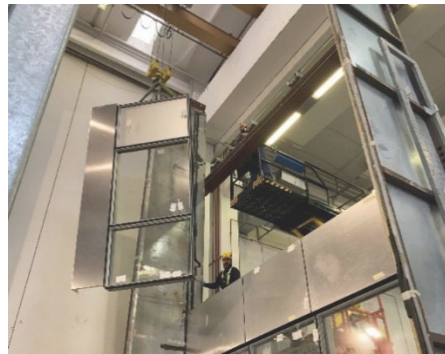
Figure 8. Façade installation process.

The sample preparation involved manufacturing and installation façade modules and then integrated sensors within the façade. Figure 7 shows the off-site process of façade manufacturing and Figure 8 the on-site installation.

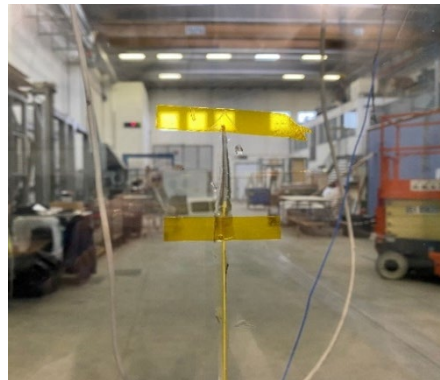
Figure 9. FBGs sensors applied on the glass surface for temperature monitoring.

For FBG, 4 different cables were installed within the façade, 2 in the glass panel and 2 on the aluminum profiles. Indeed, two cables were fixed on the glass surface through epoxy resin DP125 for bonding on glass (Figure 9) while DP410 was used for bonding on aluminum profiles (Figure 10).

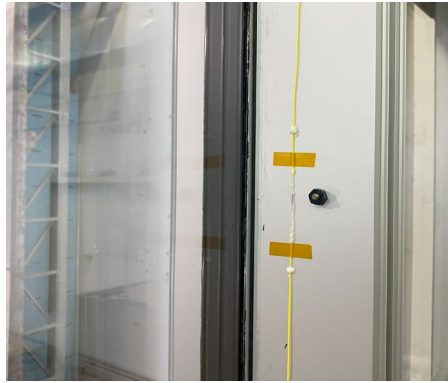
Figure 10. FBGs application on the aluminum profile for strain monitoring.

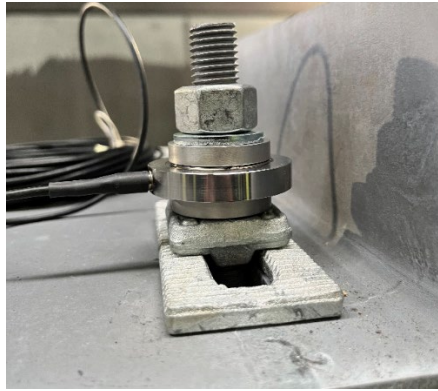
Figure 13. Zoom on the force washer installed on the bracket's bolt.

Strain gauge-based force washers were installed on the façade bolts. The sensors installed are 8, one on each façade bracket. The integration of force washers is shown in Figures 13 and 14.

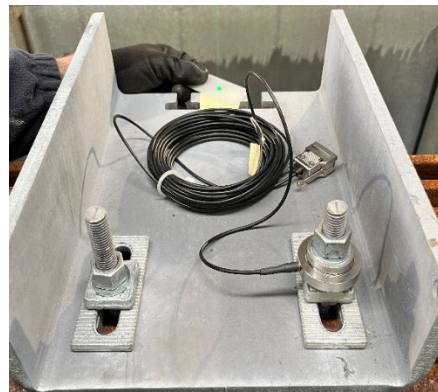
Figure 14. Façade bracket with force washer installation.

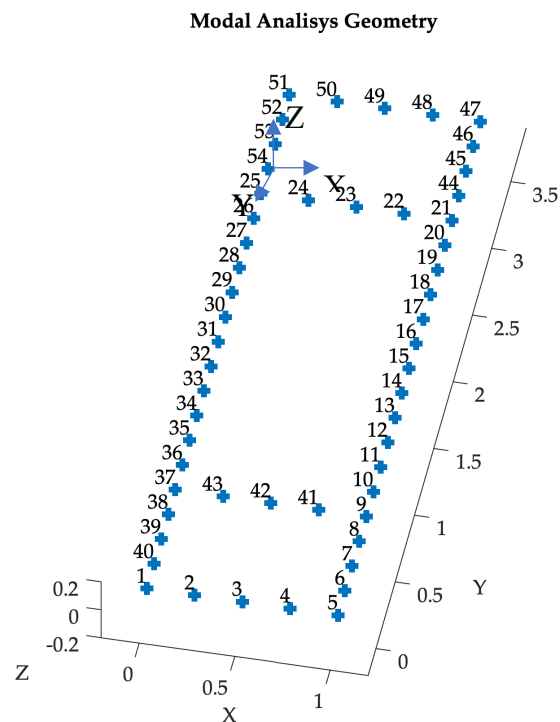
Figure 15. Modal analysis geometry.

Two modal analyses were conducted to assess any changes in structure that might have occurred due to the conformance tests explained in Appendix A. The procedure for the evaluation of the structure was applied on the central module of the wall façade and the geometry has been configured based on the dimension of the module of interest: 54 nodes have been created as represented in Figure 15.

An instrumental hammer was used for the excitation of the surface and the dynamic response at the nodes reported in Figure 15 was measured with monoaxial accelerometers, installed for measuring in Z, moved all over the nodes. The force exerted by the hammer and the acceleration were collected by means of a SIEMENS acquisition system (SCADAS). At each node the Frequency Response Function has been calculated as response over force ratio. The sum of all the FRFs acquired is reported in Figure 16.

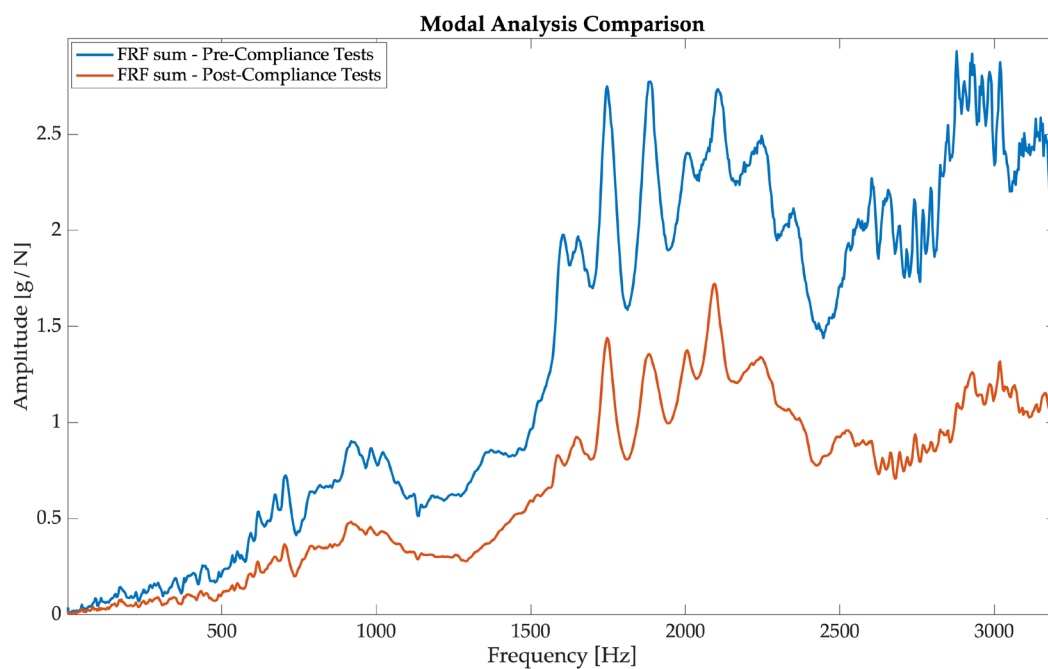
Figure 16. FRF sum comparison between pre and post compliance tests.

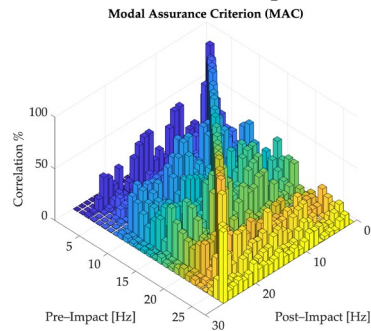
Figure 17. MAC (Modal Assurance Criterion) between the two performed modal analysis.

A modal analysis was performed on the FRF dataset collected to estimate the dynamic parameters of the structure under test (natural frequencies, damping loss factors and mode shapes). A comparison between those parameters estimated in the modal tests performed before and after the stress tests has been performed. To compare mode shapes the Modal Assurance Criterion (MAC) has been used; to compare the variation of the natural frequencies the Natural Frequency Difference (NFD) has been estimated. The MAC and the SFD are reported in Figures 17 and 18 respectively.

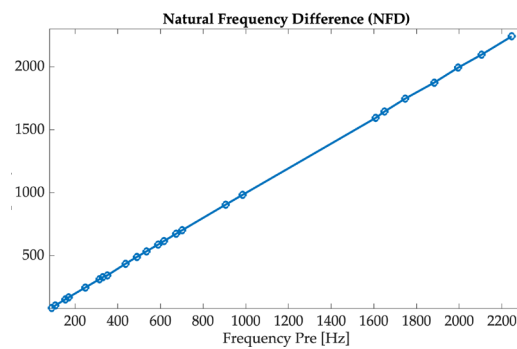
Figure 18. NFD (Natural Frequency Difference) between the two performed modal analysis.

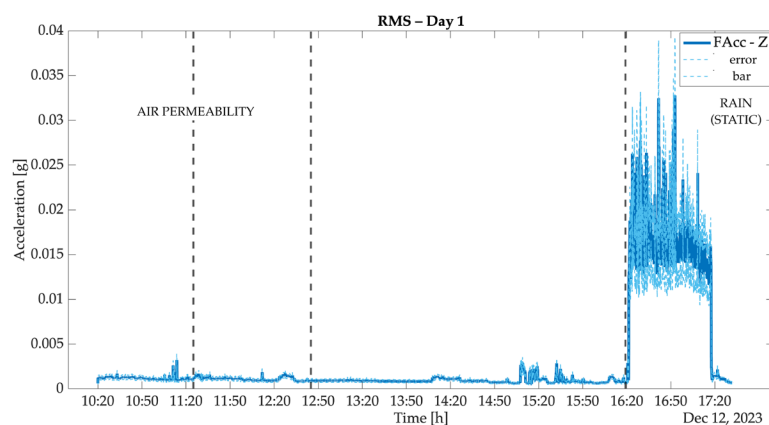
Figure 20. Signal RMS analysis. In sequence, top-figure: RMS of day 1 is shown (a), middle-figure: RMS of day 2 (b) and bottom-figure: RMS of day 3 (c).

At first the analysis of the signal in the time has been performed to understand the global response of the accelerometers subjected to the compliance tests. In fact, a Root Mean Square (RMS) analysis of the signal during time has been performed for each test day as reported in Figure 19. In the following figure (Figure 20), the error bar is shown on RMS data for each day. This value was calculated by applying the accelerometer sensitivity value of $\pm 10\%$ to the accelerometer signals. The error band is outlined by a dashed line surrounding the accelerometer signal curve.

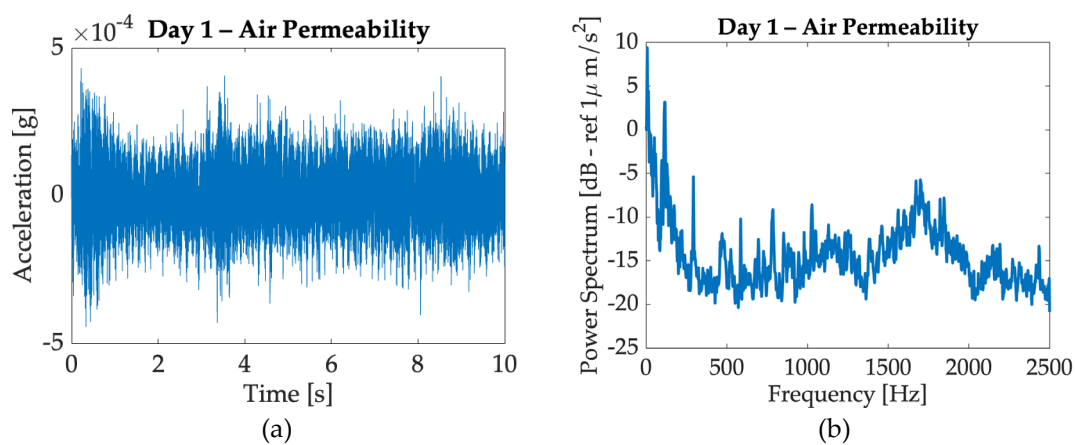
Figure 21. Day 1 tests: respectively story time and power spectrum for each test: air permeability acceleration/time (a); air permeability power spectrum /frequency (b); rain (static) acceleration/time (c); rain (static) power spectrum /frequency (d).

The tests performed during the day 1 have been acquired and are shown in Figure 21. During this day air permeability and rain have been performed. The power spectrum estimation function was used to reduce the signal noise and better evaluate information. Each 10 s time history was divided in 0.8 s chunks with a 50% overlap to obtain 25 averages.

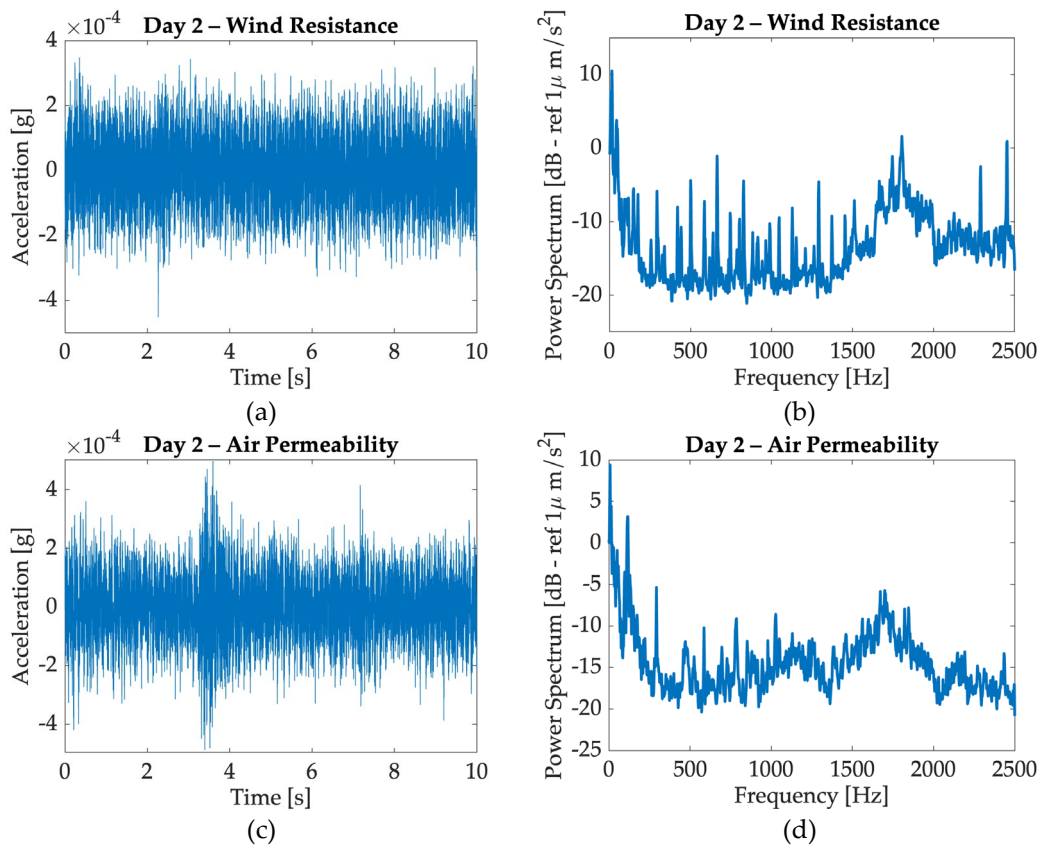
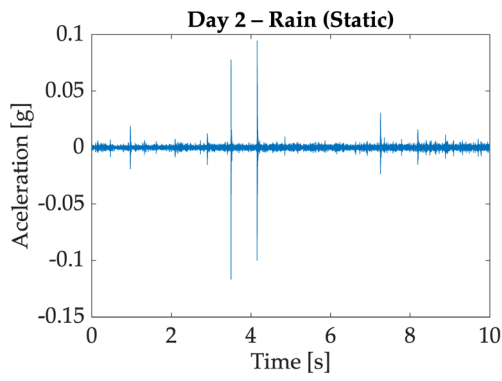
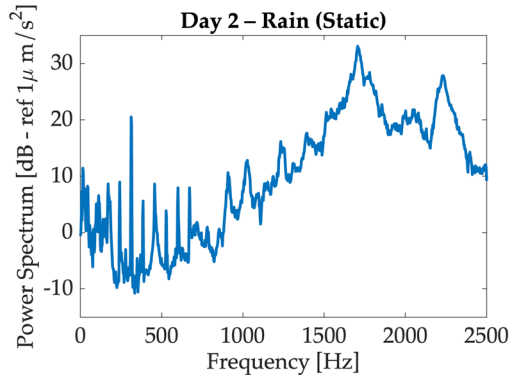
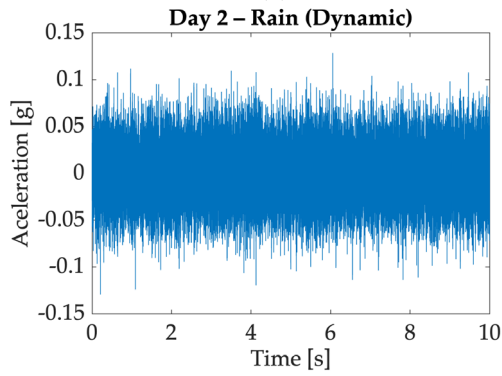
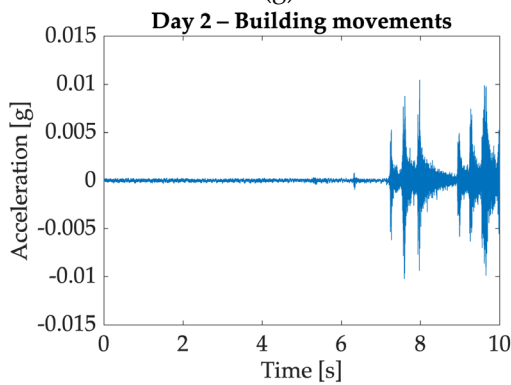
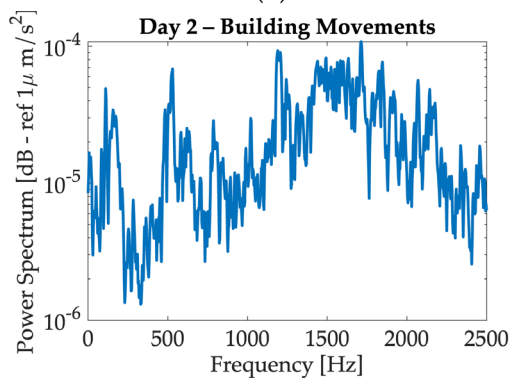
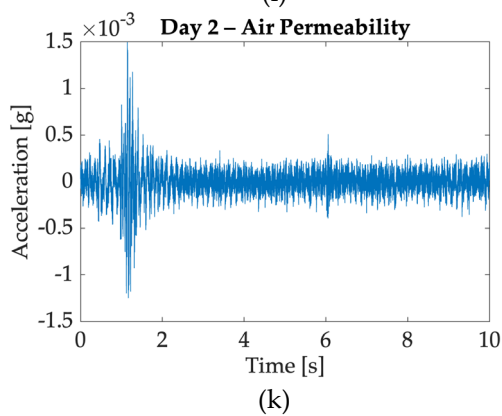
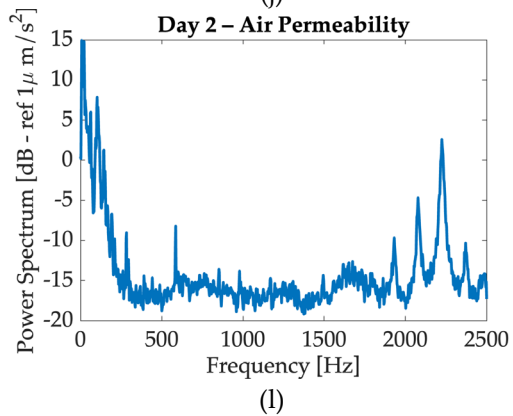
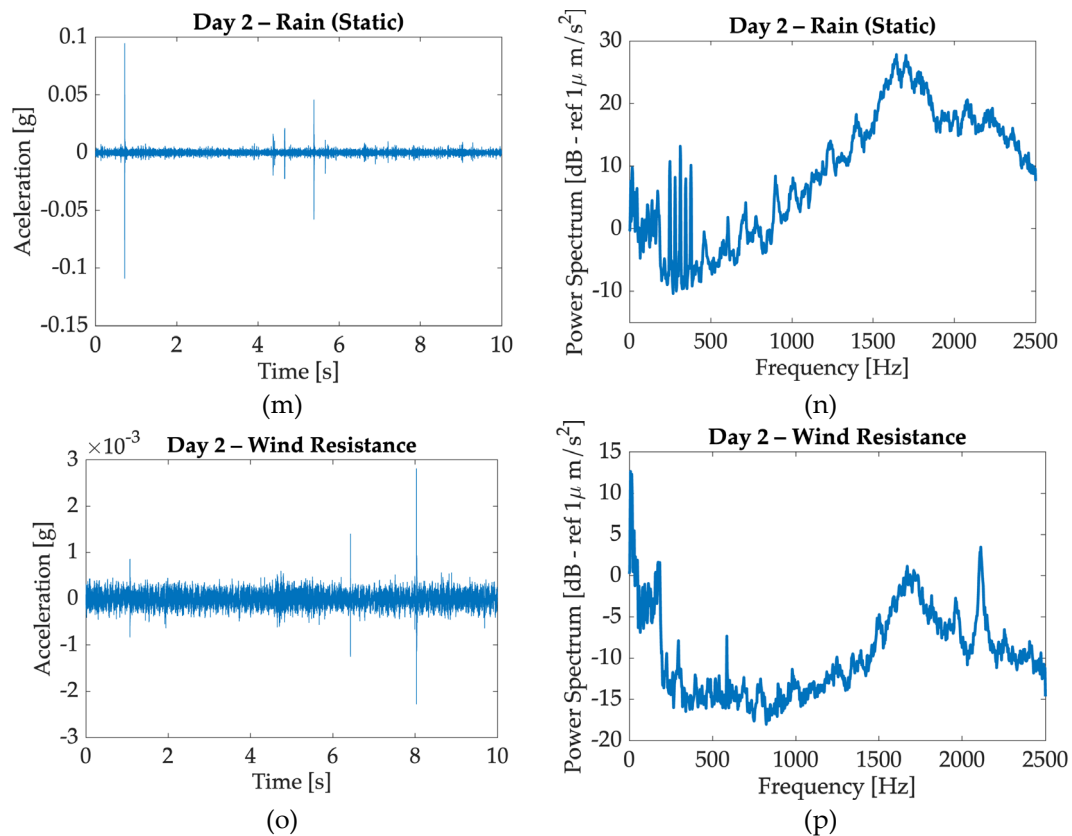
Figure 22. Day 2 tests: respectively story time and power spectrum for each test: wind resistance acceleration/time (a); wind resistance power spectrum/frequency (b); air permeability acceleration/time (c); air permeability power spectral power spectrum /frequency (d); rain (static) acceleration/time (e); rain (static) power spectrum /frequency (f); rain (dynamic) acceleration/time (g); rain (dynamic) power spectrum /frequency (h); building movements acceleration/time (i); building movements power spectrum/frequency (j); air permeability acceleration/time (k); air permeability power spectrum /frequency (l); rain (static) acceleration/time (m); rain (static) power spectrum/frequency (n); wind resistance acceleration/time (o); wind resistance power spectrum/frequency (p).

The tests performed during the day 2 have been acquired and are shown in Figure 22 and are presented following the chronological order of the appearance of events. During this day wind (repeated), air permeability (repeated), rain (repeated) and building movements have been performed. To reduce the signal noise ratio the power spectra of the signals have been calculated using a frequency domain averaging procedure. The 10 s time histories were divided in 0.8 s chunks with a 50% overlap to obtain 25 averages.

The time history registered during the building movement test Figure 22i evidenced several transients. The power spectrum of each transient signal has been calculated and then averaged to improve the signal to noise ratio.

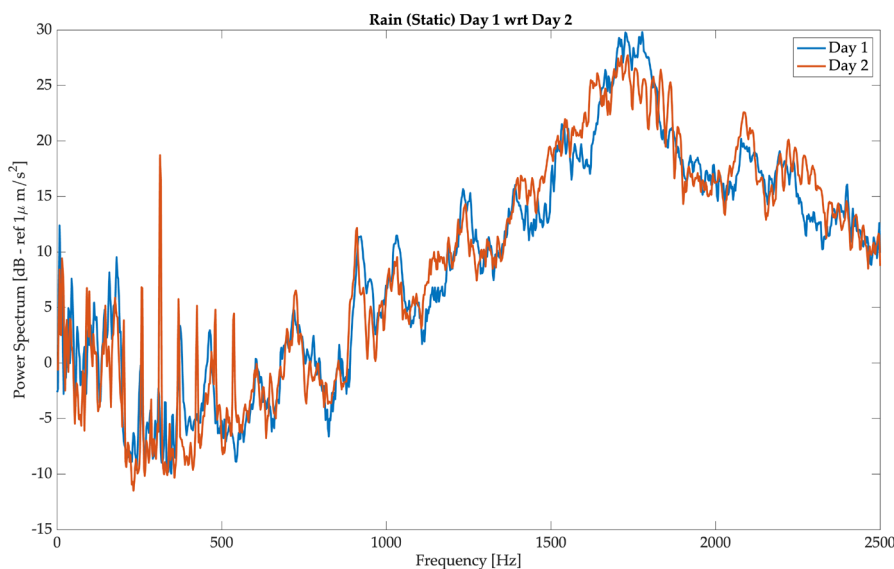
Figure 24. Power Spectrum comparison between Rain (static) test of day 1 and test of day 2.

The physical phenomenon is demonstrated with the example shown in Figure 24, in which two comparable tests—rain (static)— between two different days (day 1 and day 2) are presented. By comparing the power spectrum acquired during the first rain test (blue line) and the one acquired during the second rain test (red line) is evident that the resonances excited by the simulated environmental dynamic load (represented by the impacting rain) are shifted towards lower values. This allows the inference that the structure underwent a stiffness decrease, that can be due to structural yielding.

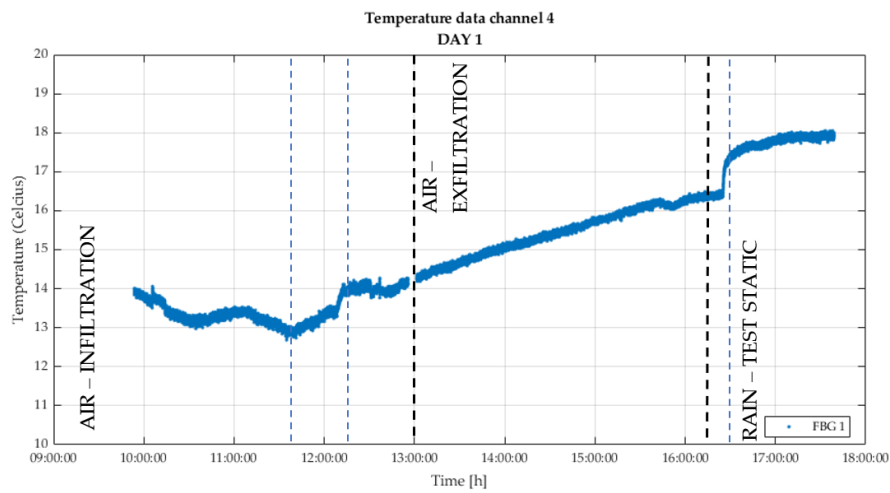
Figure 26. Day 1 FBG for temperature – Channel 4.

FBGs for temperature – Figure 26 displays the results obtained by the FBG sensor for temperature (Channel 4) associated with the InComEss architecture. A noticeable increase in temperature was recorded during the first day of testing, indicating the correct procedure for data collection. The markable timestamps are: 11.50 h - temperature decrease recorded during the air exfiltration test (-600 Pa) (i), 12.10 h - temperature increase of 0.5 degrees can be observed during the test since a heat lamp has been placed near the temperature sensor (ii), 16.30 h - rapid temperature increases from 16-18 degrees due to the rain test likely due to the water temperature (iii).

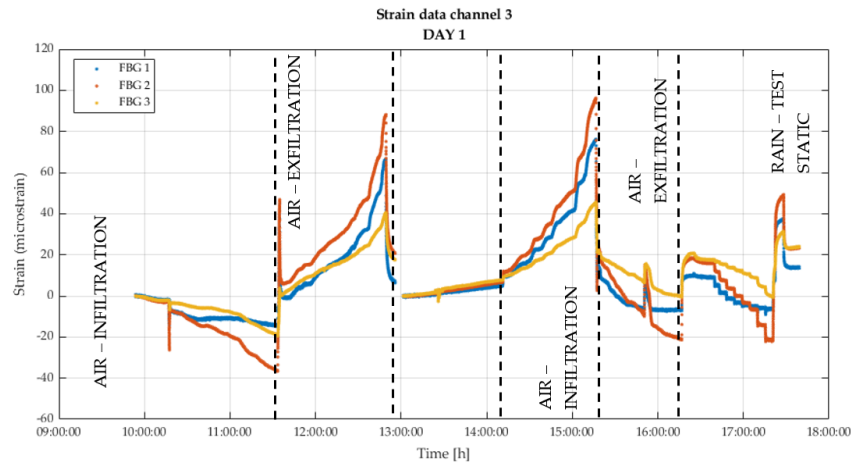
Figure 28. Day 1 FBG for strain – Channel 3.

In this paragraph the FBG for strain's test result are reported. In Figure 28, the strain results obtained by the cable applied on the glass panel during the first day can be observed. The test started with air infiltration followed by the exfiltration repeated twice. The glass surface reached negative values of strain during the increasing pressure and positive ones during the negative pressure. Indeed, the FBG sensor in the first case were in compression while in the second in they were expanded.

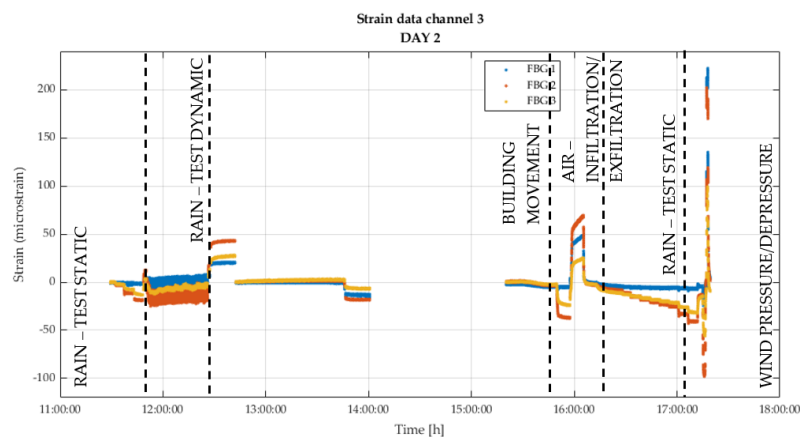
Figure 30. Day 2 FBG for strain – Channel 5.

The highest strain levels have been measured at the end of the second day in channel 3 (z) when the wind pressure and depression were executed, indeed in less than 5" the façade was stressed from 0 to +2625 Pa, and from 0 to -3000 Pa (Figures 30 and 31).

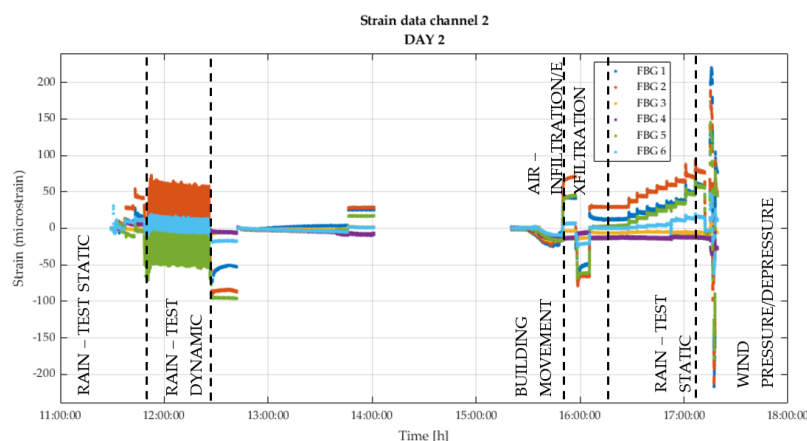
Figure 32. Day 2 FBG for strain – Channel 2.

Figure 32 reports the result obtained for channel 2 during day 2. Strain results obtained from channel 2 (z direction monitoring) are higher than channel 5 (x, y). This can clearly be observed in the rain – dynamic test executes from 11:50h until 12:20h and the rain – test static executes from 16:20h until 17:20h where the strain level raised in steps following the pressure curve increasing. (+600 Pa).
