# Assessment of the Interaction of the Combined Piled Raft Foundation Elements Based on Long-Term Measurements

Keywords: Combined Pile Raft Foundation; long-term in-situ measurements; FEM analysis; sensors

**Abstract:** Understanding the complex phenomena of interactions between the elements of a Combined Piled Raft Foundation (CPRF) is essential for the proper design of such foundations. To evaluate the effects of mutual influence among CPRF elements, a series of long-term measurements of selected physical quantities related to the performance of the foundation were conducted on a building with a frame structure, stiffening walls, and monolithic technology, consisting of seven above-ground stories and one underground story. The analysis distinguishes the real deformations resulting from temperature changes and from stress strains resulting from load changes. The two types of deformations were subject to further interpretation of only changes in stress strain over time. Changes in stress values in the subsoil, as well as strain measurements in the vertical direction of concrete columns, were recorded to assess the load distribution between the CPRF components. The numerical analy

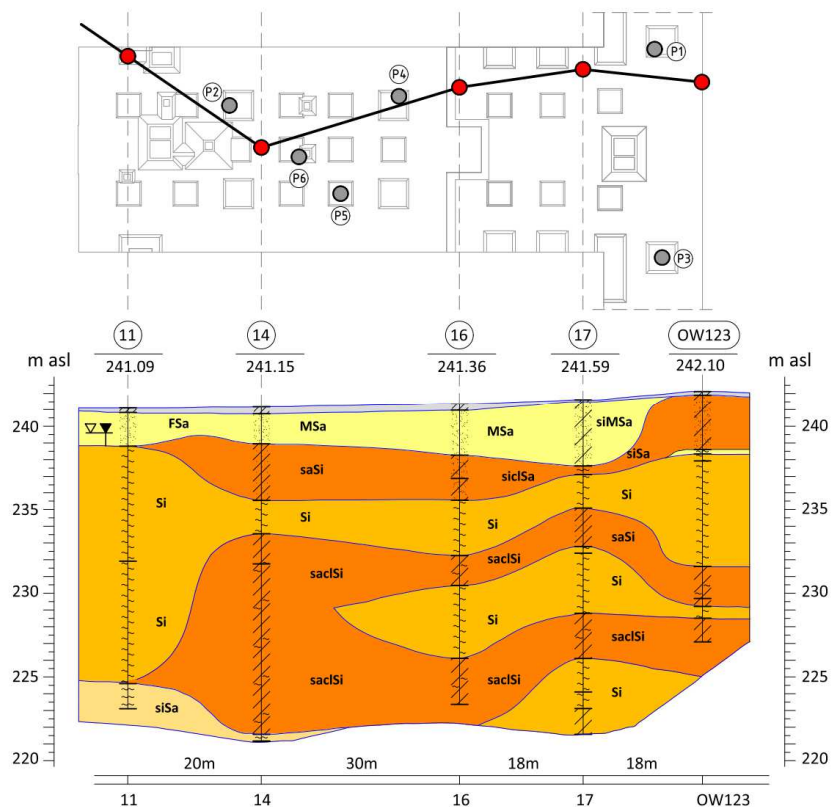
**Figure 1.** Geological-engineering cross-section of the ground beneath the analyzed building. The location of the tested concrete columns (P1 to P6) was marked [11].

Based on the research results, two essential geotechnical layers can be distinguished in the subsoil under the building, as shown in Figure 1. The first one is a layer of Quaternary Pleistocene silty periglacial formations, developed in the form of silty clays, silt, sandy silt, less frequently clays and silty clays, sporadically sandy clays and clayey sands, in a plastic and soft-plastic state with a liquidity index of  $IL = 0.4–0.55$ . Below are silty and fine sands, constituting the interbedding of Miocene clays in a compacted state, with a density index of approximately  $ID = 0.7–0.8$ .

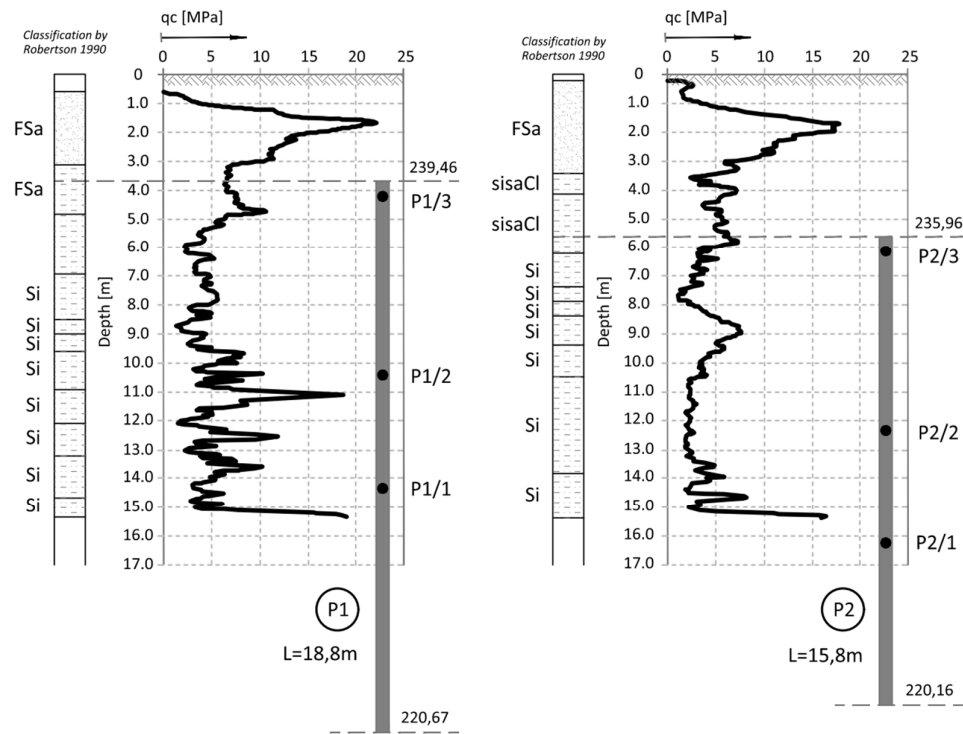
Figure 2. CPT probing in the vicinity of columns P1 and P2 [12].

The ground conditions in the vicinity of columns P1-P6 (see Figure 1) have been detailed by adding the results from the closest CPT – Figures 2 and 4 (for P1 to P6) and from the dilatometric test (Figure 3 for column P3). The resistance of the CPT recorded at the level of 2.0–5.0 MPa confirms the macroscopically recognized and presented in the geological-engineering cross-section (Figure 1) state of silty soils (by PN-B-04452:  $IL = 0.21$  for  $q_c = 5.0$  MPa,  $IL = 0.51$  for  $q_c = 2.0$  MPa).

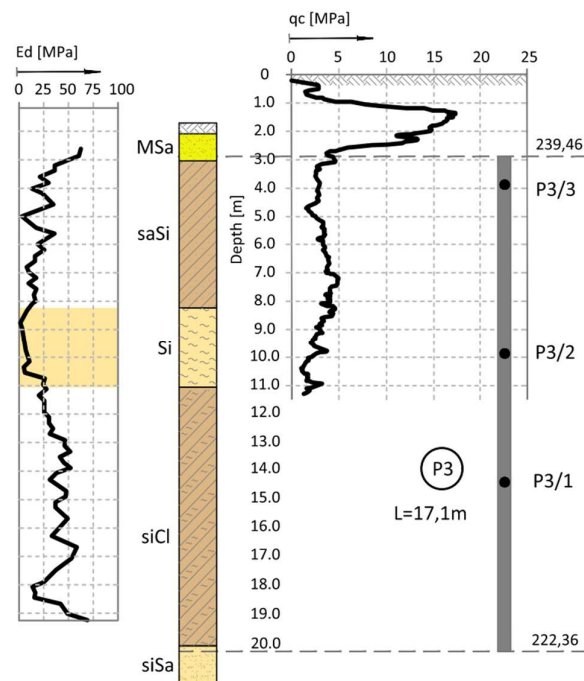
Figure 3. DMT probing (Ed module value) and CPT probing in the vicinity of column P3 [11,12].

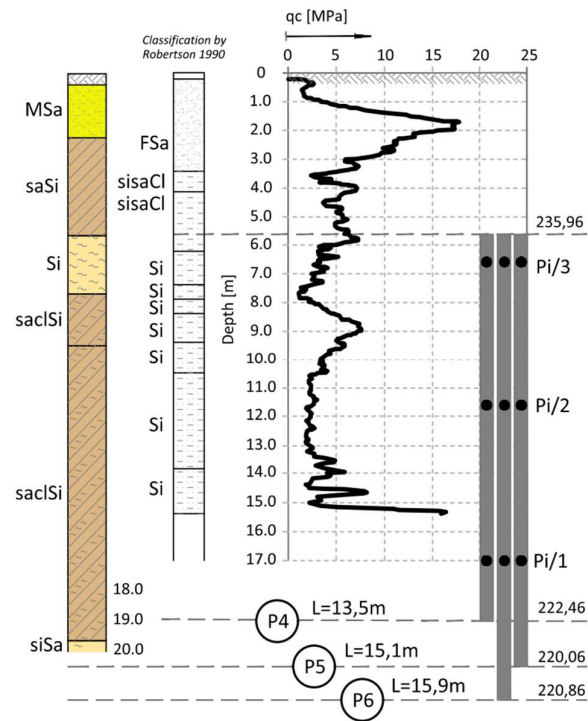
Figure 4. CPT probing in the vicinity of columns P4, P5 and P6 [12].

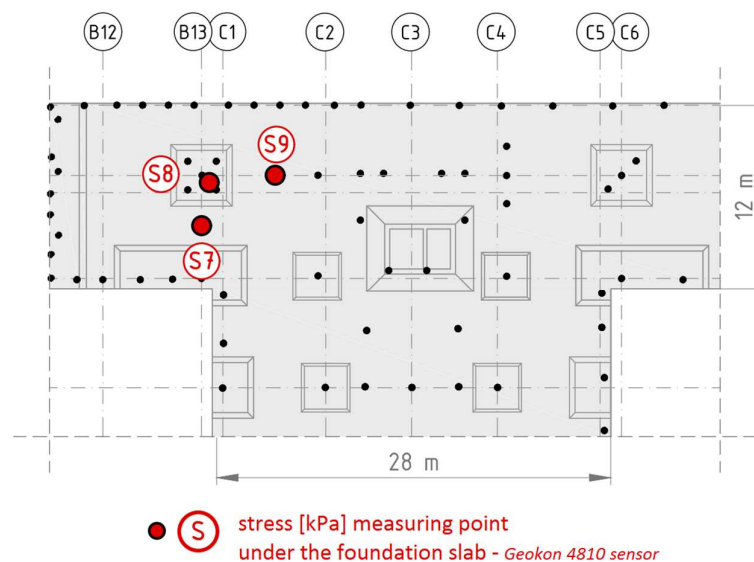
**Figure 5.** Location and names of stress measurement points in the ground under the foundation slab.

To estimate changes in stress values in the ground at the contact point with the foundation slab caused by the varying self-weight of the building during construction, three wire pressure transducers (measured in kPa) were installed in the equalization chamber [13]. One of the sensors was placed in the depression near the measured concrete column (S8), while the other two were positioned as follows: one in the middle of the distance between the edges of adjacent depressions (S7), and the other in the middle of the distance between the edge of the depression and the nearest concrete column (S9), as shown in Figure 5.

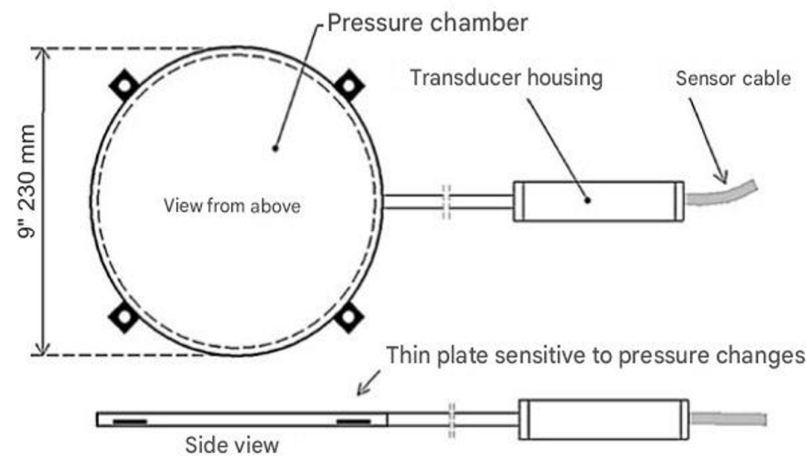
**Figure 6.** Construction of a string pressure transducer.

The system was constructed using Geokon model 4800 wire pressure sensors, which have a measurement range of 170 kPa. These sensors consist of two stainless steel sheets welded together around their perimeter, with a narrow gap between them filled with hydraulic fluid [14,15]. External loads applied to the sensor surface result in changes in the volume of the chamber, causing the fluid to move into or out of the pressure transducer. This movement alters the length of the string connected to the steel membrane that is in contact with the fluid, thereby changing the string's natural frequency [16–18]. Assuming the hydraulic fluid is incompressible, the difference in the frequency of the string vibrations can be translated into changes in pressure [19,20]. Integration with a temperature sensor enables thermal compensation for the sensor readings, ensuring accuracy across varying temperatures. Using individual calibration cards, calculations are performed to determine changes in vertical stresses in the ground beneath the foundation slab, expressed directly in kPa [21,22]. Figure

6 illustrates the construction details of the measuring device, while its basic technical data are provided in Table 2.

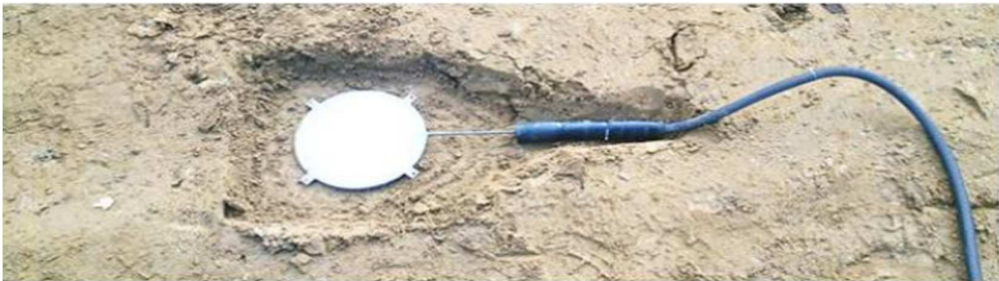
**Figure 7.** View of the recess prepared for the installation of the pressure transducer.

The pressure transducers were installed in the ground beneath the leveling concrete. Prior to installation, the mounting locations were carefully prepared: the ground was excavated to a depth of approximately 0.10 m, and the shape of the recess was adjusted to match the dimensions of the sensor, as shown in Figure 7. Each transducer was placed inside a polypropylene woven bag filled with sand. This procedure was designed to eliminate point interactions and ensure uniform pressure transfer from the foundation slab to the sensor.

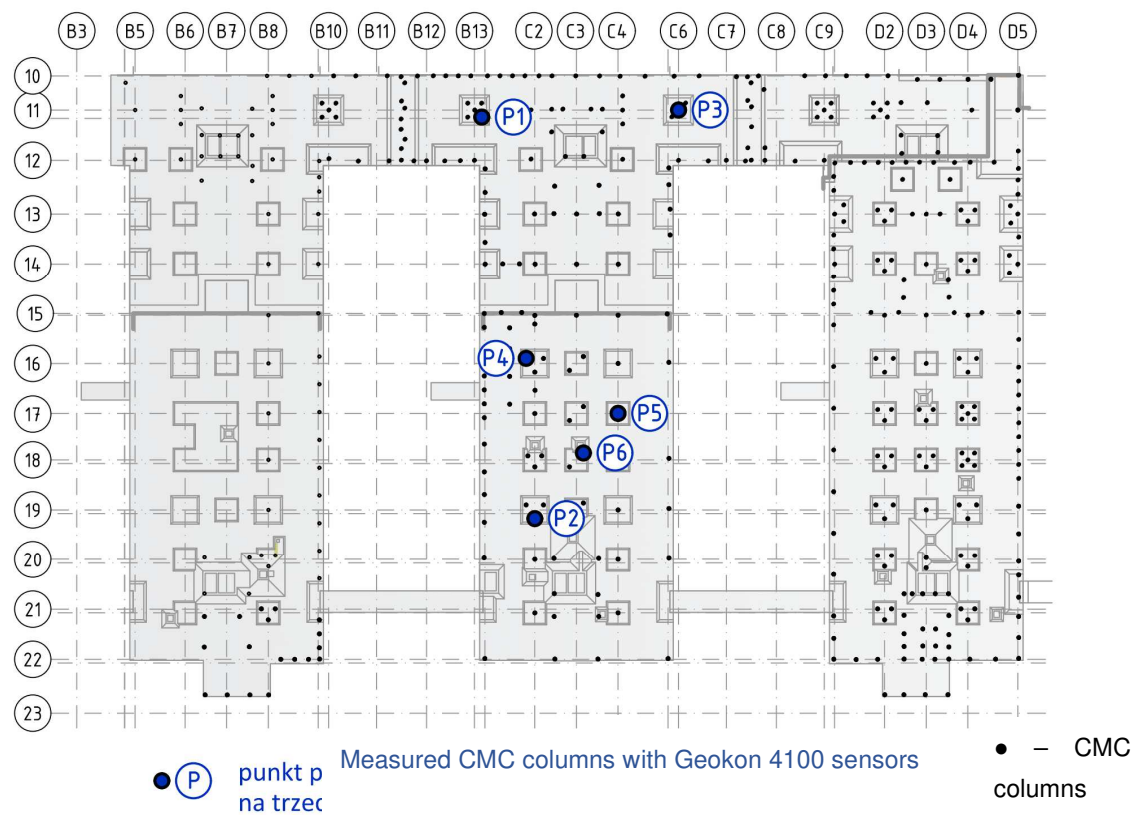
**Figure 8.** Location and marking of measured concrete columns (P1–P6).

The locations of the measured columns and the adopted nomenclature are illustrated in Figure 8. In the subsequent sections of the paper, the axial force variation was analyzed for all columns (from P1 to P6). Additionally, a stress distribution analysis was performed for the slab-subgrade-column system near column P1 [23], focusing on the distribution of load transfer between the structure, the soil beneath the foundation slab, and the concrete column(s).

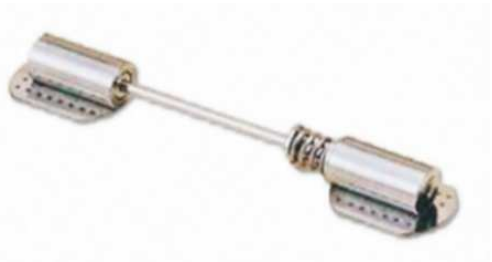
**Figure 9.** Geokon 4100 string strain sensor.

Steel profiles were embedded within the analyzed columns, and Geokon model 4100 wire strain gauges were heated and attached to the profiles at three designated locations. Figure 9 provides a visual representation of the measuring device, while its basic technical data are summarized in Table 3.

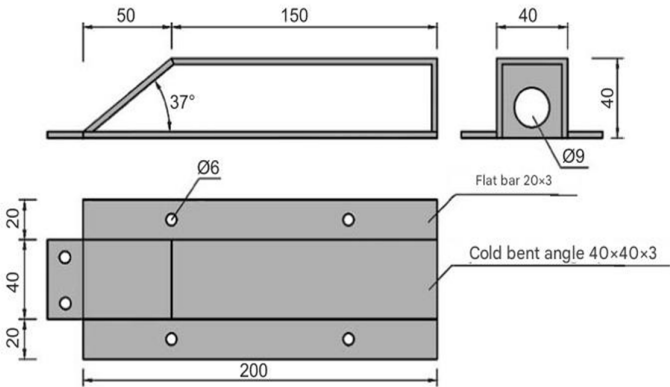
**Figure 10.** Construction of protective casings.

The sensors are enclosed within steel protective housings, as shown in Figure 10, to prevent damage during installation. These housings are specifically designed to minimize resistance from the concrete mix during the pressing or vibrating of the steel profiles, as illustrated in Figures 10 through 13.

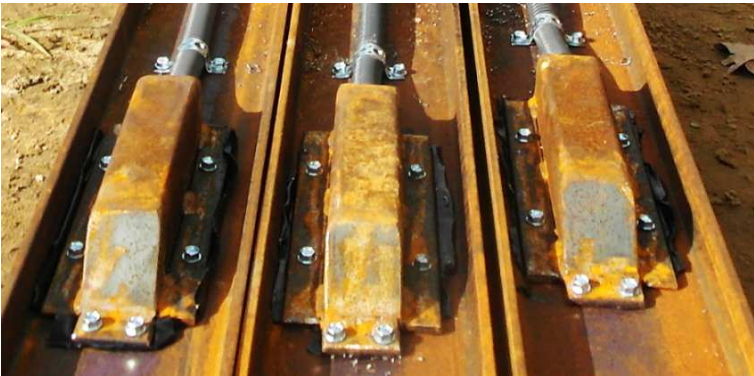
**Figure 11.** Protective casings installed on IPE120 profiles.

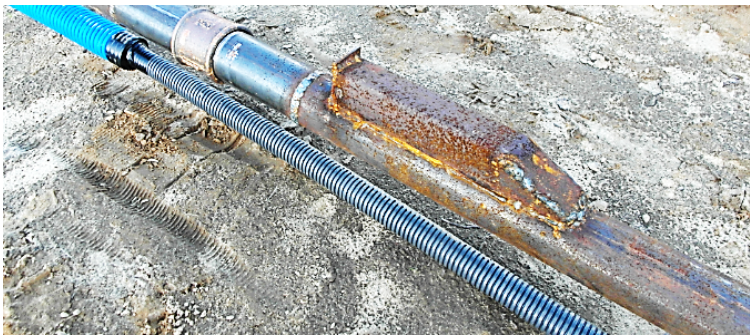
**Figure 12.** Protective casings installed on RO pipes 2"×2.9.

Columns P1 and P2 were equipped with steel pipes measuring approximately 50 mm in diameter, with a wall thickness of 2.9 mm and a length of 15.2 m. The locations of the sensors along the length of the profile are shown in Figure 14. After subjecting these columns to test loads, the upper part of the profile, approximately 1.8 m in length, was cut off to align with the upper surface of the base concrete [25].

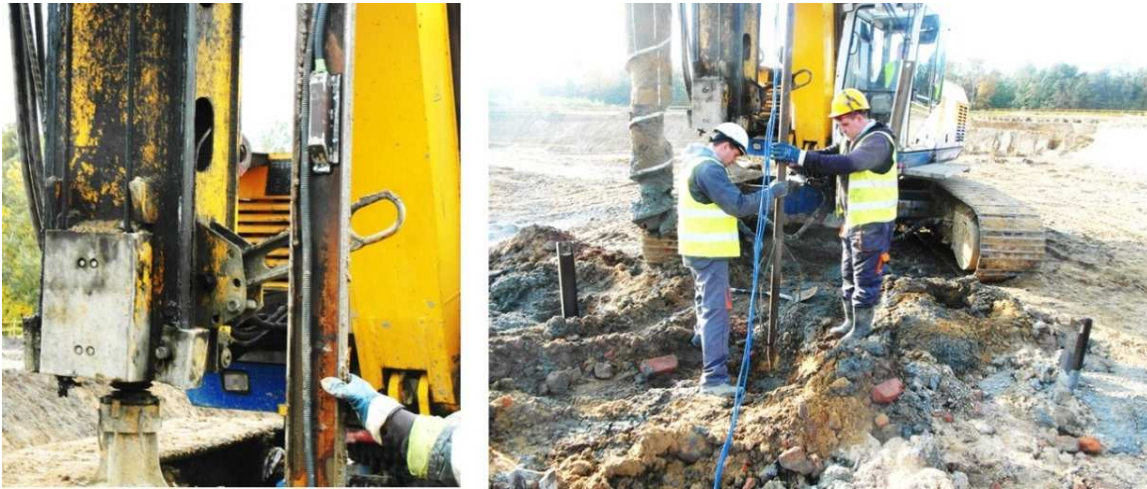
**Figure 13.** View of steel profiles with sensors during the insertion into the concrete mix.

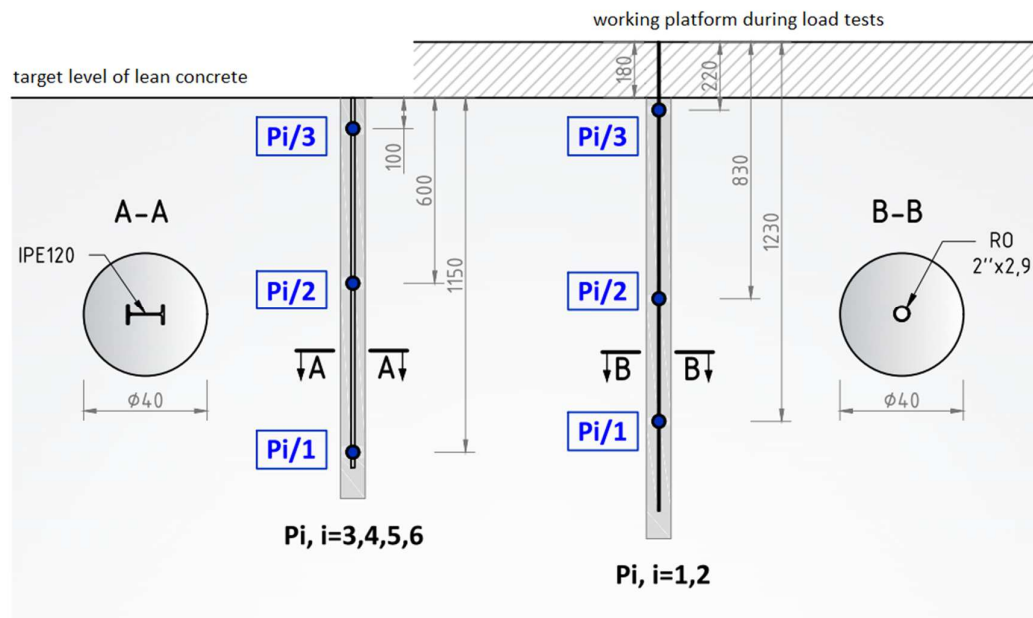
**Figure 14.** The method of installing deformation sensors and the adopted numbering.

Columns P3, P4, P5, and P6, on the other hand, were equipped with IPE120 steel I-beams, each 12.0 m long. Figure 14 also illustrates the sensor placements along the length of these profiles.

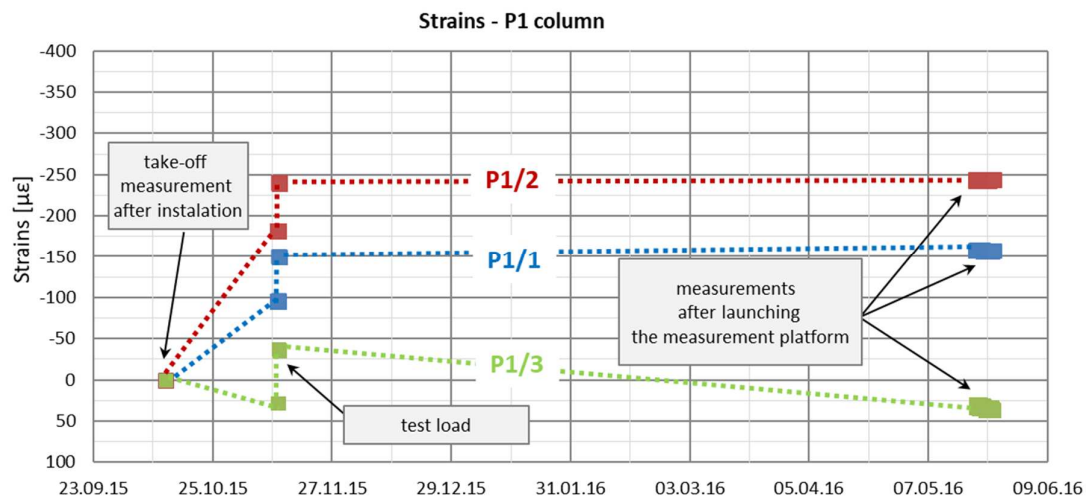
**Figure 15.** Strain graphs of the P1 column in the period from the take-off measurements to the start of automatic measurements.

Automatic measurements were started on 20/05/2016. In Figures 15 and 16, the recorded strain values from this period are presented in relation to the assumed take-off measurements from 12/10/2015. The dotted lines in the graphs below were introduced only to increase the Figures' readability because the intermediate periods' strain functions are unknown.

Based on the graphs of deformations measured in columns P1 and P2 at three depths (Figures 15 and 16), from their installation on 12/10/2015 until the activation of automatic measurements on 20/05/2016, three distinct phases can be identified. The first phase corresponds to changes in deformation due to the maturation of the concrete mix. The second phase is associated with deformation changes resulting from the application and removal of the test load. The third phase covers the waiting period for the initiation of automatic measurements during the building's construction, reflecting an increase in load due to the building's own weight.

In the first phase, column shortening was observed in all sensors except P1\_3, most likely caused by temperature changes following the release of heat during cement hydration, along with concrete shrinkage. Shrinkage occurs due to structural changes in the cement paste caused by physicochemical processes of water loss during concrete setting and hardening. It is assumed that shrinkage was facilitated by the soil's moisture content of 25%. In contrast, sensor P1\_3, located near the column head, exhibited an opposite trend: swelling, likely caused by the presence of water in the upper soil layers during the setting of the concrete mix. Column shortening may also have resulted from the load imposed by the concrete mix itself. However, since column deformations were measured at only two points in time (at the start of the concrete setting process and at the onset of the test load), it is not possible to fully or accurately interpret the processes occurring in the column during the initial 30 days after its installation in the ground.

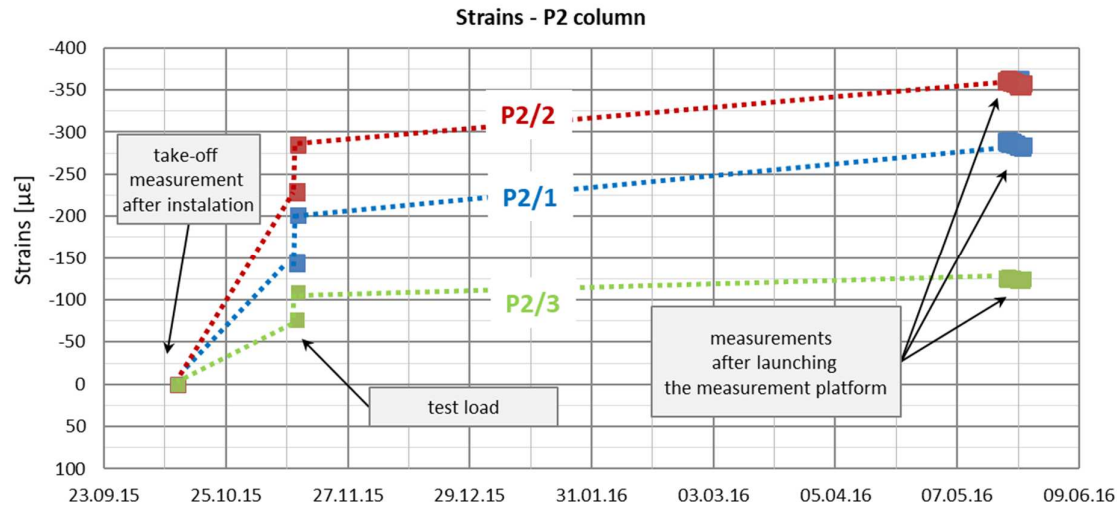
**Figure 16.** Strain graphs of the P2 column in the period from the take-off measurements to the start of automatic measurements.

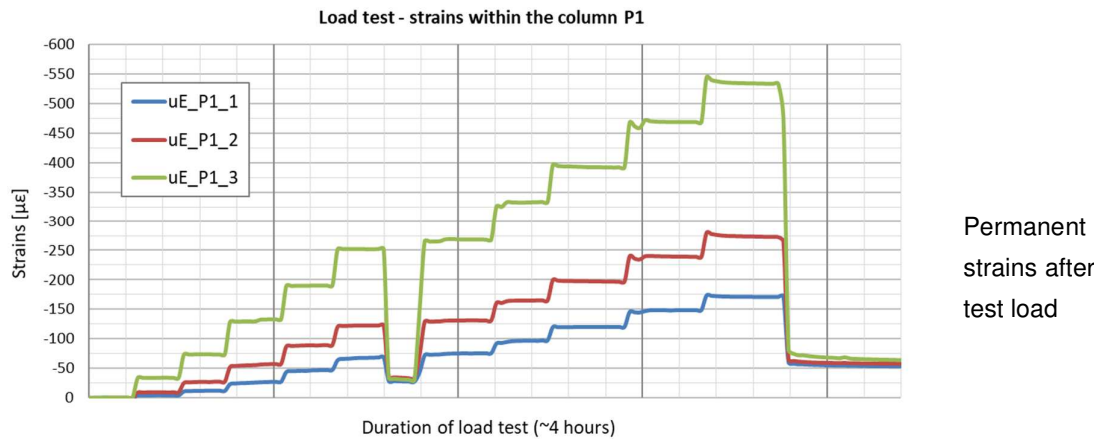
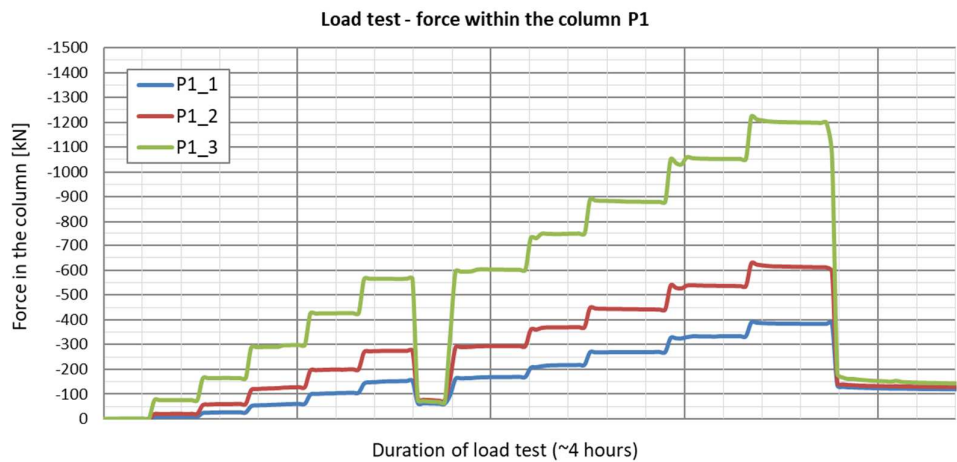
Figure 17. a) Deformation of column P1 and b) axial force in column P1 during load test.

In column P1, the distribution of the axial force (Figure 19a) corresponded to typical column operation. Specifically, the estimated force values at all stages of the test load were highest for the sensor located at the highest point (P1\_3), where the observed values were close to the force applied to the head at each stage of the load. The lowest force values were recorded by the sensor at the deepest point (P1\_1). This response indicates good cooperation between the column side and the ground, as well as good quality of the column shaft.

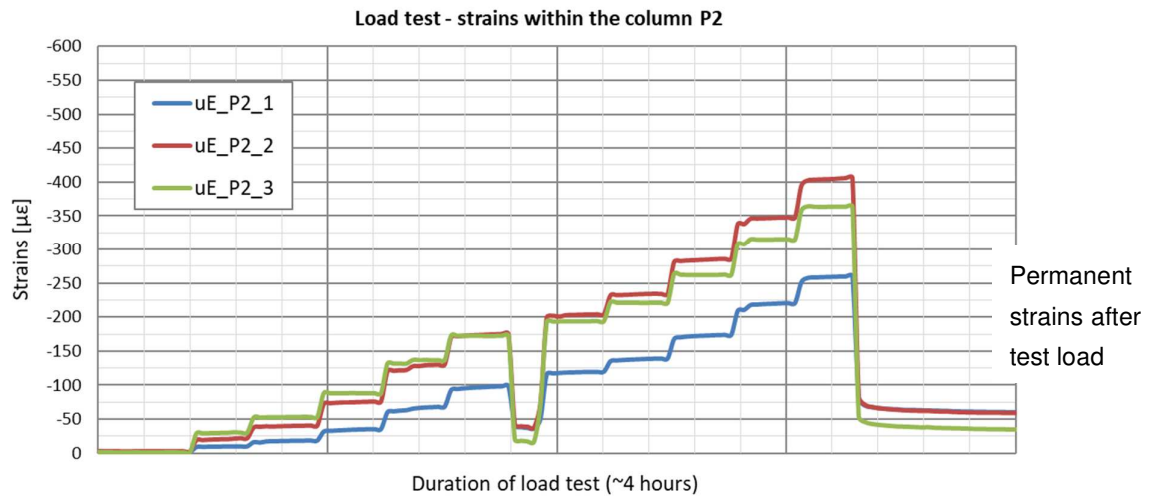
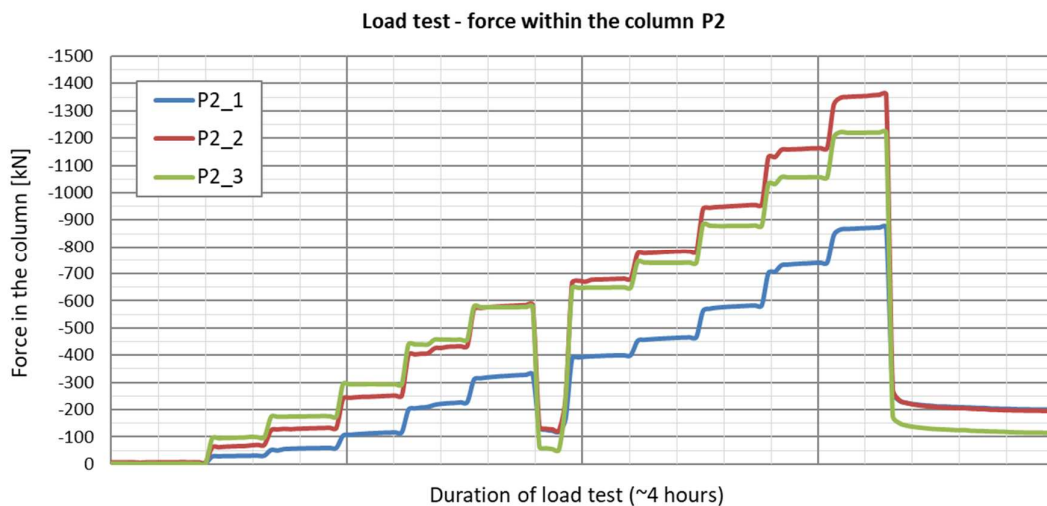
**Figure 18.** a) Deformation of column P2 and b) axial force in column P2 during load test.

During the second phase, corresponding to the test load, column shaft shortening was observed (Figure 18), accompanied by a residual force remaining in the column shaft after unloading. Based on deformation measurements, it can be concluded that the residual force in column P1 is greater than that in column P2. Comparing these observations with the axial force changes along the column during the test load (Figure 19), these conclusions appear well-founded. The performance of the side surface of column P1 is better compared to column P2, which ultimately results in the mobilization of greater force during the test load and, consequently, a higher residual force in column P1.

In column P2 (Figure 19b), during the first stage of loading, the force estimated from the measurement with sensor P2\_3 was only slightly higher than the force estimated using sensor P2\_2. After the fifth stage and unloading of the column, the force at point P2\_2 was higher than that at point P2\_3 during the subsequent loading step. Although a measurement error cannot be ruled out, the author believes this axial force distribution could indicate narrowing in the vicinity of sensor P2\_2. It may also suggest the absence of friction mobilization on the column side up to the depth at which the P2\_2 sensor was located.

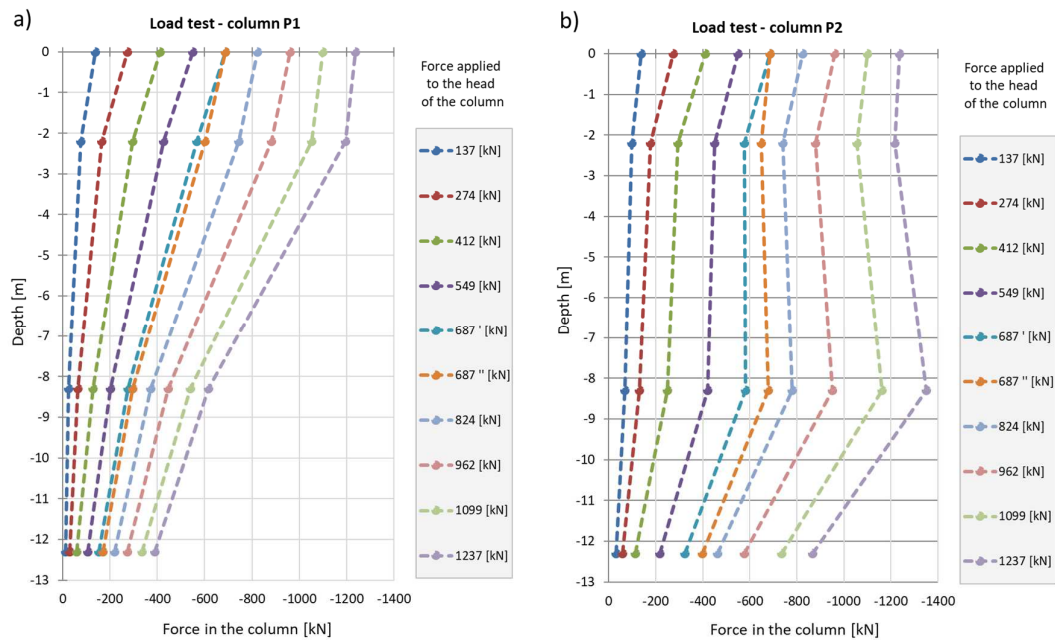
**Figure 19.** Graphs of the force distribution along columns a) P1 and b) P2 during the test load. Graphs made based on the strain readings.

The conclusions from the axial force distribution interpretation along the shafts of columns P1 and P2 (Figure 19) for different load steps can be compared to the findings resulting from the load-settlement relationship for their heads (Figure 20). After the final unloading for P1, practically no change in the head elevation was observed, while the head of column P2 moved upwards after the load was removed. The share of plastic deformation of the soil along and under column P2 is relatively small. Column P2 deforms elastically without the cooperation of the side surface (lack of lateral constraints). In the case of column P1, the side surface works much better, which is manifested by a practically complete reduction of the column head displacement upwards because the side surface counteracts the column from rising.

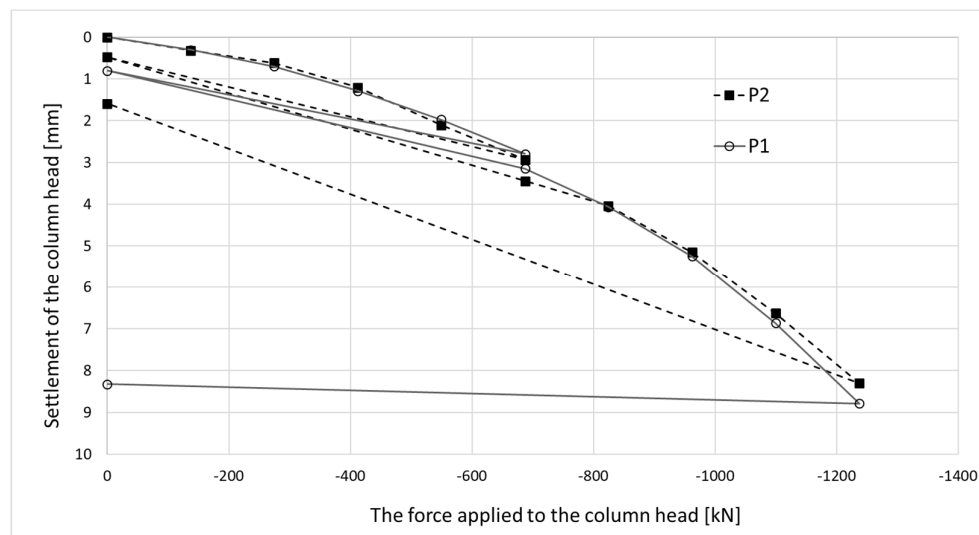
**Figure 20.** The load-settlement relationship for the head for columns P1 and P2 (load test results).

Despite the differing behavior of the side surfaces and bases of columns P1 and P2, the load-settlement relationship determined for their heads is very similar (Figure 20). This indicates that, from the perspective of the structure's overall behavior, the columns perform almost identically within the analyzed load range.

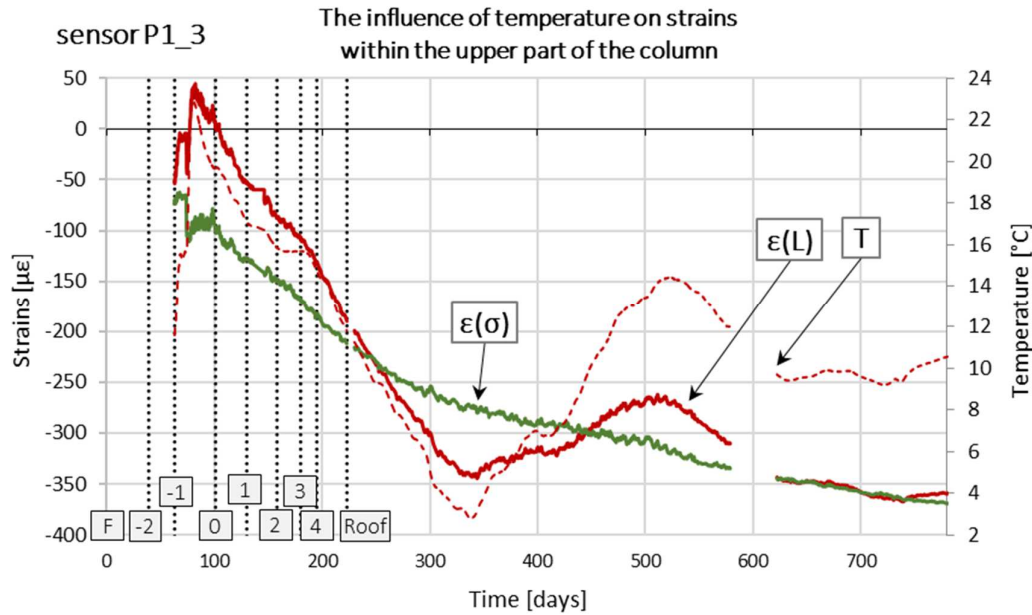
**Figure 22.** Influence of temperature on the determined strain values. Designations:  $\epsilon(L)$  - real strains [27],  $\epsilon(s)$  - stress strains.

Sensors Pi\_3 were installed at the point of the greatest temperature and atmospheric pressure fluctuation. For example, Figure 22 shows a graph of temperature changes as a function of time measured by sensor P1\_3, placed in column P1. The graph shows that the temperature of the concrete near the head changes significantly and directly affects the values of deformations and, therefore, the estimated values of the axial force in the column.

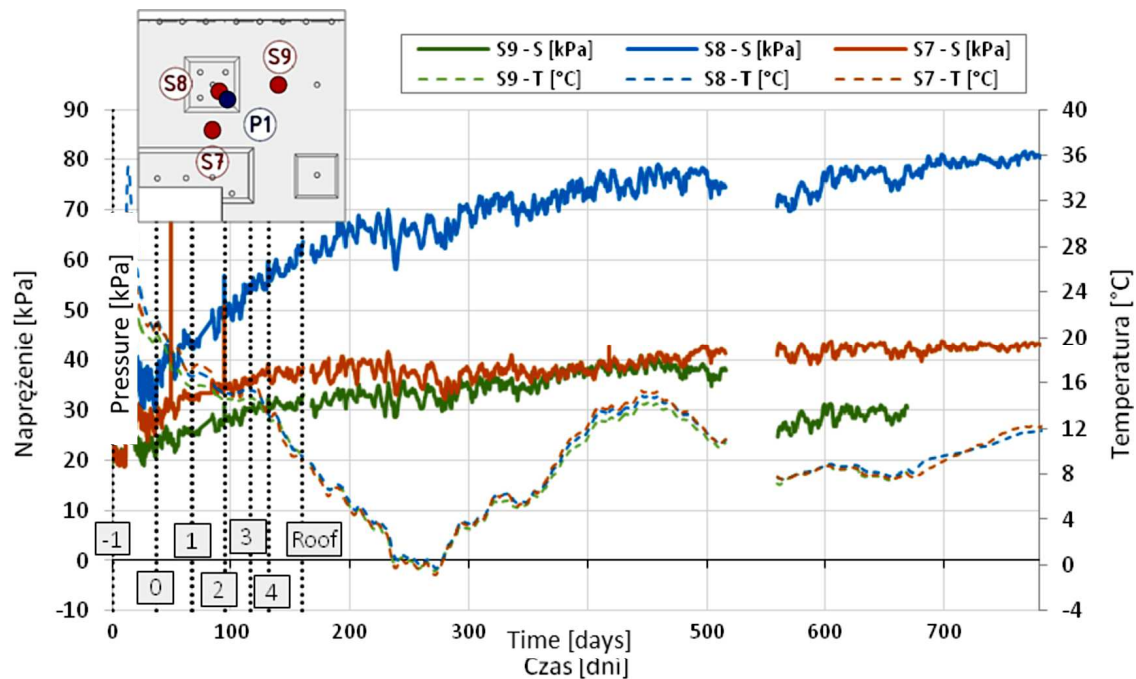
**Figure 23.** Change in the stress value in the ground under the foundation slab as a function of time for selected locations, taking into account the correction resulting from the stresses existing in the ground at the moment of starting the measurement.

The stress (pressure) change in the subsoil under the foundation slab was analyzed as a function of time (Figure 23). As mentioned earlier, the string pressure transducers were located in such a way as to enable the determination of the part of the foundation slab through which the load is transferred to the subsoil from the point support of the column type. One of the stress sensors was installed in a depression in the vicinity of the measured concrete column (S8), while the other two were in the middle of the spans, between the adjacent depressions (S7) and between the depression and the subsequent columns (S9) - compare Figure 2. The measurements were designed to provide the information necessary to determine the vertical load distribution between the subsoil under the foundation slab and the concrete columns.

The automatic measurement system was launched on 20/05/2016 at 16% of the construction progress about the shell of the entire building (compare Table 1), i.e., after the foundation slab and the ceiling above story -2 were completed in the part between axes C1-C5/15'-22' and after concreting the foundation slab between axes B12-C7/10-15 (in the measurement area). In connection with the above, a correction was introduced to the stress measurement, consisting in taking into account the initial

Based on the stress measurements in the subsoil under the foundation slab outside the recess (sensors S7 and S9), assuming for analysis the stress value from measurements taken between day 400 and 500, i.e., approx. 40 kPa, it can be hypothesized that the soil, apart from the foundation slab's dead weight, transfers the load from the above-ground part of the structure at a level of approximately 20 kPa. The area of the slab within the column, where the recess of the foundation slab with an area of  $3.5 \text{ m} \times 3.5 \text{ m}$  is located, transfers to the ground a load that is more than twice as high, i.e., the stresses measured in the ground are of the order of 80 kPa, of which 30 kPa is the dead weight of the foundation slab, and 50 kPa is the load transferred by the column to the foundation.

To determine the load distribution on the subgrade and concrete columns, a comparison was made of the stress values transferred to the subgrade by the above-ground part of the structure (Figure 23), and the forces mobilized in the concrete columns (from Figure 24) with the total value of the force transferred by the column to the foundation slab. This force was estimated by the structural designer at the level of  $F_{c,d} = 10125 \text{ kN}$  based on the analysis of the FEM model of the above-ground part of the structure. Assuming the average load factor at the level of 1.2 (static and strength calculations were carried out based on the PN-B standard package), the average value of the force in the column can be estimated as  $F_{c,k} = 8438 \text{ kN}$ . The additional load on the ground beyond the slab depth, which was measured the value was 20 kPa in the area of  $7.75 \text{ m} \times 10.30 \text{ m} - 3.5 \text{ m} \times 3.5 \text{ m} = 67.6 \text{ m}^2$ , allows us to estimate the value of the force taken up by the ground under the slab at the level of  $F_{r2,k} = 1352 \text{ kN}$ . The additional load on the ground under the slab recess determined based on the measured stress of 50 kPa in the area of  $3.5 \times 3.5 = 12.3 \text{ m}^2$  gives the force value  $F_{r1,k} = 613 \text{ kN}$ . In total, the plate transfers a force of  $F_{r,k} = 1965 \text{ kN}$  to the subgrade. The value of the axial force estimated after 788 days based on the measurement of concrete deformations with the P1\_3 sensor located near the head of the P1 column is  $F_{p,k} = 869 \text{ kN}$ . Considering the actual distribution of 7 columns within the recess (Figure 170), it can be assumed that the total load taken by the group of columns is  $F_{pg7,k} = 7 \times 869 \text{ kN} = 6083 \text{ kN}$ . The sum of the values of the force taken by the ground  $F_{r,k} = 1965 \text{ kN}$  and the columns  $F_{pg7,k} = 6083 \text{ kN}$  is  $F_{c',k} = 8048 \text{ kN}$  is very close to the force value specified by the structural designer, i.e., 8438 kN. The difference is about 4.8%. Finally, it can be assumed that in the analyzed

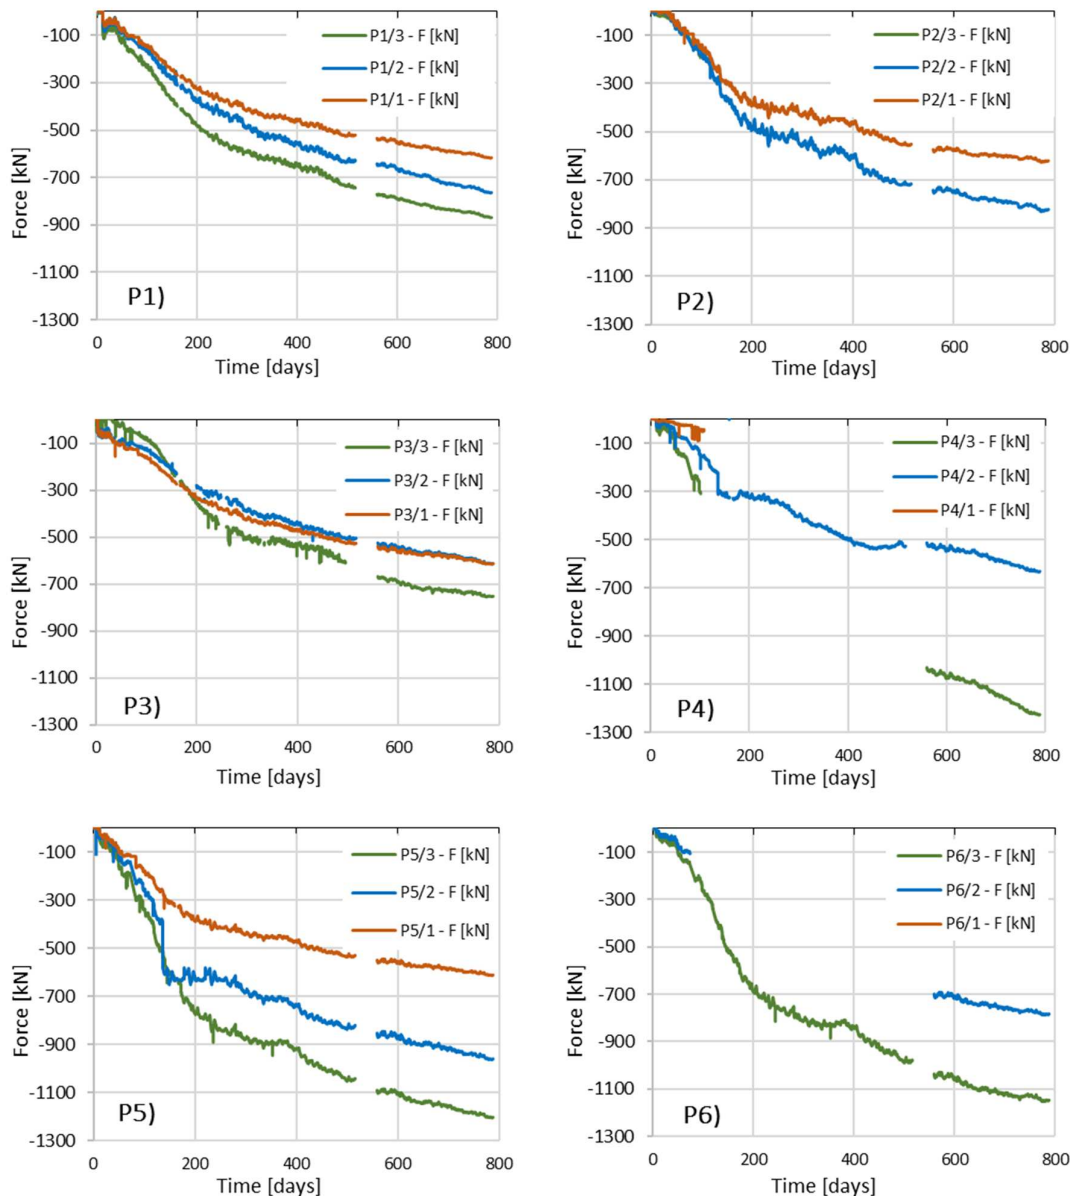
**Figure 24.** Change of the estimated value of the axial force as a function of time based on the measurement of concrete deformations.

After about 100 days of observation in column P2, sensor P2\_3, which is located in the vicinity of the column head, no correct readings were observed.

During the measurements of deformations in column P4, 120 days after their commencement, the lack of correct readings was found in two sensors: the lowest (P4\_1) and the highest located (P4\_3) sensor. The fault caused by the broken wiring was removed in sensor P4\_3 after 560 days.

During the installation of the measuring system in column P6, the repeated lifting and pressing of the steel I-beam into the concrete mix damaged the cable of the lowest-located sensor P6\_1.

After approximately 70 days of readings in column P6, the middle sensor of column P6\_2 was not receiving correct readings. The sensor was restored to working order after 560 days.

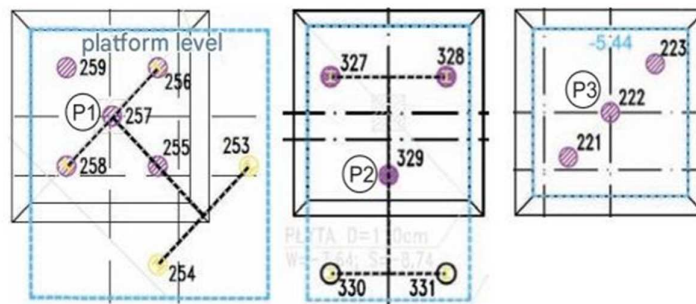
**Figure 25.** Column arrangement around column P1, P2 and P3.

Column P1 works in a group of 5 or 7 columns if we consider the additional two anchor columns made to carry out the test (Figure 25) at a spacing of 1.4 m (approx.  $3.5D$ ). Considering the anchor columns, column P1 works as a middle column.

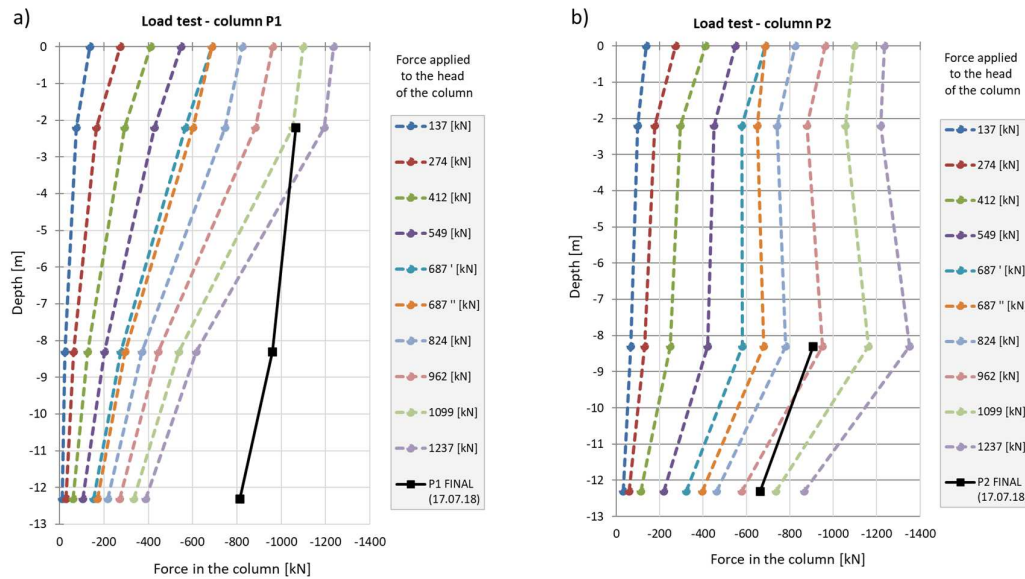
**Figure 26.** Distribution of force along columns a) P1 and b) P2 during the test load and for the last reading during the construction of the building (solid black line).

The observations led to the conclusion that the statement about the existence of the so-called “dead zone” that typically occurs at small axle spacing should be considered correct. Columns of the 3D row This situation can be explained by the limitation of friction mobilization on the side due to the reduction of the relative displacement of the upper section of the column about the surrounding soil. As a result of the pressure of the slab on the columns and the ground, the columns and the surrounding soil under the slab are subject to identical displacement. This interpretation is consistent with the conclusions presented in [28] regarding the interactions between piles and the interactions between piles and the slab, according to which the friction on the side of the pile/column in the combined piled raft foundation is mobilized only in its lower part, i.e., on  $1/3$  to  $1/4$  of the total pile length, i.e., 6.3 m in the case of our tests.

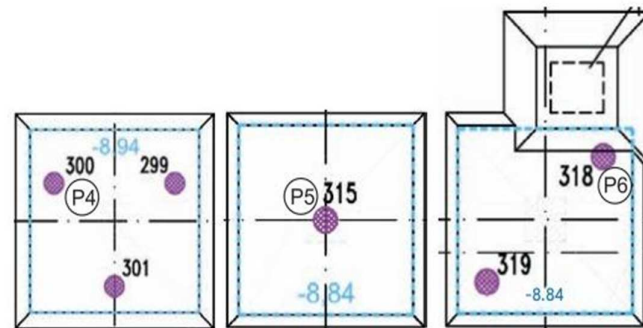
**Figure 27.** Arrangement of columns around columns P4 (No. 300), P5 (No. 315) and P6 (No. 318).

Based on the measurements carried out, the behavior of columns P4, P5 and P6 can, with high probability, be compared to the behavior of typical columns corner/edge in the spacing of the order of 6D. Columns P4, P5 and P6 were located on the edge of the column group. Mobilization of friction on the side surface along the entire length of the column results in a significant decrease in the axial force along the column.

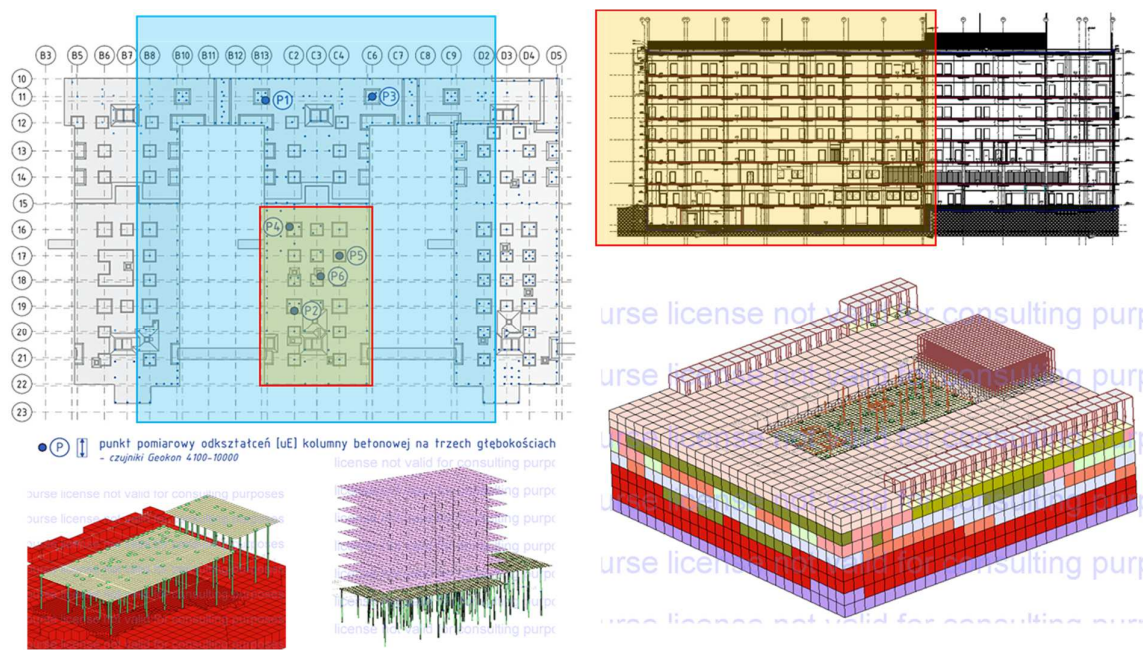
Figure 28. FEM model (ZSoil) of the selected part of the building.

The FEM model [28] [29] was limited to a detailed analysis of the part of the structure located between the B12-C7/10-15 axes (red contour) with column P2, taking into account the influence of the part located between the C1-C5/15'-22' axes and parts of the neighboring buildings with uniformly distributed load shown in Figure 28. The model considered the point average load from the most unfavorable combination of loads from all stories of the analyzed building acting on the foundation slab (from ARSA to Zsoil). The load in the form of concentrated forces was applied to the foundation slab at the locations of columns and walls. The model reproduced the actual arrangement of columns with their lengths from the as-built documentation. The columns were modelled as piles (beams) with a  $D = 0.40$  m diameter. To stiffen the structure, all stories were taken into account in the FEM model.

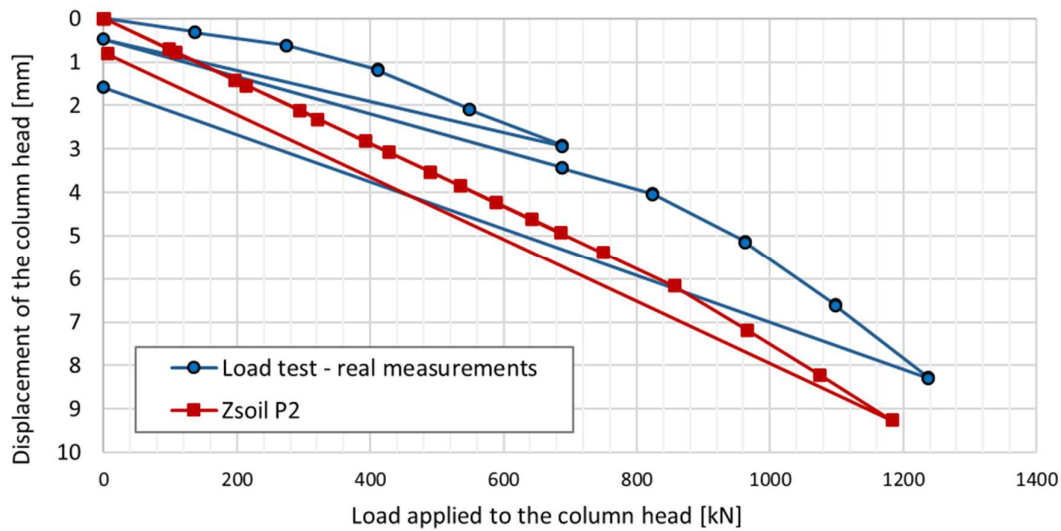
**Figure 29.** Load-settlement relationship of the P2 column head. Comparison of actual measurements with FEM simulation (ZSoil P2).

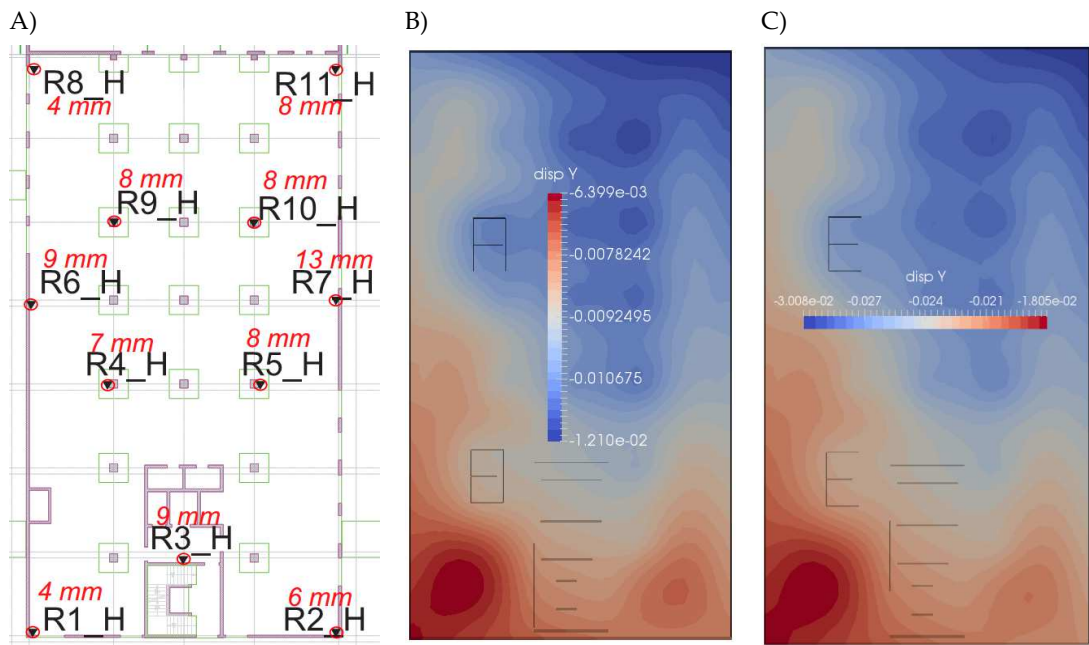
**Figure 30.** Comparison of the foundation slab settlements based on the results of A) geodetic monitoring (last measurement from 12/06/2018, identical as on 30/01/2017) and FEM analysis (ZSoil) B) for 60% load and C) for 100% load.
