# Assessment of the Interaction of the Combined Piled Raft Foundation Elements Based on Long-Term Measurements

Keywords: Combined Pile Raft Foundation; long-term in-situ measurements; FEM analysis; sensors

**Abstract:** Understanding the complex phenomena of interactions between the elements of a Combined Piled Raft Foundation (CPRF) is essential for the proper design of such foundations. To evaluate the effects of mutual influence among CPRF elements, a series of long-term measurements of selected physical quantities related to the performance of the foundation were conducted on a building with a frame structure, stiffening walls, and monolithic technology, consisting of seven above-ground stories and one underground story. The analysis distinguishes the real deformations resulting from temperature changes and from stress strains resulting from load changes. The two types of deformations were subject to further interpretation of only changes in stress strain over time. Changes in stress values in the subsoil, as well as strain measurements in the vertical direction of concrete columns, were recorded to assess the load distribution between the CPRF components. The numerical analy

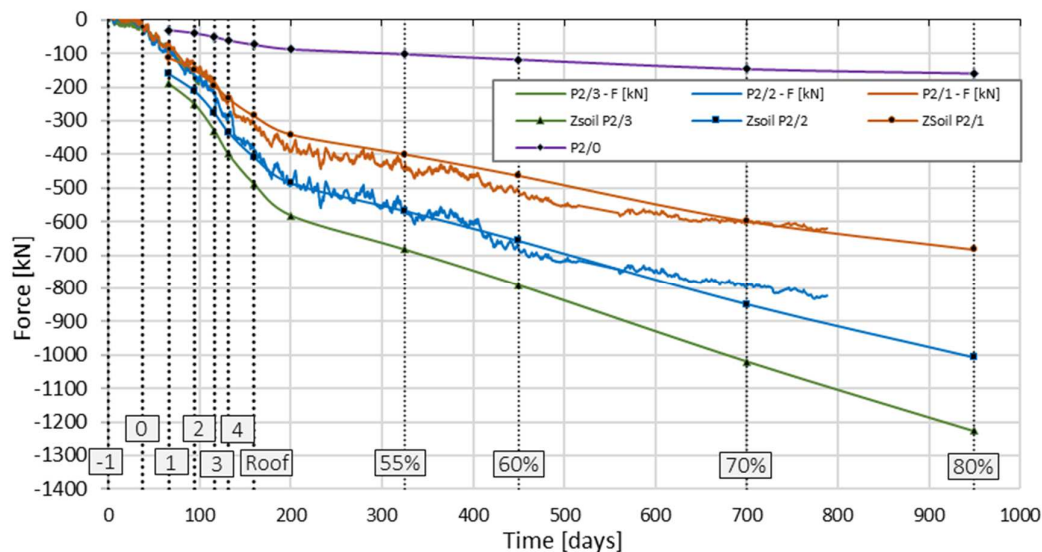
**Figure 31.** Change of axial force values as a function of time in column P2 for three depths. Force values estimated from field tests and read after correction from the FEM model (ZSoil).

Considering that automatic measurements began after the foundation slab and the ceiling above the “– 2” level were completed, the modification of axial forces also included the ceiling weight. In total, according to Table 1, the values of axial forces, estimated numerically at each load step, were reduced by the value of forces generated for 16% of the full load. In accordance with the records from the Construction Journal regarding the commencement of concreting of individual levels of the building, for each characteristic load step, the corrected value of axial force at the depth corresponding to the location of sensors P2\_3, P2\_2 and P2\_1 was read from the ZSoil program and compared with the force values from the column deformation measurements (Figure 31). Additionally, the values of axial force at a depth of 14.48 m estimated in ZSoil were plotted.

This is most likely because the load values from the most unfavorable combination were used in the numerical analysis and were overestimated compared to the actual values. The numerically determined value of force as a function of time in the P2\_3 sensor, located in the vicinity of the column head, allowed for a comparison of the behavior of a single column with the behavior of a column of a combined piled raft foundation. Figure 177 shows the course of the load settlement relationship of the column head. The actual measurement of the foundation slab settlement in the benchmark located directly above the P2 column was compared with the value of force in the P2\_3 sensor read from the FEM model.

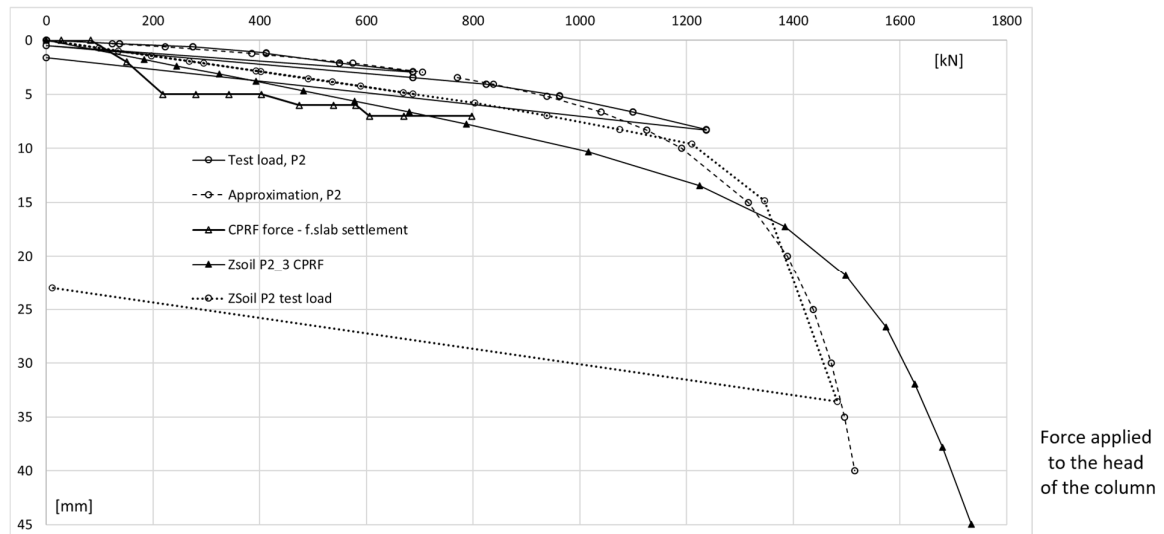
**Figure 32.** Load–settlement relationship of the P2 column head (for a column working alone vs. for a column in a slab–pile foundation). Actual measurements from the column test (continuous line, empty circle marker); FEM simulation of the test (ZSoil Test Load P2, dotted line).

Based on the comparison of the load-settlement (Ns) curve for a single column from the test load with the Ns curve for a column with a combined piled raft foundation (Figure 32), it can be concluded that the FPP column, in the range of small deformations of the soil medium (correspondingly, the settlement of the column head at the level of several millimeters), is characterized by lower stiffness, i.e., it settles more than an independent column at a similar load value.

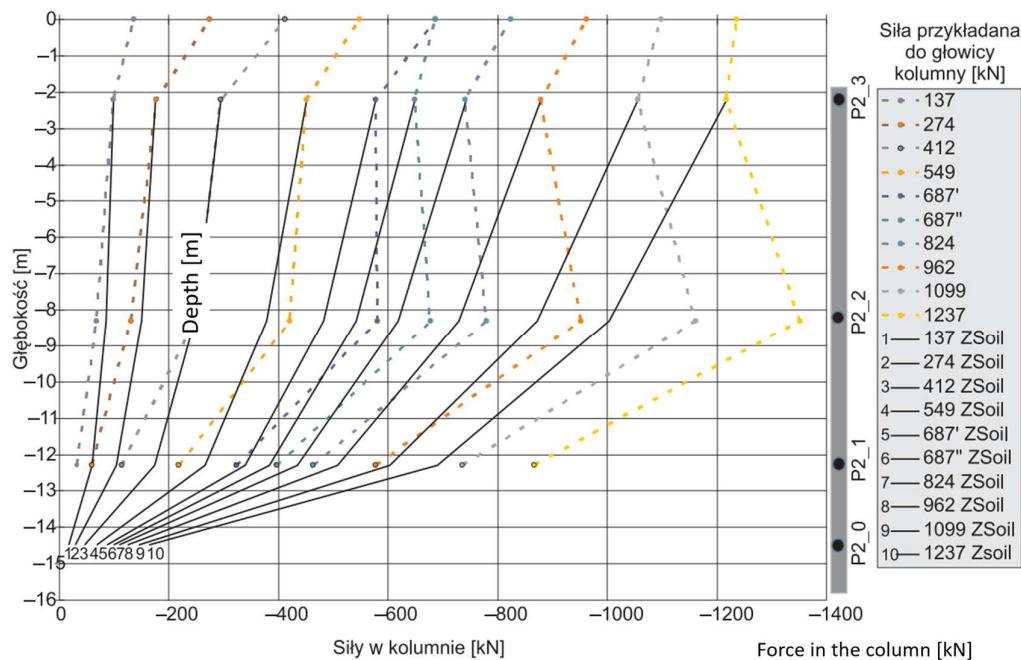
**Figure 33.** Distribution of force along column P2 during test load (actual results) and during the construction of the building based on the FEM analysis (ZSoil).
