Experimentally Based Analysis of Mechanical Behaviour of Timber-Concrete Composite Beams with Different Connecting Systems

Keywords: timber-concrete composite structures; connecting systems; experimental setup; mechanical behaviour

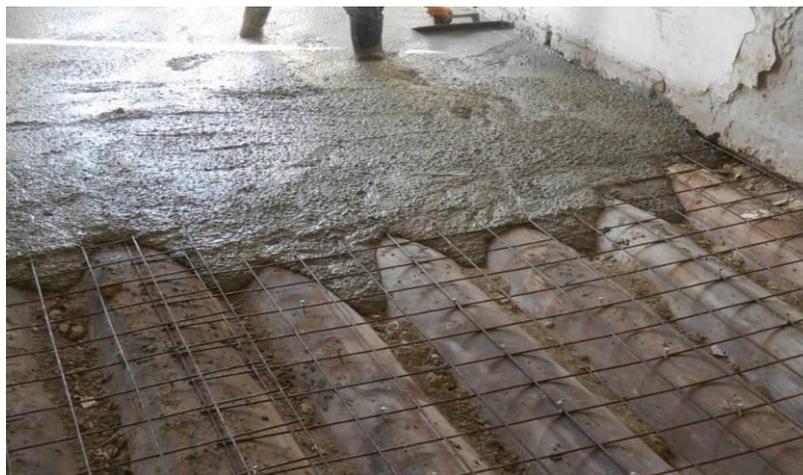
Figure 1. Strengthening of the existing timber floor structures of the object with a cultural monument status, using the method of coupling with concrete. (Serbia, R. Cvetkovic).

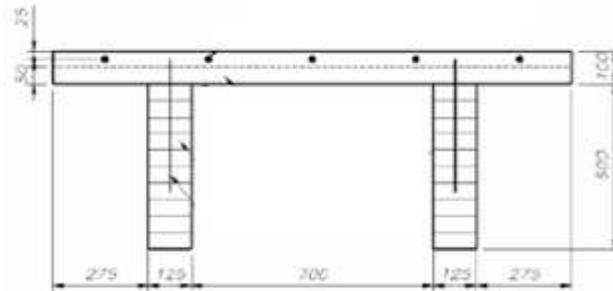
Figure 2. Cross section of a composite beam of timber-concrete type (Ceccotti, 2006).

Ceccotti [7,8], examines the composite system which consists of two LLD (glued laminated timber) beams, and a concrete slab, with a cross-section and geometry as in Figure 2, with a 6m span. A fastener connecting system made of reinforcement with the diameter of 18mm is installed into previously drilled holes positioned along the joint of the timber and concrete, with 150-450mm between the holes, and the spaces around are afterwards filled with epoxy resin. Before doing the static test up to the fracture, the beams were exposed, during a 5-year-long period, to a constant, long-term loading outdoors, and their performance was monitored. The fracture happened when the load was $2P=500\text{Kn}$, the measured deflection in the middle of the span was 33,2mm, and the movement in the interlayer between timber and concrete in the support zone was 2,47mm. The brittle fracture due to an excessive tension strength of the timber part of the construction, was caused by a 2.44 times higher value of the load than it was originally calculated. The degree of the composite action was 87-93%. The results of the experiment are compared with the result given in the y-procedure in which the slip module values of fasteners K_{04} , K_{06} , K_{08} defined by *push-out test* were used in the calculation and good results were achieved.

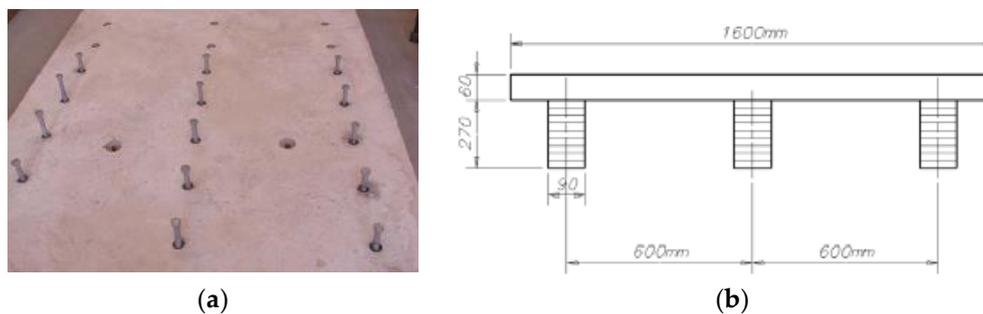
Figure 3. a) Composite beam of timber-prefabricated concrete type; (b) Cross section of sample (Lukaszewska 2010).

Lukaszewska [15–19], examined 5 beams, 4,8m long and with the cross section as shown in Figure 4. A triple T-section is formed by LLD beams over which a prefabricated a concrete slab is positioned and connected by using M20...160 positioned at different inter-distances. This connection is completed with steel anchors previously built in the concrete slab and specially shaped U profiles whose upper part is also built in the slab before its construction, while the lower part is connected to the upper part of the timber beams by nails.

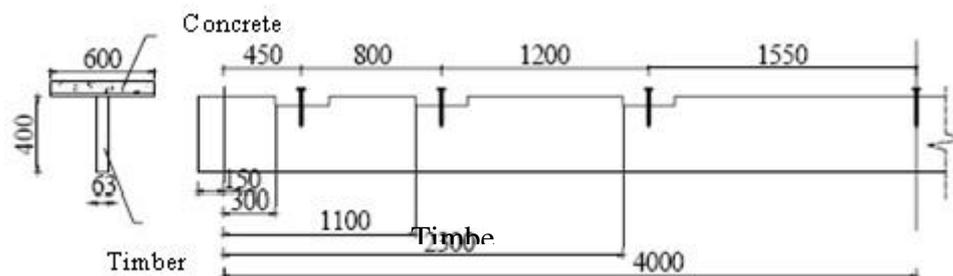
Figure 4. Composite beam of timber-concrete type with notches and screws.

According to the results of the research based on the two series of beams designed in this way, but with two different systems of coupling, she concluded that the beams with screws and steel anchors had the degree of composite actions of 60%, and in the samples where timber beams were connected to pre-fabricated concrete slab by nails, it was only 30%. In order to increase the efficiency of coupling, she suggests combining screws and steel anchors together with notches in the timber

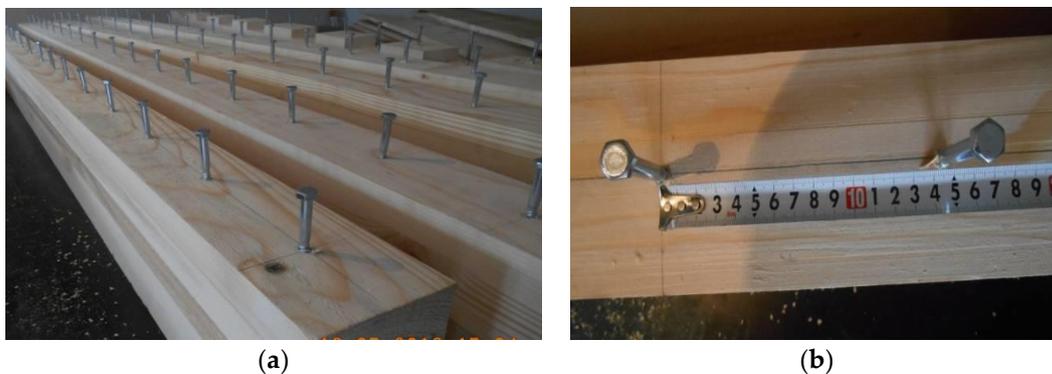
Figure 5. (a) System of coupling of A-series beams; (b) Screws positioned at 150mm distance.

The first series of beams (A-series) is made in the traditional manner (I type of coupling), by the means of mechanical fasteners, screws, installed at the distance of 15cm from each other along the whole length of the timber and concrete interlayer. The screws are 8mm in diameter and their length is $l=150$ mm. They are pressed into the timber part of the cross-section up to 100mm deep, Figure 5, and the remaining 50 mm are filled with concrete and remains in the concrete part of the cross-section.

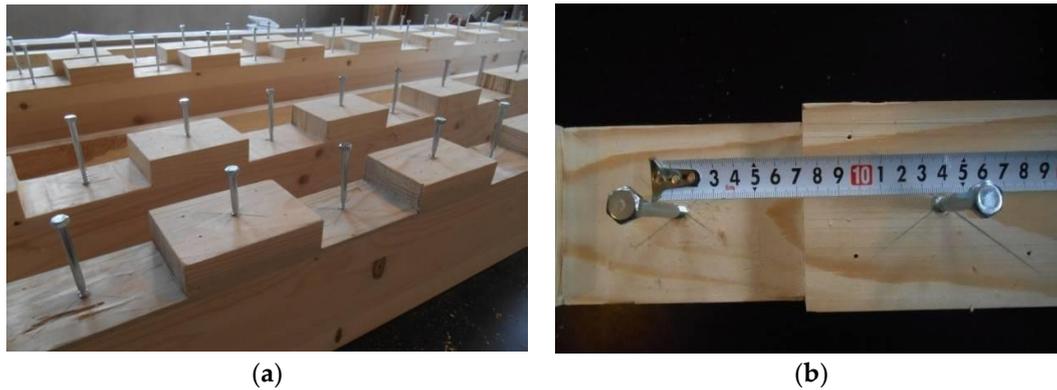
Figure 6. (a) System of coupling of B-series beams; (b) Screw + notch reinforced by a screw.

The second series of beams (B-series) which was tested, was created by coupling of timber and concrete by the means of connecting system created by combining parallelepiped notch, cut in 30cm of the distance along the length of the composite beam and additional screws (II type of coupling). In the middle of the notch, screws with the diameter of 8mm and length $l=180$ mm were used, and in the timber part of the beam, between the notches, screws $l=8/150$ were applied. In this way, a connecting system consisting of two screws of different lengths and a notch of 35mm depth, 150mm length and width equal to the timber beam, 100mm, was formed. In practice, the screws are again at the distance of 150mm, but participate in accepting shear force in the timber and concrete interlayer alternately, some of them directly, and the others together with the notch filled with concrete, Figure 6.

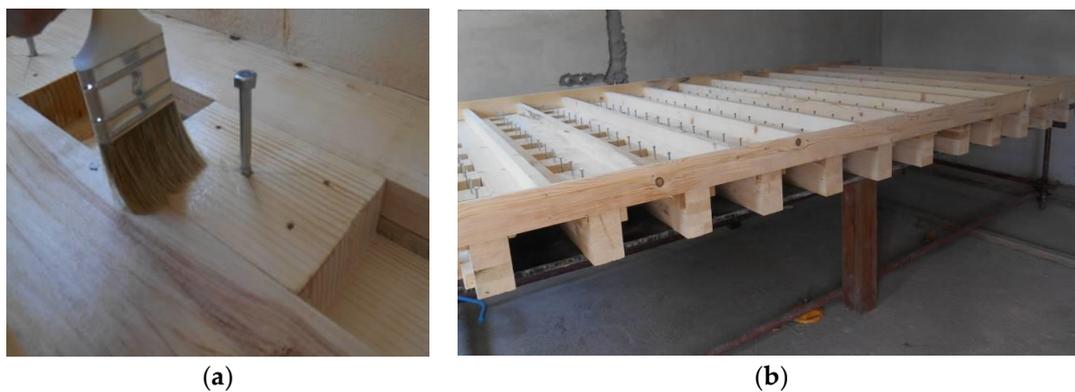
Figure 7. (a) Moisture protection of samples; (b) Platform for creating formwork of composite timber-concrete beams, series A and B.

The screws are built into previously created holes with the diameter 10% smaller than the screw diameter. Prior to this, while trying to install screws without previously drilled holes, there had been a screw fracture due to a high timber quality from which glued laminated beams were made and a low moisture content of timber. The formwork for casting concrete and making composite beams is positioned on a previously prepared platform with an appropriate working height and leant on concrete floor of a hall by the means of a stable steel construction frame, Figure 7.

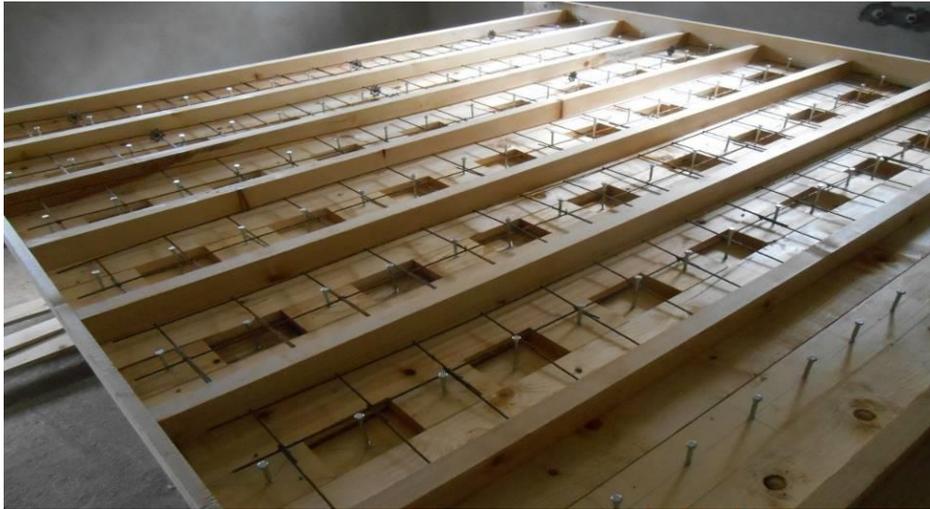
Figure 8. Formwork of composite timber-concrete beams before casting concrete.

The formwork is made at the same time for all 12 beams. Before casting concrete into the formwork and over timber beams, into which screws were already installed and notches of certain geometry made according to the above mentioned draft, a transparent polish is applied over the upper parts of timber beams and the bottom and sides of the formwork in order to prevent water transfer from concrete into timber. In this way, the adhesion between timber and concrete parts is reduced to minimum, that is, the friction coefficient in the adherent surface of timber and concrete composite cross section is reduced which results in the biggest part of shear force in the adherent surface being taken over by the connecting systems.

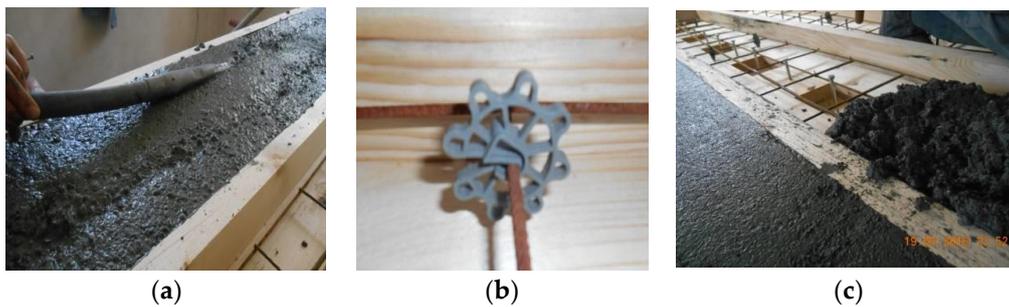
Figure 9. (a) Pervibrator usage; (b) Distanced steel mesh; (c) Concrete application.

The concrete of the cross section was reinforced by a steel mesh (Q 131, MAR 500/560) which was, by the means of distancers, positioned 20 mm from the lower part of the concrete cross section. Concrete was, while applied, vibrated, so that the notches could be filled in a compact way, Figure 9. A lot of care was taken in order to prevent concrete segregation because of the pervibrator usage and the fact that the concrete slab was only 7cm thick.

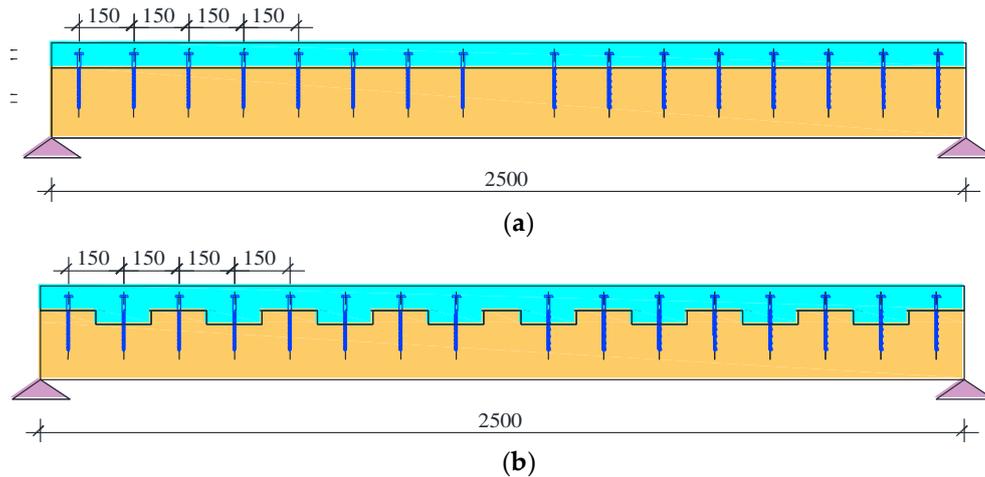
Figure 10. (a) Geometric characteristics of composite beams A-series; b) Geometric characteristics of composite beams B-series B type and the positioning of fasteners and notches.

By an experimental analysis [25,26], a correlation of results in an analytic, numerical and experimental sense, would be established and more accurate conclusions would be reached. Experimental testing of the mechanical properties of timber and concrete built in beam models, as well as testing of relocations of the applied adhesions are described in Chapter 4 in detail. These laboratory tests were carried out to reach a more accurate initial formulation of numerical models of two beam systems with different systems of coupling. The testing and defining of the necessary mechanical parameters were carried out in the laboratory of the Faculty of Civil Engineering and Architecture as well as the Faculty of Mechanical Engineering in Nis. The final geometry of the tested beams of A and B-series and the locating of the measurement types and equipment are given in Figure 10.

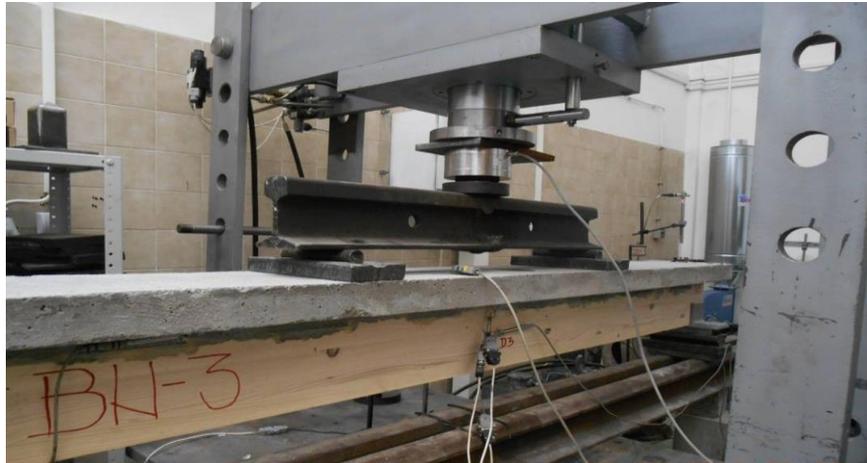
Figure 11. Eksperiment setup of composite beams B-series.

The testing of the performance of the composite beams of the A and B series under a short trial loading up to the fracture was carried out in the laboratories of the Faculty of Civil engineering and Architecture and the Faculty of Mechanical Faculty in Nis. The Laboratory of Mechatronics at the Faculty of Mechanical Engineering did the machine laboratory test, while the Faculty of Civil Engineering and Architecture Nis, whose experts were engaged in this project, tested six composite timber-concrete beams in their laboratory using measure equipment, Figures 11–13.

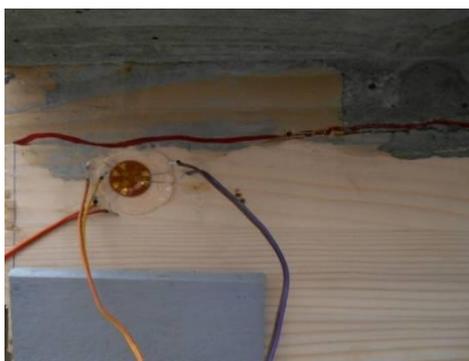
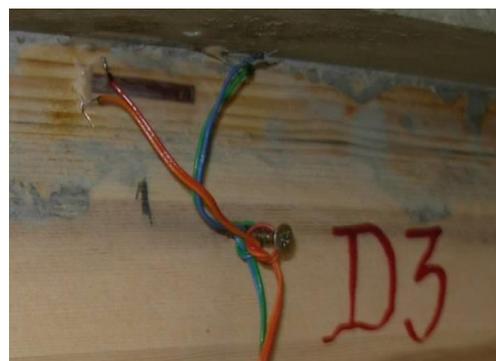
Figure 12. (a) Position of rosettes and strain gauages in the zone of support; (b) Position of strain gauages in the middle beam zone in the upper timber fibre and lower concrete fibre.

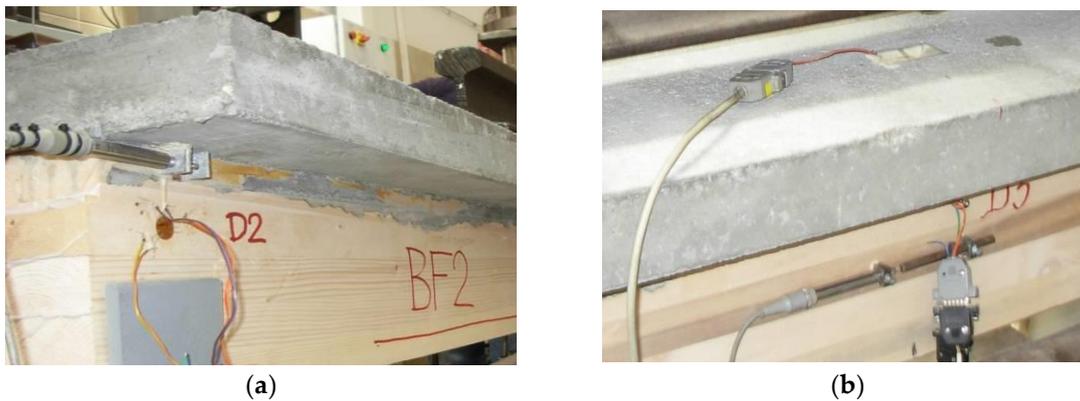
Figure 13. (a) Dilatometer position in the support zone; (b) Dilatometer pos. in the middle beam zone.

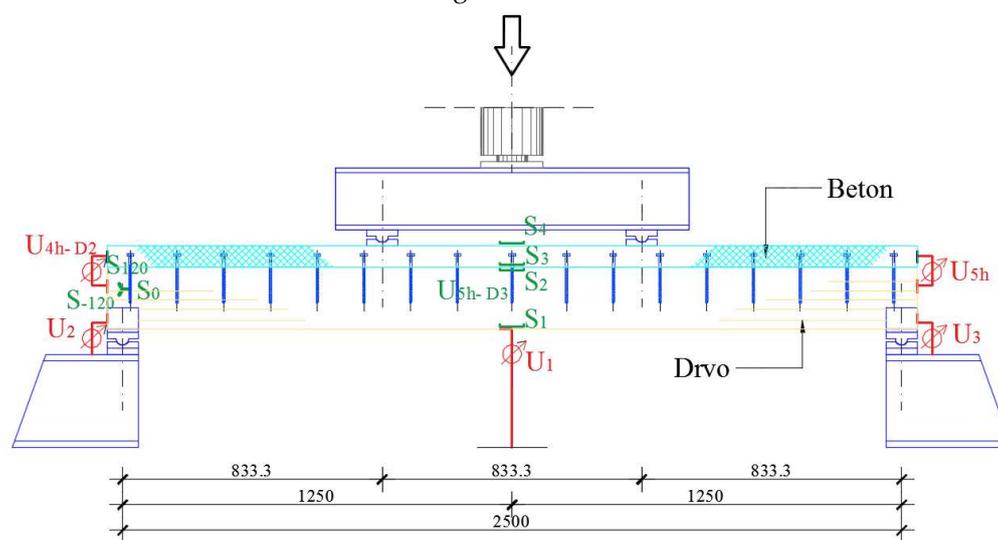
Figure 14. Model of a composite beam of BF type. Loading disposition, the location of measuring points.

In the Figure 14, there is a graphic presentation of the configuration of the experimental procedure of the composite timber-concrete beam of A type (marked as BF) with the instrument marks and the position of the measuring points. There is a detailed description of the measuring points in the Table 1 in accordance with the Figures 12–14.

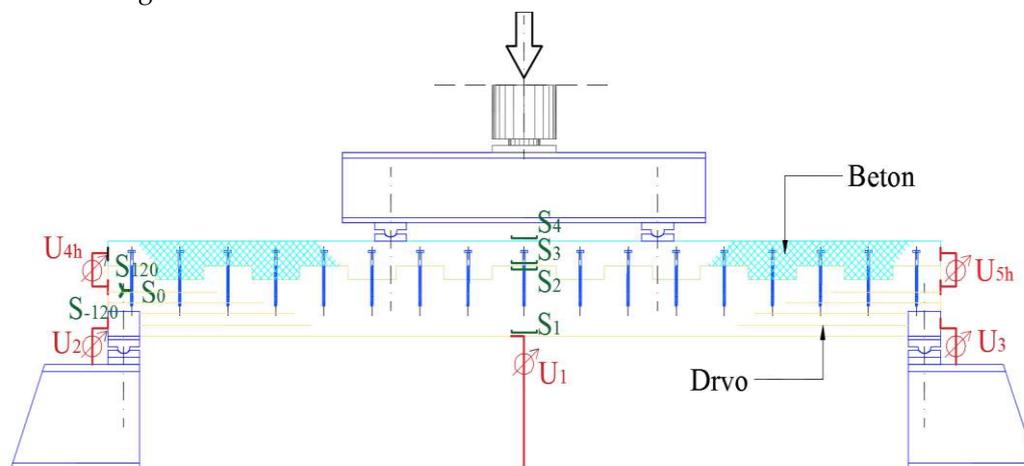
Figure 15. Model of composite beam of the B-series, BN type, loading dispositions, measuring points position.

In the Figure 15, there is a graphic presentation of the configuration of the experimental procedure of the composite timber-concrete beam of the B series (BN-i) with the marking and the position of the measurement points. In the Table 2, there is a detailed description of the measuring points as in the Figure 15.

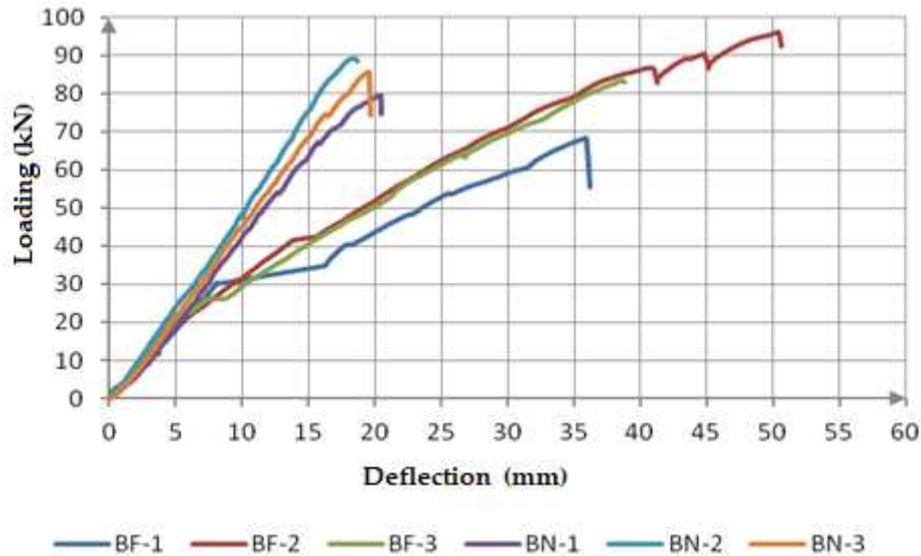
Figure 16. Comparative presentation of the relationships of F-u of all tested beams.

In the Figure 16, the interconnection of the loading and deflection in the middle of the composite beams of A-series is shown. In the case of BF-1, as the first one to be tested, but it was later continued up to the moment of the explicit fracture. The result of this action is the diagram with an obvious discontinuation on the F-u function (loading-deflection). At the point of failure, there was a timber fracture due to an excessive stress tension in the middle of the span and fractures on the side edges in the lower part of the concrete slab. The failure of the connecting systems (screws), due to an excessive the embedding strength of the timber and of the bending stress of the screw is one more element in the complete picture of the fracture of the tested samples of the A-series. In the support zone, there was a 4-4,5mm displacement in the interlayer between the timber and concrete part of the beam which is a direct consequence of the excessive above mentioned stresses.

Composite beams of the A-series (BF-1, BF-2, BF-3), while being loaded up to a fracture point showed a linear-elastic behaviour and it is clearly seen in the loading-deflection diagram which is shown for each composite beam in the Figure 16.

The B-series composite beams (BN-1, BN-2, BN-3), during the loading up to the fracture showed a linear- elastic behaviour, which can be seen in the loading – deflection diagrams, shown for each composite beam separately in the Figure 16. Beams showed, when compared, a high level of similarity in their behaviours while applying the loading up to the fracture point. The variability coefficients of the achieved results related to the fracture force and the size of the elastic deformity are very low, which indicates a high quality level of the used materials of the experimental samples as well as the high quality of the experiment procedure.

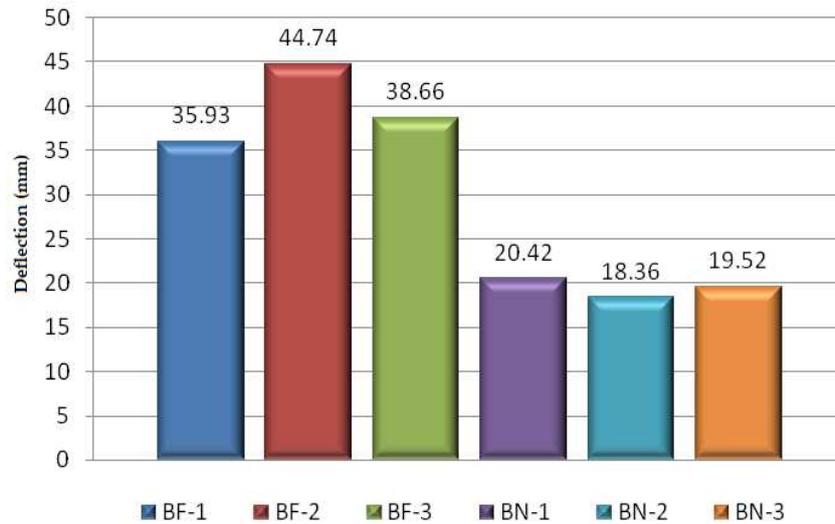
Figure 17. Comparative presentation of deflection values at the fracture point of all tested beams.

In the picture Figure 17 there is a presentation of the maximum reached deflections at the moment of fracture of the "B" series composite beams (BN-1, BN-2, BN-3). On the basis of the measured values, a mean value (BN-mv) of the maximum deflection in the middle of the span of the BN beams is calculated.

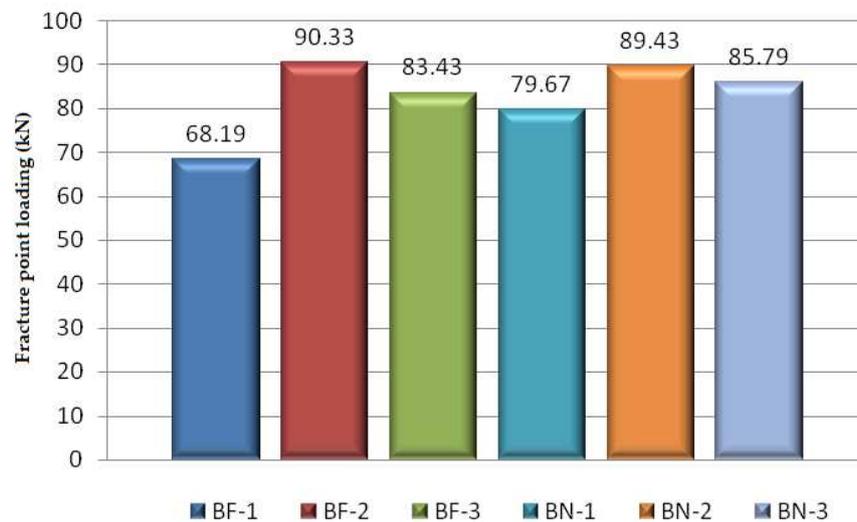
Figure 18. Comparative presentation of loading values at the fracture point of all tested beams.

In the Figure 18 there is a comparative presentation of the loading intensity which caused the fracture of the “B” series composite beams (BN-1, BN-2, BN-3). On the basis of the achieved results, the mean value of the fracture force for this series (BN-mv) was calculated. We can notice a similarity of the values of the fracture loading in the tested samples. The composite timber-concrete beams of this series are coupled by a more complex connecting system, which enabled a high stiffness degree of that interlayer and created a homogenous cross-section in which the mechanical properties of the cross-section elements are used up to a maximum point.

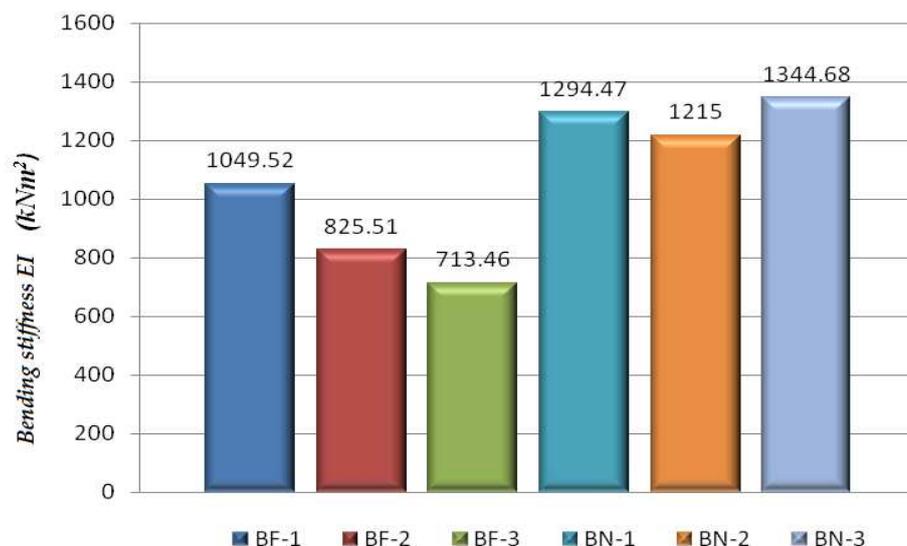
Figure 19. Comparative presentation of calculated values of bending stiffness (EI) at the fracture point of all tested beams.

In the Figure 19. the stiffness of beams (EI) of the composite beams of A-series (BF-1, BF-2, BF-3), calculated for their linear-elastic behavior is presented. On the basis of the calculated stiffness values of some samples of the A-series, the mean value of stiffness of this series of beams (BF-mv) is calculated and it is shown in Table 3.

Figure 19. gives a comparative presentation of the calculated values of bending stiffness at the moment of fracture of all tested beams marked as BF-1...BN-3

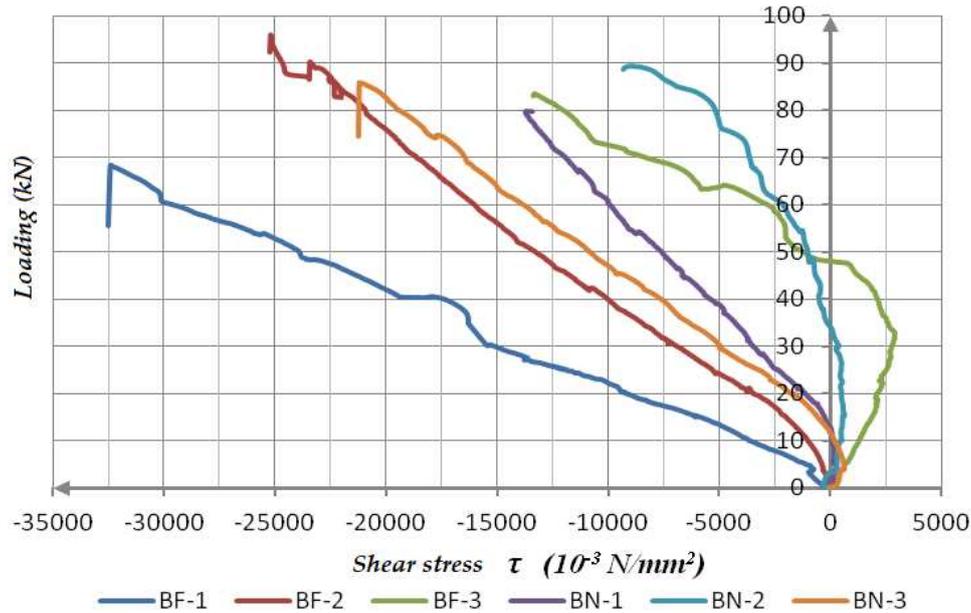
Figure 20. Comparative presentation of F- τ relation of the tested beams.

In Figure 20 there is a comparative presentation of the development of the function of shear stress depending on the loading increase in the support zones for each tested beam, separately.

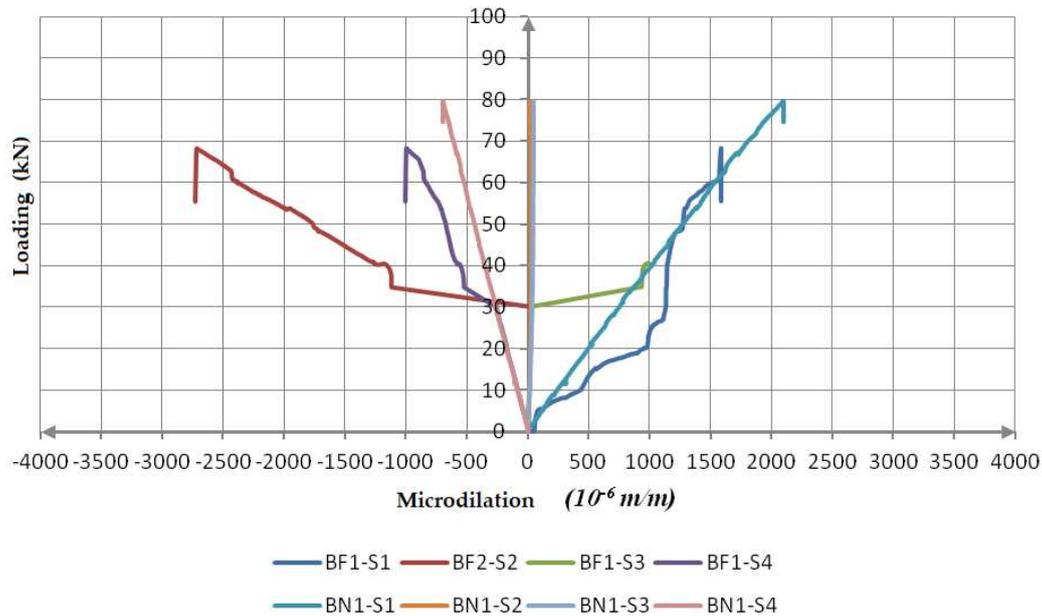
Figure 21. Comparative presentation of measured dilatations of BF-1 and BN-1 beams.

According to the achieved results and the presented diagrams of the relationship loading–dilatation in the edge grains of the timber and concrete parts of the coupled cross-section, we can conclude that:

2. in the upper edge grain of the timber part of the coupled cross-section, the pressure dilatation development (the red line), at the moment of fracture, is in the range of 2800-3900 micro-dilatations, or 0,0028 – 0,0039m/m, or 2,8 – 3,9‰. The development of this dilatation in all three tested samples is approximately linear and steady;

3. The lower edge grain of the concrete part of the cross-section (the green line) and the upper edge grain of the timber part, the measurement types S2 and S3 up to the level of 20-30% of the applied loading at the moment of the fracture have an almost identical progress, almost equal to zero. After that level of the applied loading, there is a very short tension strain development in the lower edge grain of the concrete, up to the failure of the measurement type, which causes cracks and ultimately indicates the degree of coupling timber and concrete with screws used in the first type of coupling, the degree of slipping of the interlayer and beam stiffness. After that, their diagrams are separated based on the stress, that is the pressure in the upper grain of timber (S2) and tension in the lower grain of concrete (S3). Thus, we can conclude that after approximately 30% of the maximum loading, there is a slip in the interlayer of timber and concrete, and creation of two neutral axes. The composite beams of A-series, beside the above mentioned, are characterized by a high deflection in the middle of the span, which is shown in Table 3. A significant deformity prior to the fracture of the tested beam created a field of micro-cracks and cracks in the middle third of the span, which is a clear proof of the failure of concrete tension strength. In the previously shown pictures, which show BF-i beams, after their fracture, clear positions of the cracks can be noticed, and we should emphasize that they go to the half of the cross-section height of the concrete part;

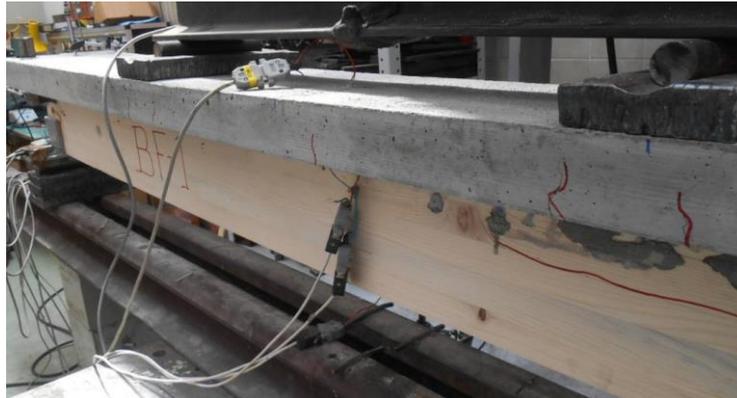
Figure 22. Fracture of BF-1 beam, cracks development in concrete and timber parts of a composite beam.

Before the fracture in the timber part of the beam, there were cracks in the tensioned lower part of the concrete cross-section in the area under the loading in the thirds of the beam span, Figure 22. The development of the cracks is obvious, but their opening is lower than the allowed (tolerated) crack width ($a < 0,3\text{mm}$). None of the tested beams showed signs of plastification in the compressed zone of the concrete part of the cross-section. There was not a failure of the concrete part of the cross-section while applying the loading, and the first cracks were observed just prior to the timber fracture, when the deflection of the beam, reached a high level.

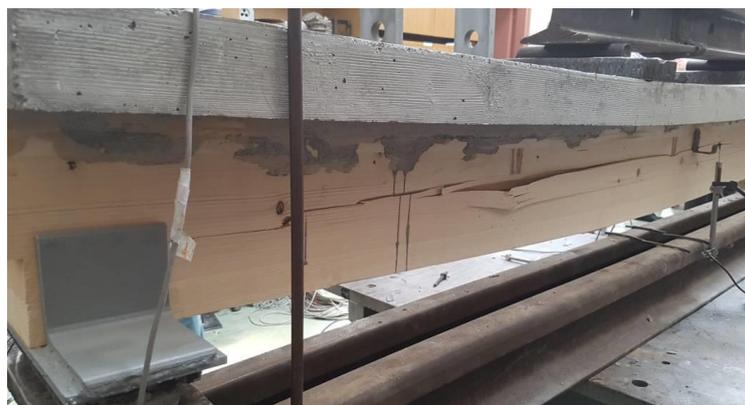
Figure 23. Fracture of BF-2 beam, cracks development in concrete and timber parts of a composite beam.

In the Figure 23, which shows the BF-2 beam after the fracture, with the maximum deflection in the middle of the span of 44,74mm and the fracture due to an excessive tension strength and shear strength of timber, with a clearly shown fracture of timber in the middle of the span and by development of a crack along the whole length of the beam, close to a neutral plane of the coupled cross-section, there are very slight indications of cracks in the lower concrete part of the coupled cross-section, which indicates a certain level of the reached degree of coupling, that is a co-action of the fasteners, of the concrete and timber part of the cross-section. None of the tested beams showed any signs of plastification in the compressed part of the glued-laminated timber.

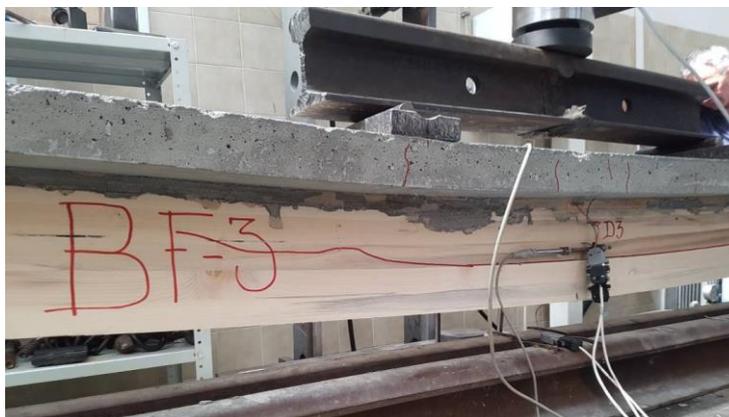
Figure 24. Fracture of BF-3 beam, cracks development in concrete and timber parts of a composite beam.

In the following Figures all beams of the A-series, with clearly marked development of longitudinal, horizontal cracks in the timber part of beams and the development of cracks in the middle third of the concrete slab (the zone of the maximum moment of bending) are shown.

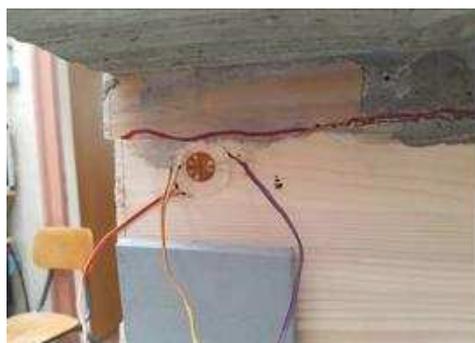
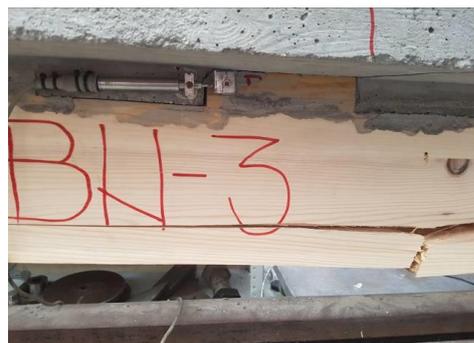
Figure 25. (a) Fracture of the timber part of the support notch of BN-3 beam; (b) Crack development in concrete and timber fracture in the middle third of the span.

In the left support of the BN-3 sample, there was a total destruction of the notch ending of the timber beam by shearing and the displacement of 12mm, which is shown in the Figure 25. The B-series beams have a much higher stiffness level compared to the A-series beams. The fracture occurs due to an excessive tension strength parallel to the grains in the timber part of the beams, and it is the stiffness of the timber-concrete joint achieved by a more complex fastening system that causes the irregular fracture which moves along the elements in the middle third of the span. After creating the necessary conditions for this fracture, the neutral line goes upwards, stresses are transferred to the timber-concrete joint zone, there is the slip of the elements of the connecting system of the B type beams, local excesses of timber shear strength and concrete tension strength in the notch zone. The consequence of this is simultaneous fracture due to an excessive timber tension strength in the middle third of the span and timber shear strength in the support notches. We must emphasize that the fracture always occurred in timber and never at the interlayer of the lamella filled with glue. This indicates that the load bearing capacity of the tested BN-1 and BN-3 beams is used completely by reaching the limit shear stress values in the support cross-sections.

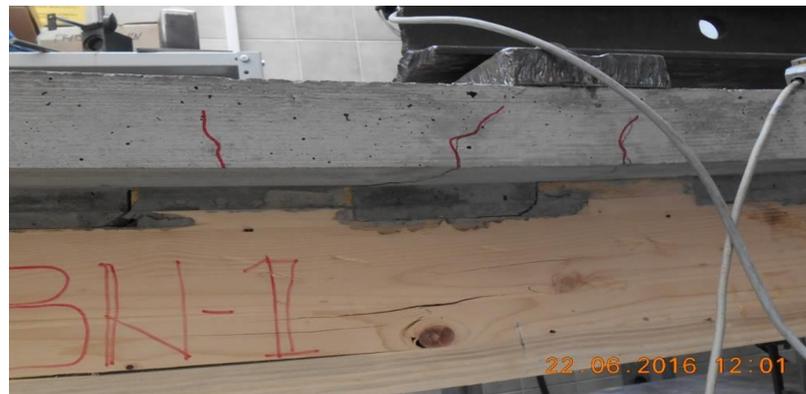
Figure 26. Fracture of BN-1 beam, cracks development in concrete and timber.

The Figures 26–28 show all B-series beams with the marked development of longitudinal, horizontal and inclined cracks in the timber part of the beams and the crack development in the middle third of the concrete slab, as well as in the concrete notch support zones.

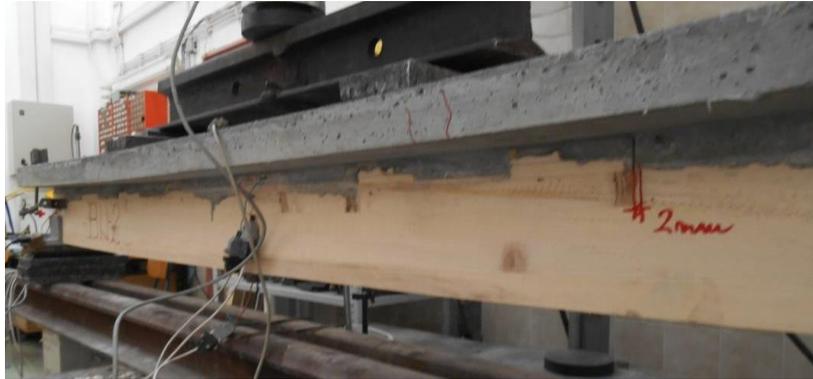
Figure 27. Fracture of BN-2 beam, cracks development in concrete and timber.

BN-2 beam, with an approximately equal level of the applied loading and the reached value of the elastic deflection, shows a completely different behaviour, that is, shows a behaviour similar to the one of the tested samples of the A-series. The fracture occurred in the right support zone due to the excess of the shear stresses and the cracks develop horizontally towards the left support. In the notch joint of the timber-concrete part of the beam there is a noticeable their symmetric displacement up to the fracture point, related to the middle of the span.

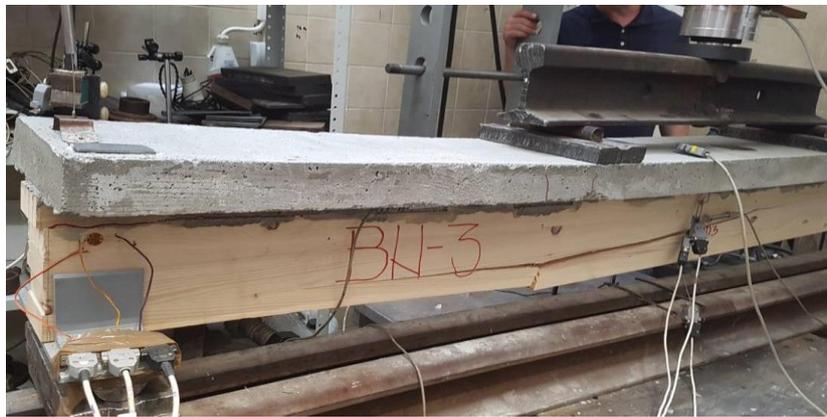
Figure 28. Fracture of BN-3 beam, cracks development in concrete and timber.
