Study of the Clogging Phenomenon of Submerged Nozzles in Continuous Casting

Abstract: The continuous casting nozzle which guides and protects the flow of liquid steel undergoes a progressive reduction in its internal diameter following the accumulation on the internal wall of non-metallic inclusions. This narrowing of the channel is due to a mechanical attachment (non-metallic inclusions) and this, because of the turbulent regime of the flow of the liquid steel. This phenomenon is very often associated with the casting of low carbon steels deoxidized exclusively with aluminium. Clogging generally leads to a slowing down of the casting speed and, in severe cases, to the total stoppage of the installation and consequently to the appearance in the slab of the defect called "resumption of casting or belt". The aim of this work is to determine the nature of the deposit and the blocking mechanism of the pouring nozzles. For that, a chemical analysis as well as tests concerning the adhesion of the deposit were carried out on samples taken from damaged pouring nozzles. We found that it was at a load of 187.5 kgf that the rupture of the sample took place, during the interfacial indentation

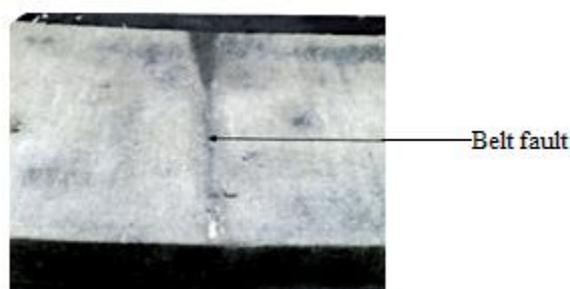
Figure 1. Slab with belt.

The blockages of the nozzles affect the quality of the slabs in the form of "belts" which can be defined as a discontinuity in cross section of the slab; Figure 1 shows a resumption of casting or belt in the slab.

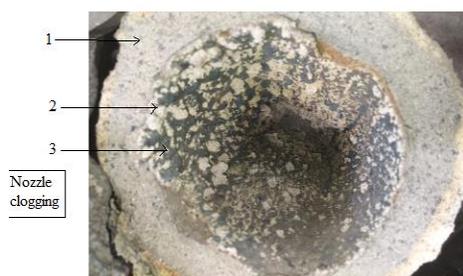
Figure 2. View of a clogged worn nozzle.

The morphological identification of the deposit consists of observing a sample using a binocular magnifying glass. The sample was cut from the lower part and cut by an ordinary chainsaw, and then we detached the metal envelope, as well as the terminal deposit and leaving only the dense deposit which adheres to the refractory body of the nozzle.

(1) clogged nozzle body, (2) white deposit (3) metal casing.

The lower part is almost completely clogged by a deposit, while the deposit in the upper part only measures a few millimeters;

The deposit formed on the inner wall of the lower part can be divided into three layers:

- A gray metallic envelope.

- Layer of slag having a thickness comparable to that of the deposit formed on the upper part.
- An extremely thick deposit, several centimeters long with a crumbly appearance, in the form of a powder stuck to another white deposit, denser and less thick.

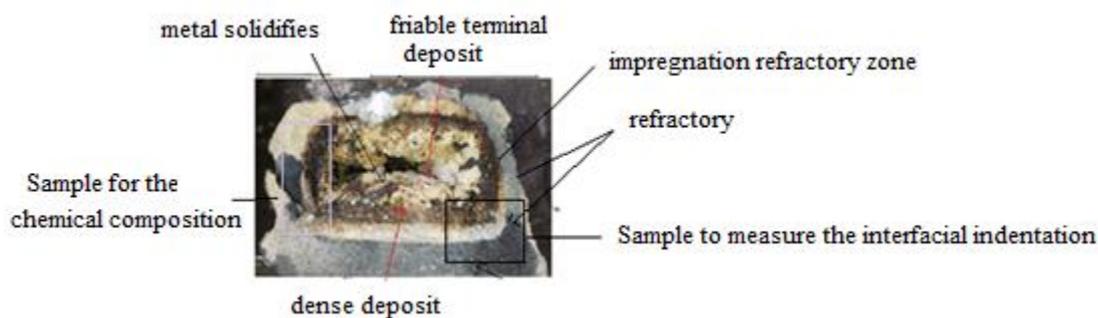
Figure 3. Cross section of a submerged nozzle.

View of a cross section of the lower part of a nozzle

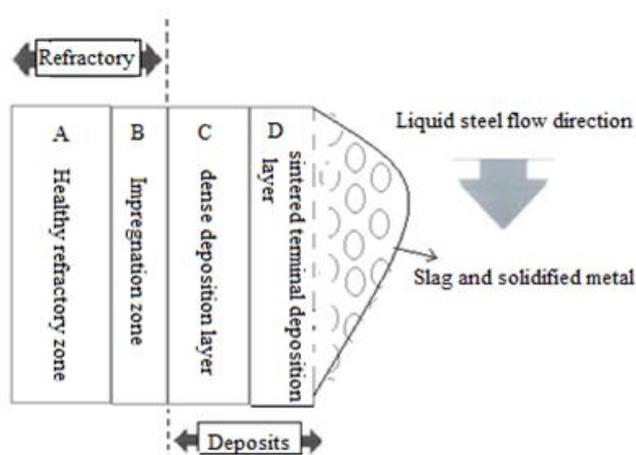
Figure 4. Layout diagram of the different layers.

After the macromorphological identification of the deposit, we took a sample from each zone as shown in the diagram of Figure 4.

The metal casing and the deposit of the lower part of the nozzle are made up of a mixture of slag from the converter and metal oxides resulting from deoxidation.

In the figure, we have divided our nozzle profile into two parts according to the nature of the base materials (refractory or steel), the results obtained after chemical analyzes by X-ray fluorescence are collated in Table 2, namely:

- Refractory: it comprises the zone of sound refractory (A), as well as the zone of the layer of refractory affected by impregnation (B);
- Deposit: it comprises the dense deposit (C) as well as the terminal sintered deposit (D).

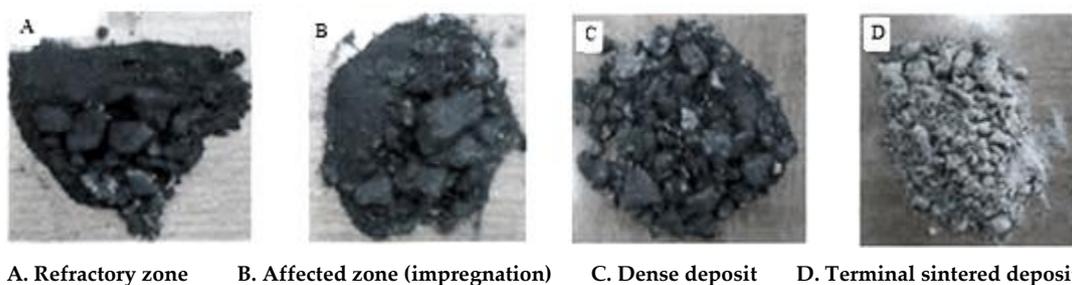
Figure 5. Materials obtained after separation.

The taking of the samples of the deposit to carry out the chemical composition is carried out by a chainsaw, then to take off the dense deposit (C), from the impregnated refractory zone (B), we used a hammer and a chisel, then in the same way we separated the affected refractory zone (B) from the healthy refractory (A).

We crushed these materials to obtain fine powders with a particle size of approximately 5 to 15 μm to produce pellets after fusion in order to carry out chemical analysis using X-ray fluorescence.

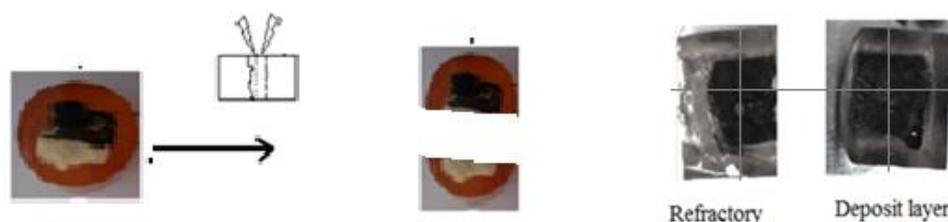
Figure 7. Determination of the nature of the break.

To perform the interfacial indentation, we used a Vickers microhardness tester, a Vickers hardness tester, and finally a Rockwell hardness tester until the part was destroyed.

a. Sample before interfacial indentation b. After indentation c. Side view of the two parts of the broken sample.

We operated in the same way as the previous tests except that this time we started with a load of 60 kg f, but only at 187,5 kg. Force that the damage has taken place as shown in Figure II.6. We consider that this load represents the level of adhesion of the deposit on the internal wall of the refractory, which is quite high. The observation by the SEM of the two faces after the interfacial indentation and the chemical analysis by EDS of the two points selected by the crosses in wire showed that there was a brittle rupture and not a detachment, indeed, one observed in Figures 12 and 13, the same chemical composition, (the iron and aluminum % peaks are superimposable).

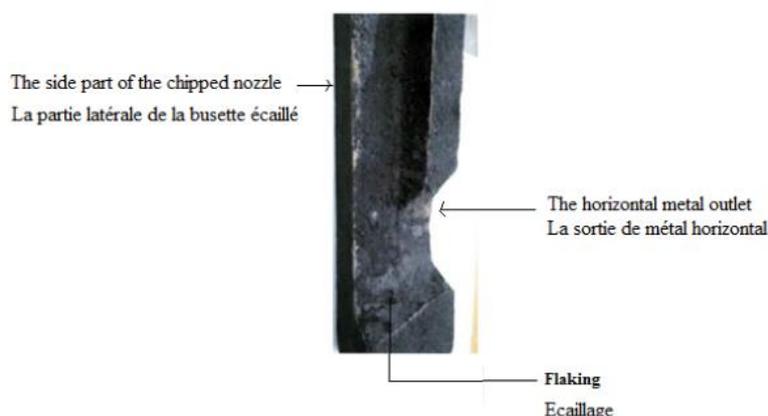
Figure 9. View of a sample of a nozzle after heating at the steelworks.

The heating time from the nozzle to the surface is 8 hours and more in some cases, the burner is oriented towards the bottom of the nozzle which undergoes intense heating over 1000°C while the top remains relatively cold, knowing that refractories are poor conductors of heat, this temperature difference causes the surface to burst, the consequence of which is spalling Figure 9.

Among the factors that increase the adhesion of non-metallic inclusions (Al_2O_3) on the internal walls of the casting nozzle is the presence of flaking which is due to the overheating of the lower part of the nozzles (more than $1000^\circ C$) for a fairly long time (more than 8 hours) in the conditions of steelworks. Indeed, the experiment carried out in our laboratory on three samples heated to $750^\circ C$ with different holding times has shown that the internal surface condition of the nozzles is smoother, and that there is rather has an improvement in the state of the interior surface as evidenced by the roughness tests Indeed,

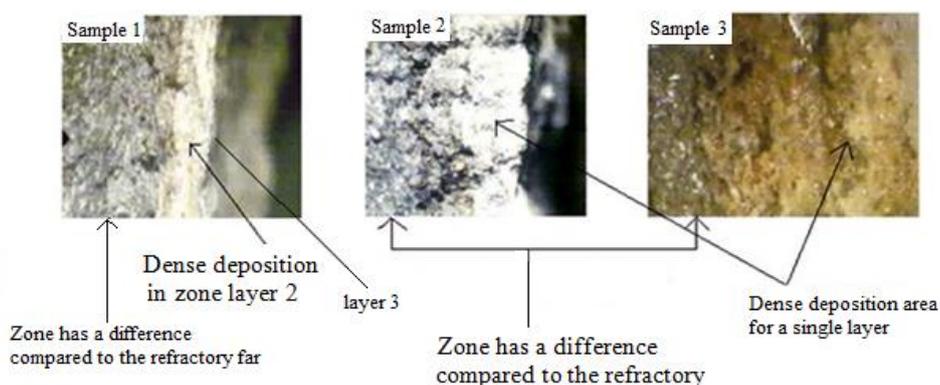
Figure 10. Binocular observation of the deposit.

The observation of the deposit was carried out using an Optika digital binocular loupe, the photos of the different samples with an enlargement of 200 μm .

In addition to the layer separated before the observation and the dense deposit adhered to our samples, we detected a third layer of refractory origin according to its macroscopic morphology and its color;

After these observations, the new configuration of the deposit layers then becomes included inside the healthy zone according to the following order:

First zone: is the decarburized zone called the impregnation zone, its thickness is between [300; 3000] μm ;

Second zone: is the dense deposit zone, white color with dark brown spots and light brown spots. Its thickness is between [200; 6250] μm ;

Third zone friable terminal deposit: a very thick and very friable layer.

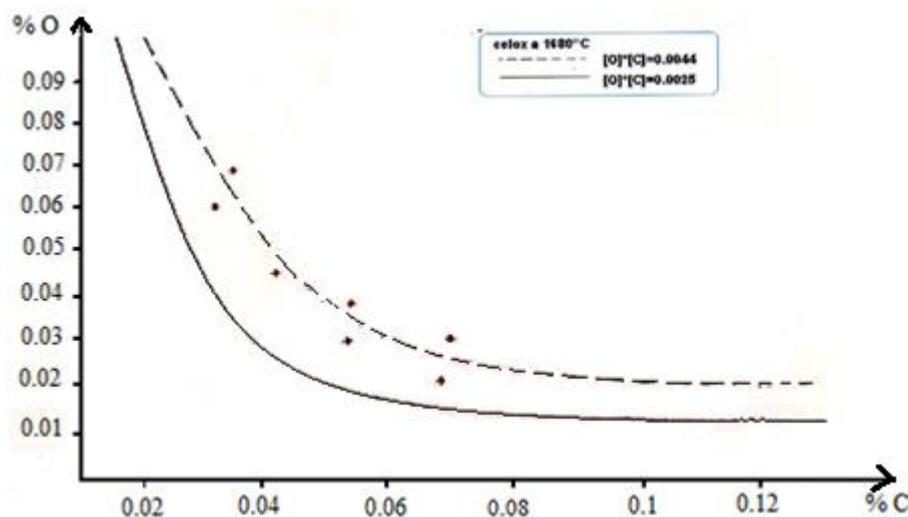
Figure 11. Relationship between carbon and oxygen.

At the end of the refining operation and just before casting, it is useful to measure the oxygen activity in order to be able to determine the quantity of deoxidizer to add to the bath at a temperature of 1680°C.

The results of the measurements of the activity of oxygen in our case enabled us to construct Figure 1 where we note that the equilibrium concentration of oxygen at the end of blowing is clearly higher than that of the theoretical equilibrium curve.

All the conditions favorable to the increase of oxygen dissolved in the liquid metal are therefore united. To deoxidize steel, a large amount of aluminum is used.

The activity of the oxygen in the liquid steel must be reduced as much as possible to avoid the formation of blisters, but too much quenching with aluminum causes the clogging of the nozzles by the inclusions of alumina.

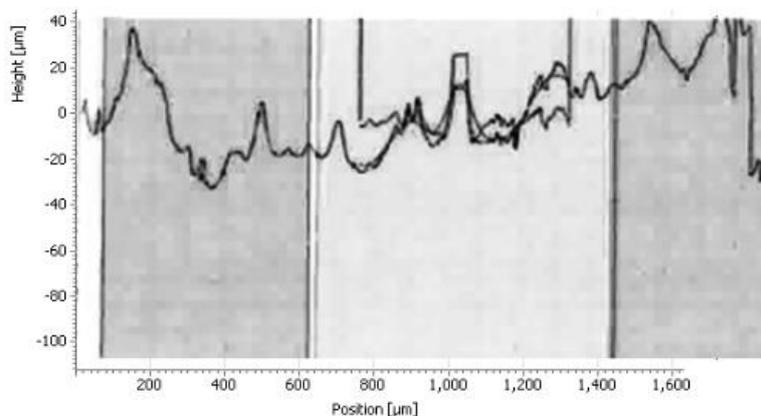
Figure 14. Roughness profile of the sample for 45 minutes of holding 750°C.

We took three samples that we cut and heated at a constant temperature of 750 °C for periods of 45, 75 and 120 min, to determine the influence of temperature and heating time on roughness.

The roughness test gives us the graphs of Figures 14–16:

The results of the histograms (Figures 14–16), enabled us to construct the histogram of Figure 17. Indeed, the study of this histogram shows that the roughness decreases with the increase of the time of maintenance of the temperature. The roughness, after 120 minutes of maintenance at a temperature of 750° C., increased from 8.3 µm before heating to 2.81 µm, we can explain this decrease by the crumbling of the spikes during the roughness tests. In the industrial case, the preheating of the nozzles is rather anarchic and unbalanced, which has caused spalling at the level of the internal wall of the nozzle.

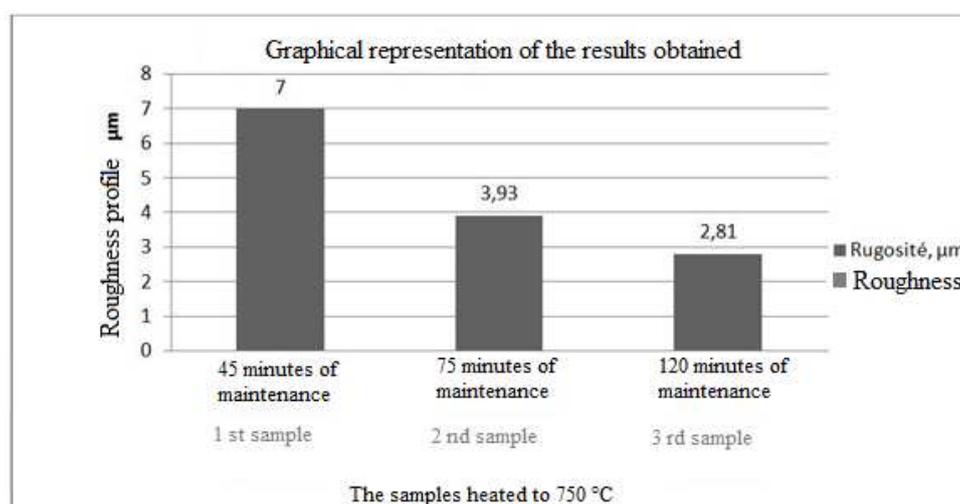
Figure 17. Histogram indicates the roughness.

The histogram in Figure 17 shows the roughness of the sample
