The Collapse of the Vaults of the Ambato Matriz Church in the 1949 Earthquake: A Response with Technical Approach

Abstract: This research concerns the virtual reconstruction and technical constructive analysis of the emblematic and disappeared Matriz church of Ambato city, whose structure was demolished after the collapse of its vaults in the 1949 earthquake, about which it was said to have had deficiencies in its construction. Through an exhaustive historical review of documents and images, its constructive hypothesis was achieved, and using photogrammetry technique, its virtual reconstruction was obtained, where, through the interpretation and understanding of the generated plans, the verification of its technical and constructive characteristics associated with its hypothetical mechanical behavior inherent to its stone construction was carried out. For the structural study, the principle of the Limit Analysis of Structures was used, where through a graphic static approach, the technical stability conditions of a masonry structure are established, in this case, to give an interpretation to the possible poor execution of the church's work, and eventual cause that could have contr

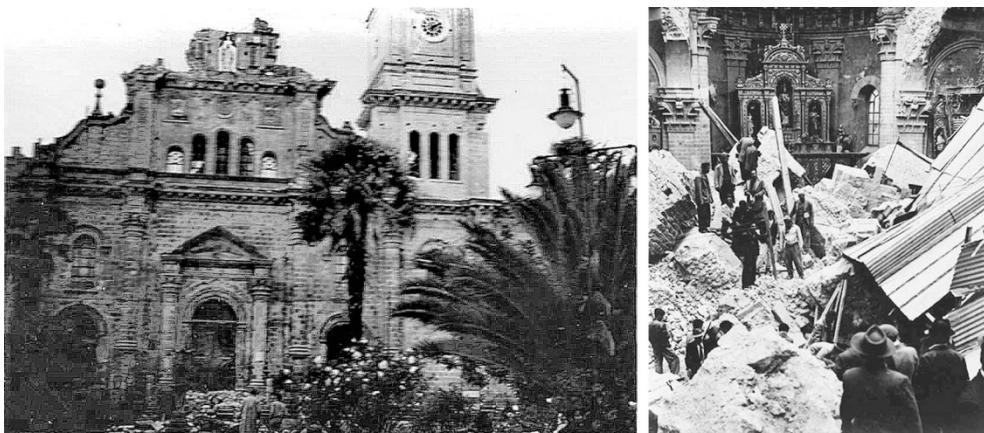
Figure 2. Ambato Matriz Church. Front facade [4] and interior of the central nave after the 1949 earthquake [10].

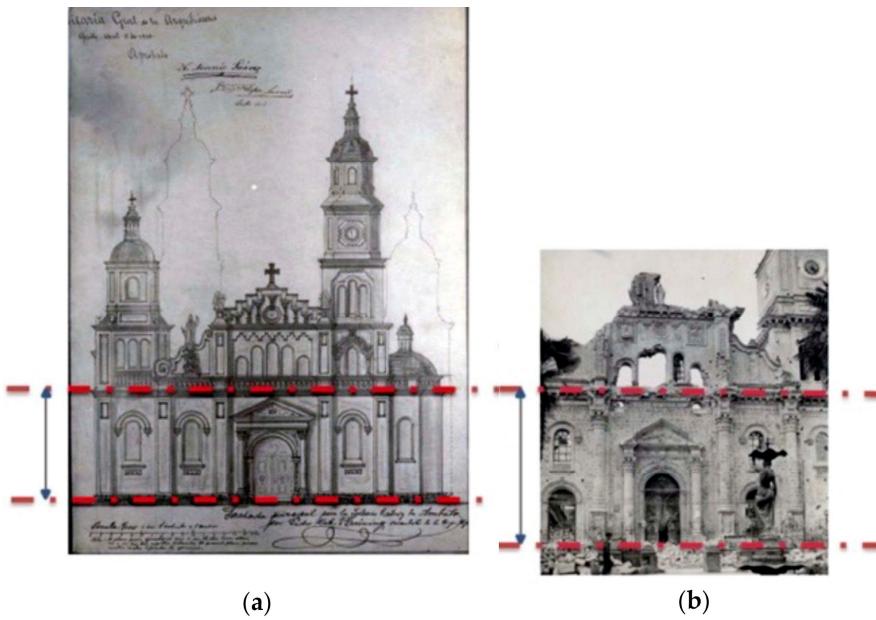
Figure 3. Ambato Matriz Church. (a) Facade designed by Pedro Brüning, 1910 [3]; (b) Facade in the process of demolition after the 1949 earthquake [3]. Illustration by the authors.

In the referential comparison of the facade plan with one of the photographs of the church in the process of demolition, considered because it was one of the clearest, it was possible to notice the addition of a mezzanine in the lower floor segment, and an addition in the upper segment.

In the lower floor segment compared to the original plan, the height of the main entrance was doubled, maintaining the alignment of the windows with the top of the entrance, with which, downwards, in the added height, two doors were added on each side of the main entrance.

While in the upper segment, a space was added above the five projected and constructed windows, where the symbol of the Lamb of God, and the coats of arms of the Cardinal and the Province of Tungurahua were placed (Figure 3).

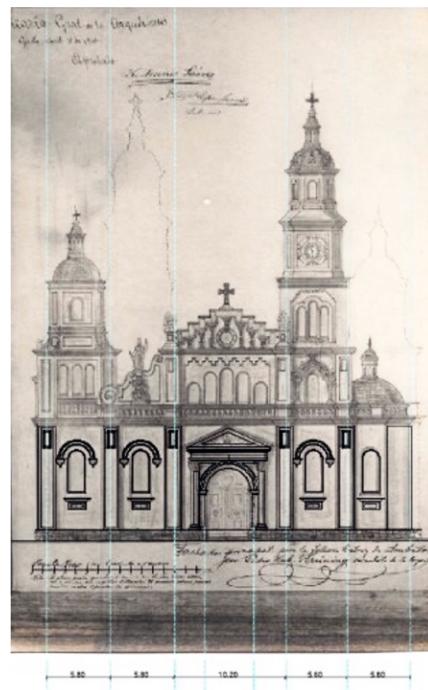
Figure 4. Ambato Matriz Church. Superposition of axes in the original drawing by Father Brüning [3] to extract the dimensions of the aisle. Illustration by the authors.

Despite the difference between what was drawn and what was built, the graphical scale of Brüning's facade allowed for the provision of images and the implementation of photogrammetric processing to transfer measurements to the interpretive drawings (Figure 4). It is possible to observe the superimposition of axes in the original drawing to extract the dimensions of the aisle. The structural configuration of the plan emerges from the axes of this facade, also considering photographs of the interior before and after the earthquake.

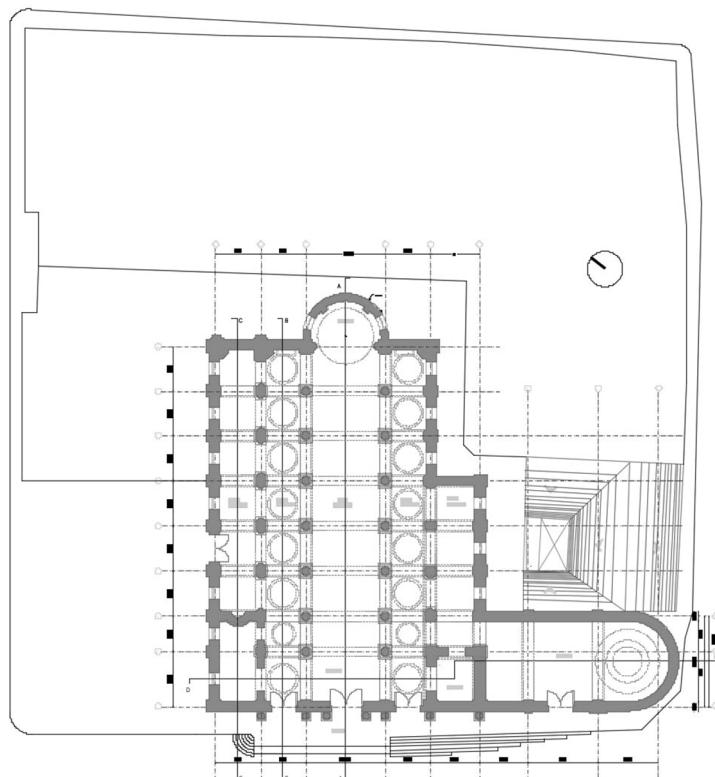
Figure 5. Ambato Matriz Church. Graphic restitution of the floor plan and block reference [11].

The architectural survey included the graphic delineation of plans at a 1:100 scale, of the location, general plan (Figure 5), roof plan, and elevations of all exterior facades of the church as a whole, including all its architectural components, including its parapet, tower, and side chapel (Figure 6), as well as the longitudinal sections of the church's aisle (Figure 7), one for each aisle; and the complete transverse sections of the church, one at the height of the narthex, another at the height of the high choir; one in the center of the church; and one in the area of the presbytery.

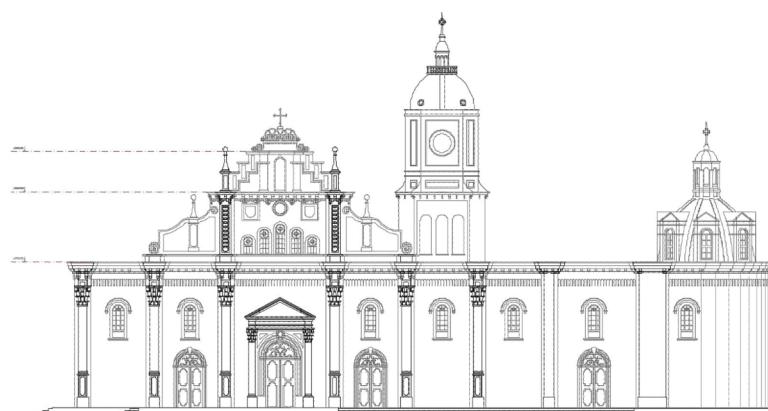
Figure 6. Ambato Matriz Church. Graphic restitution of the front facade [11].

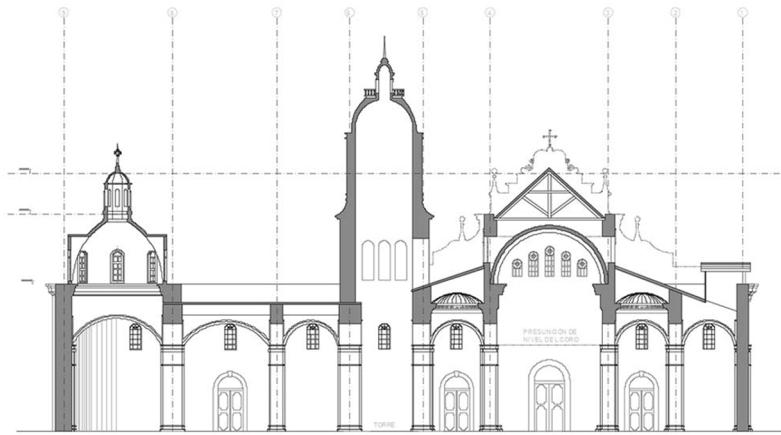
Figure 7. Ambato Matriz Church. Graphic restitution of the transverse section at the foot of the temple and transverse chapel [11].

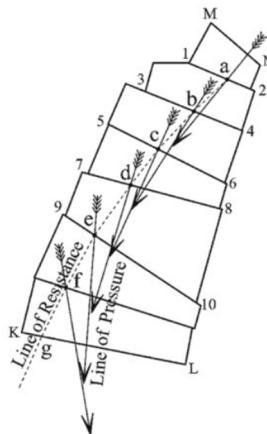
Figure 8. Line of resistance and line of pressure. Graphic method of analysis [18].

In the conceptual scheme presented by Moseley (Figure 8), in which a distinction is made between the resistance line and the pressure line, the directions of the successive thrust forces are arbitrary and not properly proportioned according to the corresponding weights of the successive stone blocks. To know the equilibrium state of a structure, it is necessary to know both lines: the thrust line and the line of inclinations [21].

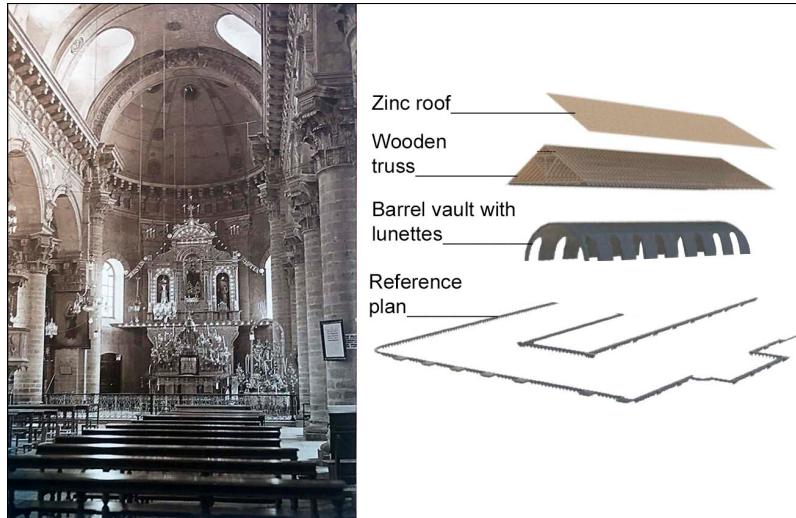
Figure 9. Ambato Matriz Church. Central aisle [4]. Roof components and reference plan.

The central barrel vault with lunettes, made of pumice stone (Figure 9), apparently had the same characteristics in seven of its eight sections, ending its head in an apse, and its foot in the narthex equivalent to the eighth section. This last section articulated the entire composition of the facade wall and the tower from where the front lateral aisle of the church started, meaning finishes that remained standing after the earthquake.

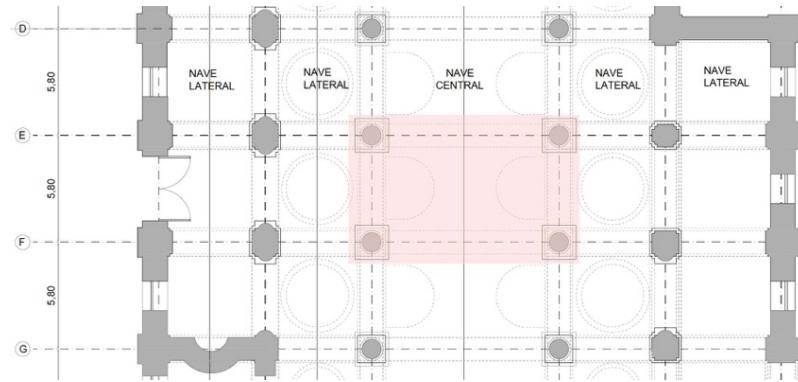
Figure 10. Ambato Matriz Church. Typical section of the central aisle for analysis [11]. Illustration by the authors.

Having the central aisle with similar characteristics along its entire length, with the challenge of spanning the largest free span of 10.20 m, and since it was the most critical structurally for not having

buttresses, a standard section was considered for analysis, corresponding to one of the seven sections with a transverse measurement of 5.80 m (Figure 10), which is the most common measurement.

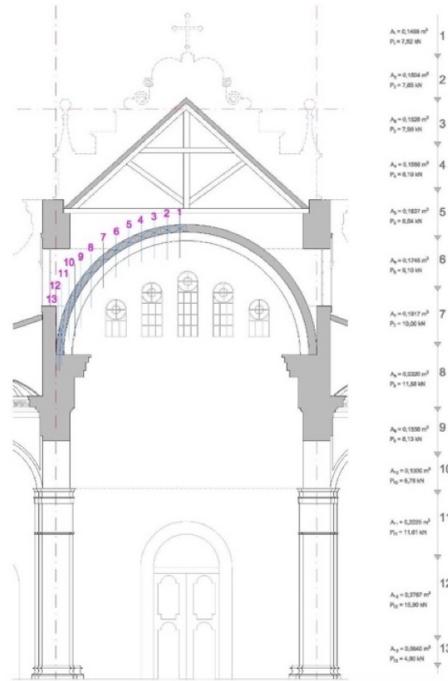
Figure 11. Ambato Matriz Church. Structural analysis. Section of the central vault with the breakdown into 13 voussoirs and graph of their weights. Illustration by the authors.

The results of the Structural Limit Analysis, obtained from one of the most repeated sections of the central vault, were based on the study of the vault section in this section, which was divided in half into 13 parts, from which the area and the center of gravity were obtained (Figure 11). It should be considered that the criterion of taking half of the vault for the division into 13 parts is due to the symmetry it presents, simplifying the analysis of structural stability. With these geometric data and knowing that the specific weight of pumice stone is 9 kN/m³, it was possible to obtain the lines of action and the value of the weights of each vault section. To obtain the weight, the area is multiplied by the length of the section considered (5.80 m) and by the specific weight of the stone.

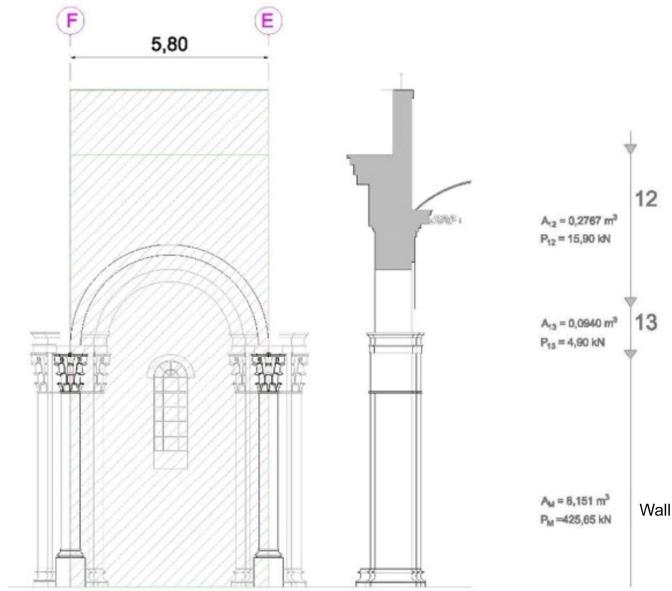
Figure 12. Ambato Matriz Church. Structural analysis. Cross-section of the vault section and graph of their weights. Illustration by the authors.

Next, the weight of the wall was added; for this, the weight of the elevation of a vault section was estimated, considering the solid areas at the start of the vault and the pillars at the bottom (Figure 12). In this figure, on the left, the hatched area in the elevation and the section that has been

considered as the wall area are graphed; on the right, the area and weight considered for the wall are graphed, obtained in the same way as for the voussoirs.

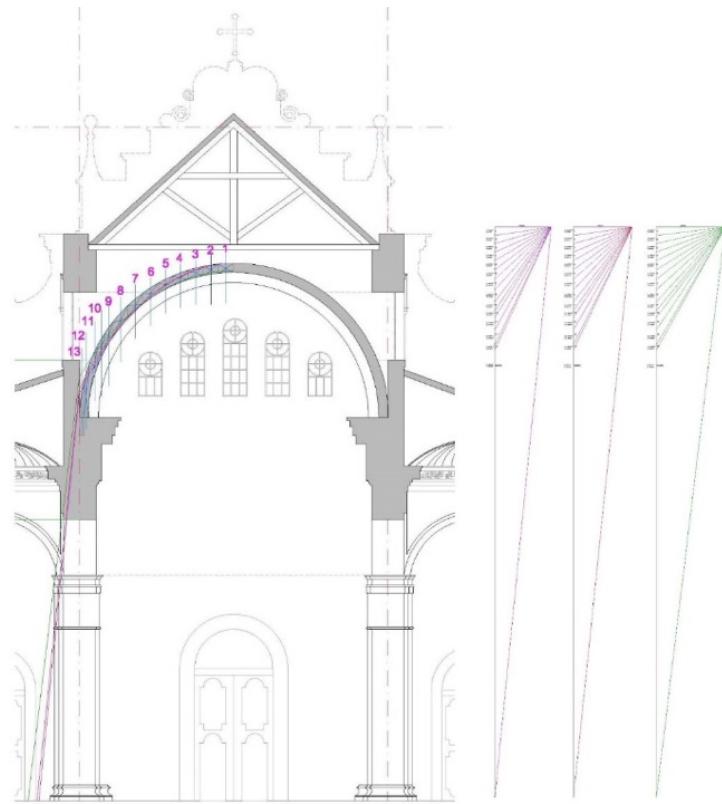
Figure 13. Ambato Matriz Church. Structural analysis.

Cross-section of the vault with thrust lines. Illustration by the authors.

With the data obtained, different thrust lines were tested on the vault, drawing the weights and lines based on a graphic scale according to their value in kN, assuming different thrust values on the central keystone, finding that there is none that can be completely drawn inside.

A thrust line was initially tested, drawn in green, which turned out to be too flat and immediately exits through the sides of the vault. Consequently, the thrust is progressively reduced with two other lines, in red and purple. The purple one corresponds approximately to the minimum thrust; it touches the upper end of the vault in the keystone area and exits through the intrados in an intermediate area (Figure 13), in this figure on the left, the cross-section of the vault is graphed with the three thrust lines and; on the right, the force polygons (voussoirs and wall) are graphed which serve as a basis for drawing the thrust lines graphed in green, red, and purple.

The three lines could be roughly drawn inside the vault, assuming a solid fill in the kidney area; it turned out that all of them exit at the base of the wall or pillar, thus demonstrating an insufficient thickness of this element and the need for the church to have a structural solution to provide the necessary stability to the vaults and therefore to the entire structure. The thrust lines on the cross-section of the vault, as well as the force polygons constructed to draw them, were graphed showing the detail of the force polygon (Figure 14), with the areas and weights of all the voussoirs, and the start of the wall with its data.

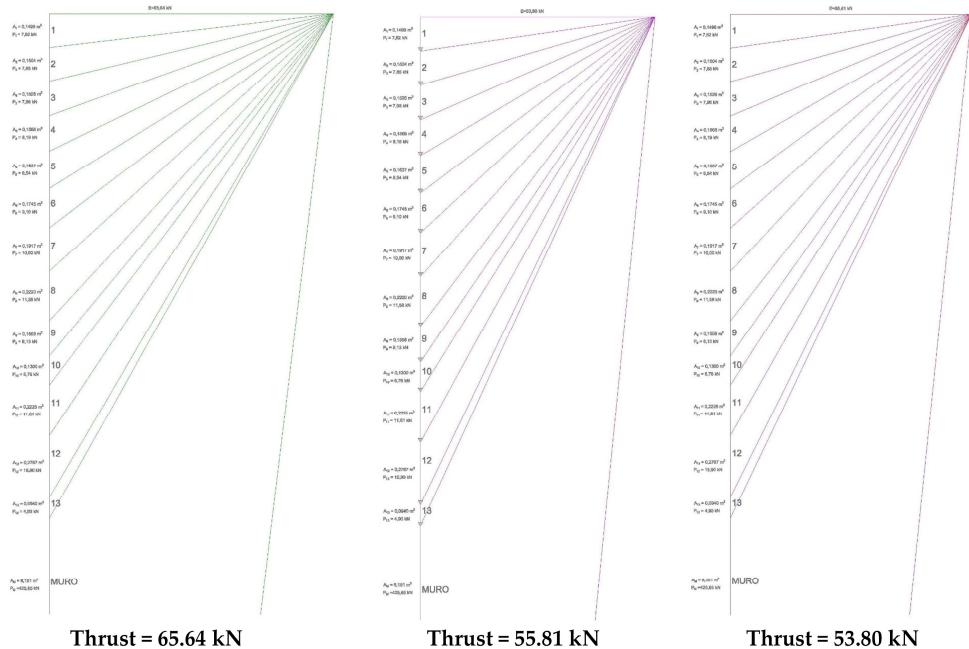
Thrust = 65.64 kN

Thrust = 55.81 kN

Thrust = 53.80 kN

Figure 14. Ambato Matriz Church. Structural analysis. Detail of the force polygon for each thrust line. Illustration by the authors.

It was possible to determine with the force polygons and therefore with the thrust lines, how these lines exited the supporting structure, demonstrating that there was not a sufficient thickness in these elements to contain it and that it did not pose a risk of imminent collapse at any time, an issue in which the construction of buttresses would undoubtedly have greatly contributed, precisely those that were not installed, and which are fundamental for these masonry works. With the absence of buttresses, a structural element devoid of reinforcements was obtained, which could collapse at any moment, especially in the event of an earthquake.
