Investigation on Full-Scale Crash for Reinforced Divided Central Median W-Beam Barriers with Post-Densification

Keywords: central median; W-beam barrier; post-densification; full-scale crash test; safety performance

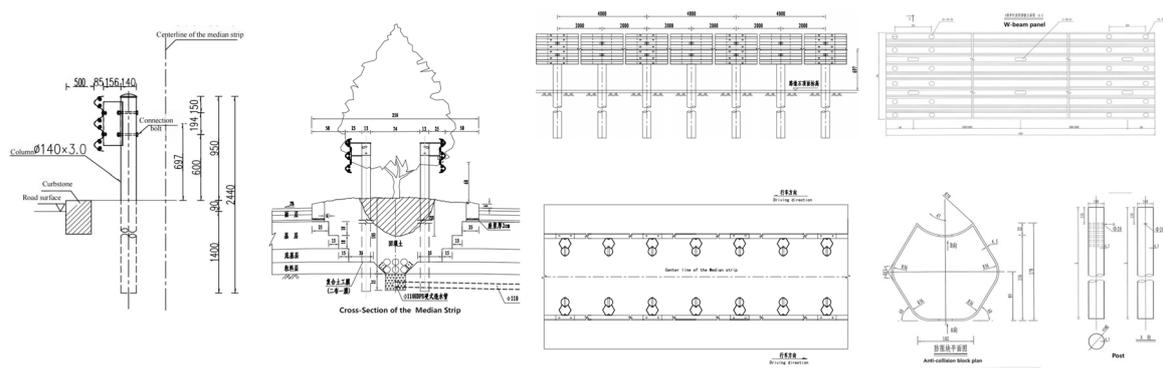
Figure 1. Barrier installation design diagram.

To scientifically validate the effect of post densification on enhancing the protective capabilities of barriers, this study employed a comprehensive scene reconstruction approach to accurately replicate the design and construction conditions of the central median. Measures were implemented to ensure the stability of soil compaction across parallel tests. Specifically, the central median was designed with a width of 2.5 meters. According to the design requirements (Figure 1), foundation excavation, pipeline installation, backfilling, compaction, tree pit excavation, tree planting, and soil backfilling were carried out. The tree pits were sized at 80 cm in diameter and 60 cm in depth, spaced 1.5 meters apart. Curbstones were installed on the impact side of the central median (Figure 2). Soil density parameters were obtained through compaction tests [37], and the soil compaction of the central median was measured using the ring knife method [38]. The measured data indicates that the maximum dry density of the foundation soil in the impact area is $1.72 \text{ g}\cdot\text{cm}^{-3}$. Prior to the tests with the small passenger car, medium bus, and medium truck, samples were taken from the central median, revealing dry densities of $1.43 \text{ g}\cdot\text{cm}^{-3}$, $1.32 \text{ g}\cdot\text{cm}^{-3}$, and $1.39 \text{ g}\cdot\text{cm}^{-3}$, respectively. The corresponding compaction degrees were 83%, 77%, and 81%.

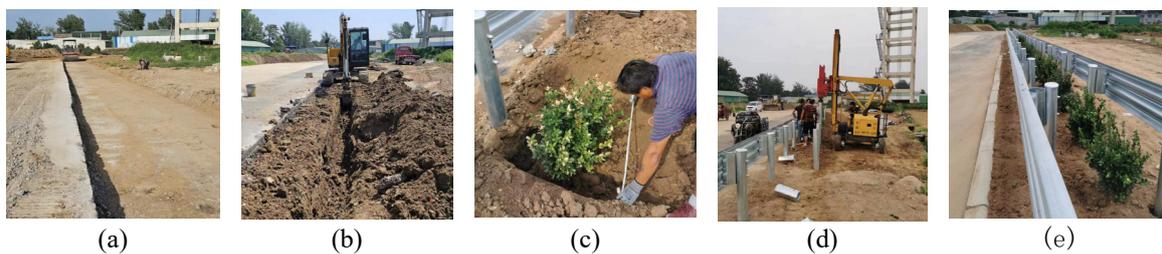
Figure 2. On-site construction diagram: (a) Foundation compaction, (b) Pipeline excavation, (c) Tree pit excavation, (d) Barrier installation, (e) Overall effect diagram.

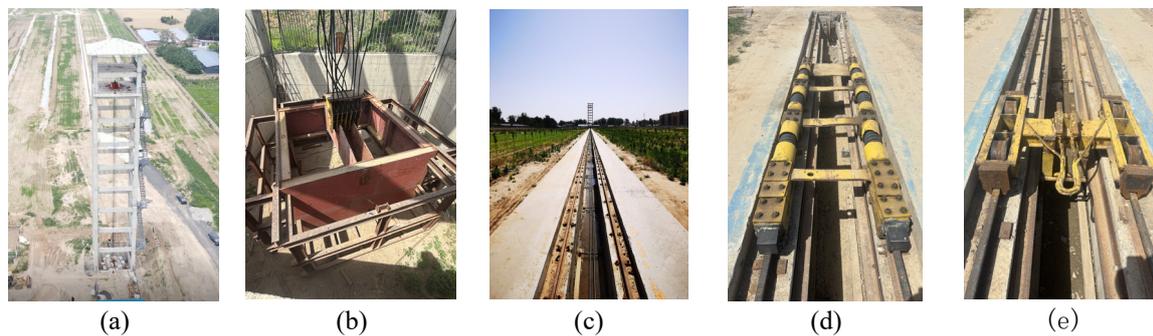
Figure 3. Full-scale vehicle acceleration system: (a) Gravitational potential energy tower, (b) Drop weight, (c) Acceleration runway, (d) Braking system, (e) Acceleration traction vehicle.

In this study, a drop weight traction vehicle acceleration system was employed to accelerate the test vehicles. This system consists of a gravitational potential energy tower, an acceleration runway, an acceleration traction vehicle, a braking system, and a test vehicle traction system. The acceleration traction vehicle is fixed on a track and connected to the drop weight via a steel cable of specific specifications. The drop weight is elevated to a predetermined height on the gravitational potential energy tower to provide potential energy. At the start of the test, the drop weight is released, and its falling kinetic energy is transmitted to the acceleration traction vehicle through the steel cable, which in turn accelerates the test vehicle. Once the test vehicle reaches the set speed, the acceleration traction

vehicle disengages from the test vehicle, allowing the test vehicle to freely travel and impact the test barrier at the predetermined angle (Figure 3)

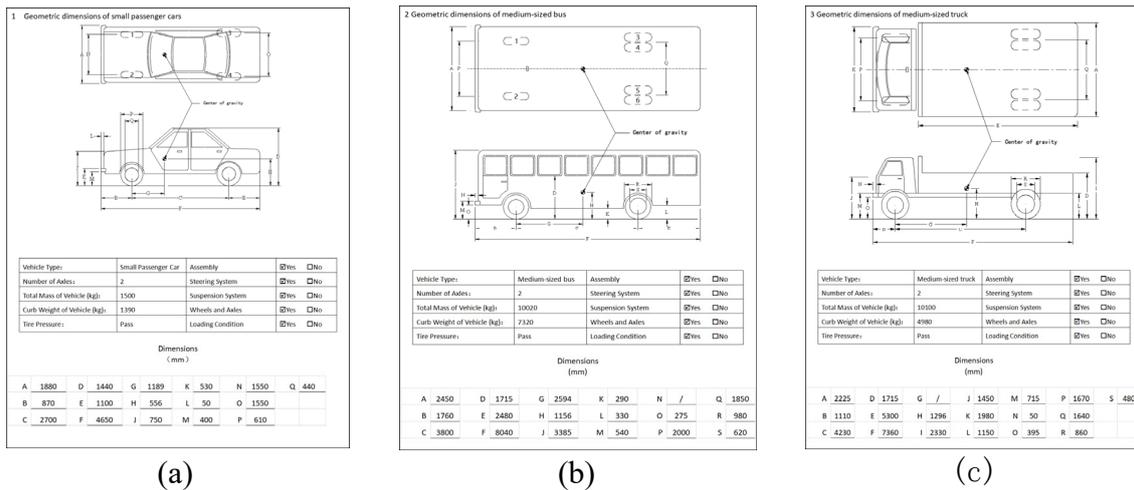
Figure 4. Test vehicles: (a) Small passenger car, (b) Medium bus, (c) Medium truck.

The protection level of the barrier is classified as Level 3 (A), and the full-scale vehicle test conditions were set according to the standards specified in [39]. Table 2 details the collision conditions for Level A barriers. To effectively compare and analyze the differences between the two schemes, this study selected several key performance indicators: redirection performance, containment performance, buffering performance, deformation of the barrier and vehicle, and the anti-intrusion resistance of the barrier. These indicators were used to conduct both qualitative and quantitative analyses of the performance of the post-densification scheme in full-scale vehicle tests. During the medium bus test, extensive water spraying was conducted in the central median to simulate long-term rainfall conditions, thus analyzing the impact of rainfall on the performance of the divided central median barrier under low compaction conditions. Detailed information on the three vehicle types used in the full-scale tests can be found in Figure 4.

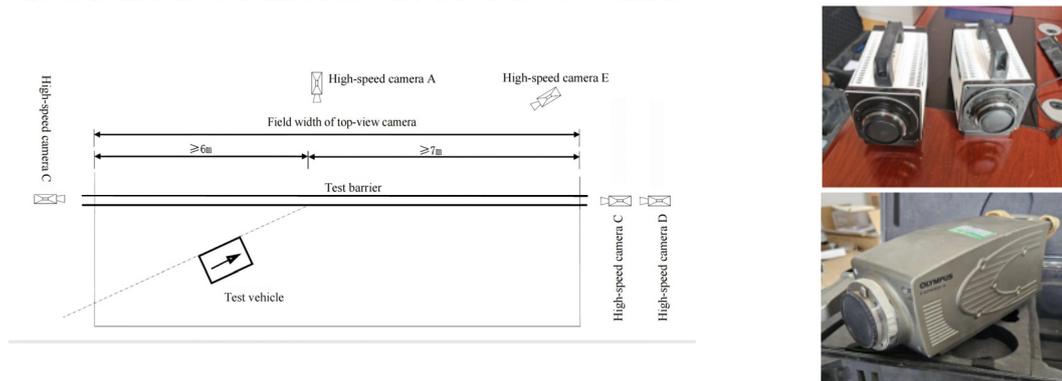
Figure 5. High-speed cameras and their arrangement.

In this study, high-speed cameras (Figure 5) were utilized to capture footage of each critical moment during vehicle-barrier collisions. The cameras operated at a frame rate of 500 frames per second, providing clear images and detailed observations. This allowed for thorough analysis of the vehicle's motion and the deformation behavior of the test barriers.

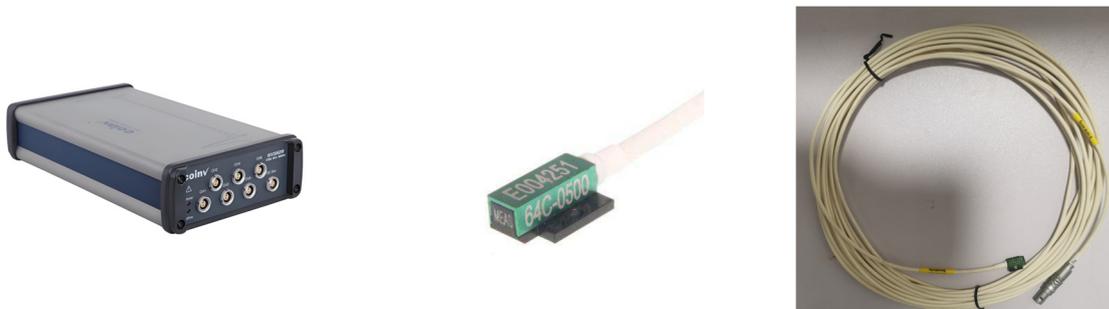
Figure 6. Data acquisition system and accelerometers.

Accelerometers were installed at the vehicle's center of gravity to measure acceleration in both the longitudinal (X) and lateral (Y) directions. A dynamic data acquisition system was utilized to collect longitudinal and lateral acceleration data during the collision. This data was used to obtain and analyze technical indicators related to the buffering performance of the barrier during the collision. (Figure 6)

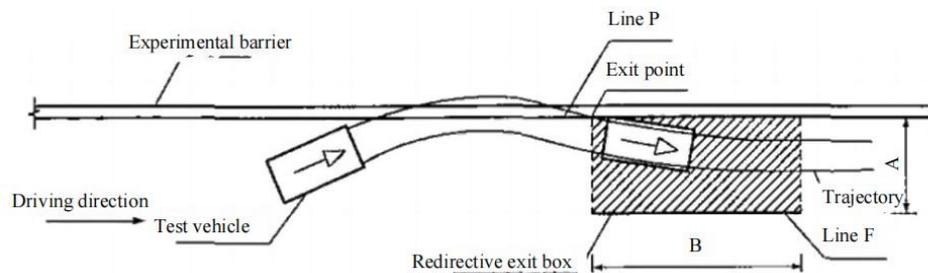
Figure 7. Redirective exit box.

- Line P represents the ground projection of the innermost edge of the test barrier's impact surface before the collision.
- Line F is parallel to Line P and spaced at a distance A from it.
- The starting point of Line F is the projection point of the exit point on Line F, with a length of B. The values of A and B are listed in Table 3.

(1) Redirection Performance: This determines whether the test vehicle overturns and whether the vehicle's wheel tracks upon exiting the collision meet the requirements of the standardized redirective exit box, as illustrated in Figure 7.

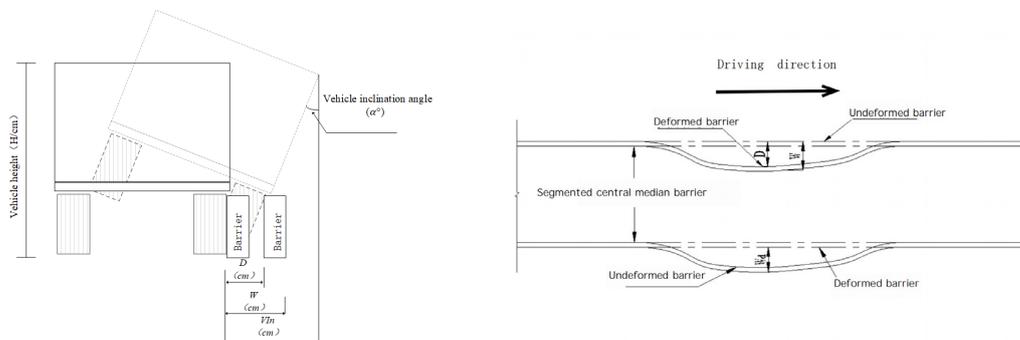
Figure 8. Barrier anti-intrusion capability indicators.

(4) Barrier Anti-intrusion Resistance: The barrier's ability to prevent out-of-control vehicles from colliding with obstacles within the central median or from intruding into the opposite traffic lane (Figure 8). The control indicators include:

- Maximum dynamic lateral deflection of highway barrier (D): During the vehicle collision test, this is the maximum lateral horizontal displacement of the impacted face of the barrier relative to its initial position.

- Maximum dynamic widening distance of lateral deflection of highway barrier (W): During the vehicle collision test, this is the maximum lateral horizontal distance from the outermost edge of the deformed barrier to the innermost edge of the barrier before the collision.

- Maximum dynamic vehicle incline-out distance (VI): During the collision test, this is the maximum lateral horizontal distance from the outermost edge of the vehicle to the innermost edge of the barrier before the collision, observed when medium and large vehicles (including extra-large buses) overhang.

- Normalized maximum dynamic vehicle incline-out distance (VI_n): The maximum dynamic overhang value of the vehicle measured in full-scale crash tests, converted based on a total vehicle height of 4.2 meters.

- Barrier intrusion distance (W_a): During the vehicle-barrier collision process, this is the maximum lateral horizontal distance of the outermost edge of the opposite barrier of the divided central median barrier after deformation, relative to its outermost edge before the collision.

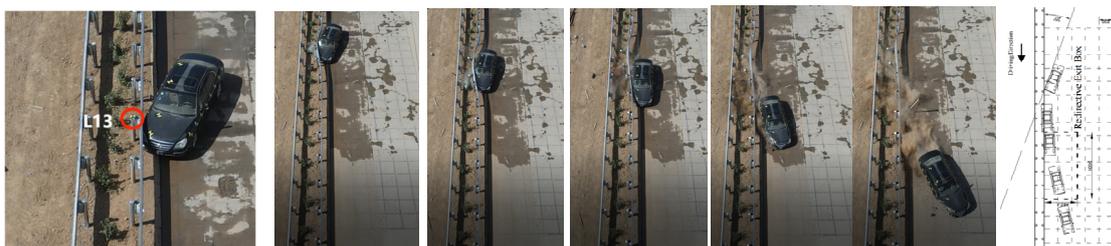
Figure 9. Trajectory of the small passenger car.

In this small passenger car test, the measured soil compaction degree of the central median in the barrier installation area was 83%. The vehicle collided with the barrier panel between posts 13th and 14th, resulting in significant horizontal displacement near the ground end of the barrier panel. Subsequently, the vehicle's right front wheel hit posts 14th and 15th. After the front of the vehicle passed post 16th, the vehicle's direction became parallel to the barrier. The test vehicle disengaged from the barrier at post 17th; after disengagement, the test vehicle continued to travel without being affected by the curb (Figure 9). Throughout the collision process, the near-ground ends of posts 13th to 17th experienced significant lateral displacement due to soil compression, with the collision causing a barrier deformation length of 8 meters. The vehicle's speed was $104 \text{ km} \cdot \text{h}^{-1}$ at the time of collision and $60.1 \text{ km} \cdot \text{h}^{-1}$ at the time of disengagement, resulting in a kinetic energy loss of 67%.

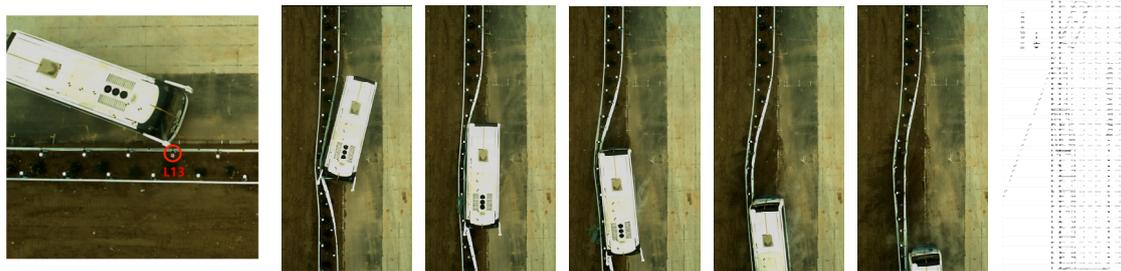
Figure 10. Trajectory of the medium bus.

In the medium bus test, the measured soil compaction degree of the central median in the barrier installation area was 77%. Subsequently, the soil was soaked with water to ensure that the soil moisture content within the tree pit depth range (60 cm) exceeded 20%. During the test, the vehicle first collided with post 13th and then post 15th, after which its direction became parallel to the barrier. The rear of the vehicle then fishtailed, hitting the barrier panel between posts 13th and 14th. The test vehicle disengaged from the barrier at post 17th. After disengagement, the right wheels of the test vehicle were affected by the curb, causing the vehicle to travel closely along the barrier, with mutual friction leading to deceleration until the vehicle came to a stop (Figure 10). The entire collision process resulted in significant horizontal displacement of posts 12th to 25th, with posts 14th to 18th leaning against the opposite barrier panel, causing a barrier deformation length of 26 meters. The vehicle's initial collision speed was $61.3 \text{ km} \cdot \text{h}^{-1}$, and the disengagement speed was $30.6 \text{ km} \cdot \text{h}^{-1}$, resulting in a kinetic energy loss of 75%.

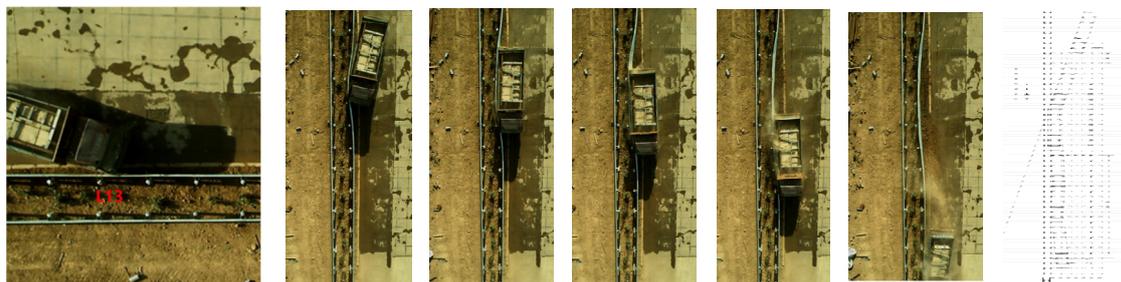
Figure 11. Trajectory of the medium truck.

In the medium truck test, the measured soil compaction degree of the central median in the barrier installation area was 81%. The vehicle initially collided with the barrier panel between posts 13th and 14th. After the vehicle's front end passed post 16th, its direction became parallel to the barrier. Subsequently, the rear of the vehicle fishtailed, hitting the barrier panel between posts 14th and 15th. The test vehicle disengaged from the barrier at post 18th. After disengagement, the test vehicle was influenced by the curb, causing it to travel closely along the barrier. Due to the limited length of the curb installation, the test vehicle eventually disengaged in an area without curb installation and exited the barrier zone (Figure 11). The entire collision process resulted in significant horizontal displacement of posts 12th to 19th, with the affected barrier length being 14 meters. The vehicle's collision speed was $61 \text{ km} \cdot \text{h}^{-1}$, and the disengagement speed was $33.2 \text{ km} \cdot \text{h}^{-1}$, resulting in a kinetic energy loss of 70%.

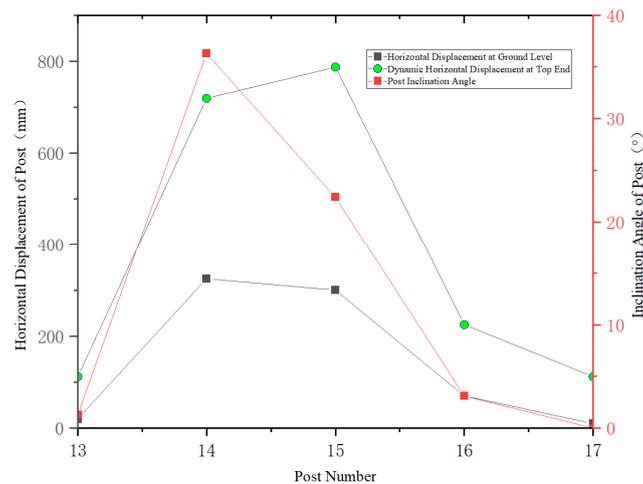
Figure 12. Post deformation: small passenger car.

In the small passenger car test, the barrier posts numbered 13th to 17th experienced lateral displacement and soil compression, resulting in a total foundation deformation of 725 mm around the posts, with an average deformation of 145 mm and a maximum deformation of 325 mm (14th). The total dynamic displacement at the top of the posts was 1955 mm, with an average of 391 mm and a maximum of 787 mm (15th)(Figure 12). The maximum tilt angle of the posts was 36.3° (14th). The 14th post bent 505 mm below ground with a bending angle of 31.2° , and experienced deformation 290 mm above ground. The 15th post bent 585 mm below ground with a bending angle of 6.7° , and experienced deformation 250 mm above ground. The anti-block bolts of the 14th and 15th posts perforated and detached from the barrier panel. During the test, the barrier panels did not fracture and the overall deformation was minimal (Figure 13).

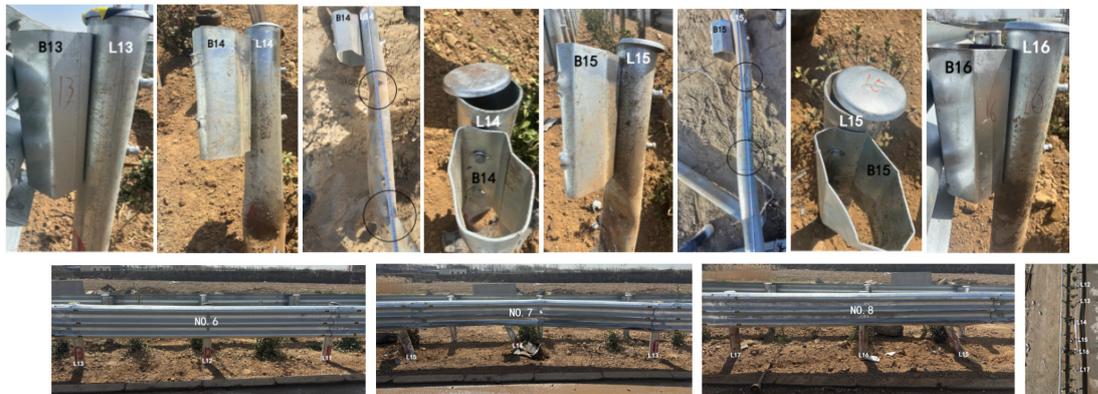
Figure 13. Barrier deformation: small passenger car.

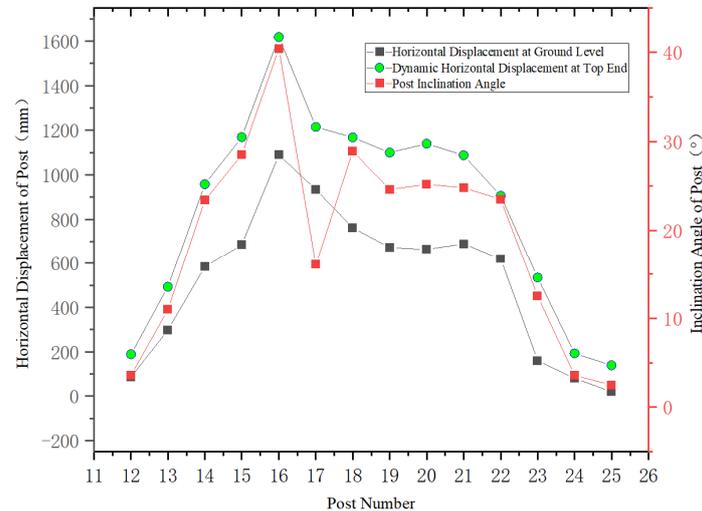
Figure 14. Post deformation: medium bus.

In the medium bus collision test, the impact caused the 12th-25th posts to undergo lateral displacement and compression of the subgrade, resulting in a total deformation of the surrounding foundation of 7343mm, with an average value of 525mm and a maximum value of 1090mm (16th). The total dynamic displacement of the post tops was 11911mm, with an average value of 851mm and a maximum value of 1618mm (16th). The maximum inclination angle of the 16th post reached 40.4° . The 15th, 16th, 17th, and 18th posts were damaged and deformed due to being run over by the right rear wheel of the vehicle, with the damaged areas within 300mm above the ground. The anti-collision block connection bolts of the 16th post were perforated, causing the anti-collision block assembly to detach from the barrier plate system, resulting in the displacement of the 16th post no longer being affected by the subsequent rebound of the barrier plate. This explains why the 16th post had the

largest displacement and showed a sudden change in the data graph (Figure 14). The anti-collision block of the 17th post did not fall off, but it relied on the opposing barrier post when impacted by the rear wheel of the vehicle, resulting in a reverse bend 23mm above the ground with a bend angle of 36.6° , which also reduced its inclination angle. From the post-test barrier plates, it can be seen that during the test, the splice bolts between the barrier plates did not fall off, and the connections were tight, with no fractures or significant damage to the barrier plates minimal (Figure 15).

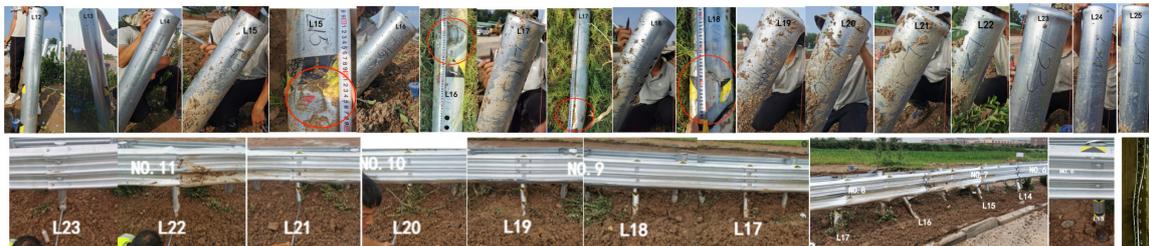
Figure 15. Barrier deformation: medium bus.

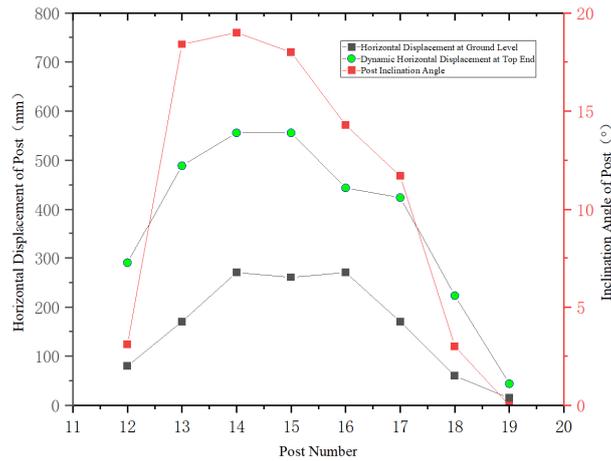
Figure 16. Post deformation: medium truck.

In the test with a medium truck, the collision caused lateral displacement and soil compression around posts 12th to 19th, with a total foundation deformation of 1295 mm, averaging 162 mm, and peaking at 270 mm (14th and 16th). The dynamic displacement at the post tops totaled 3026 mm, averaging 378 mm, peaking at 556 mm (14th and 15th), with a maximum inclination angle of 19° (14th). 13th experienced a bend below at 492 mm depth with a bend angle of 21.4° ; 14th at 597 mm depth with a bend angle of 14.5° ; post 15th at 512 mm depth with a bend angle of 13° ; post 16th at 364 mm depth with a minimal bend angle; and post 17th at 579 mm depth with a bend angle of 11.2° (Figure 16). Throughout the experiment, there were no instances of separation between the post's energy-absorbing block and the barrier panel, and no fractures were observed in the barrier panels. Panels 6th, 7th, and 8th bent at posts 12th, 14th, and 16th respectively, with varying degrees of corrugation, yet overall barrier deformation was minimal (Figure 17).

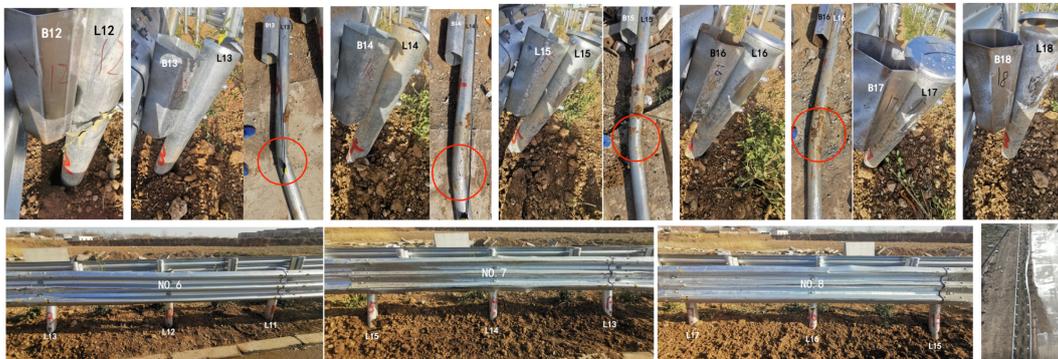
Figure 17. Barrier deformation: medium truck.

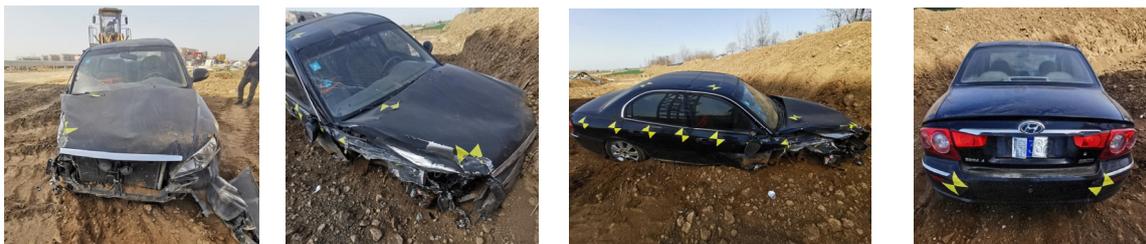
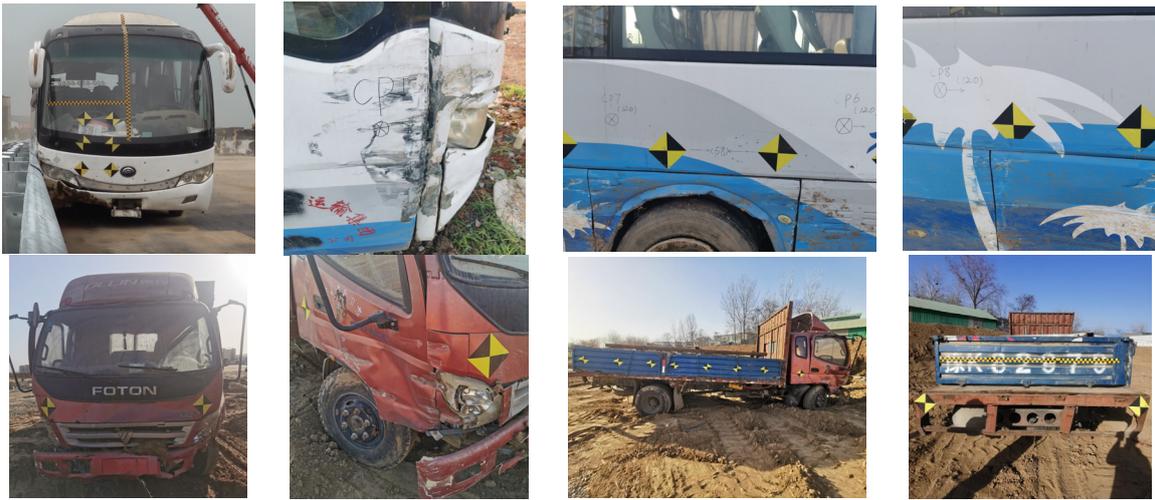
Figure 18. Vehicle deformation.

Due to the low soil compaction, in the small passenger car test, the vehicle's impact on the post compressed the soil, causing horizontal displacement and tilting of the post at ground level. The wheel on the impact side crossed the post axis after striking the barrier, and during the reorientation process, the vehicle struck the 14th and 15th posts, resulting in the detachment of the right front wheel and causing some deformation at that position. In the medium bus test, the vehicle was smoothly guided out of the collision zone after impacting the barrier. Due to the influence of the curb, the vehicle decelerated while closely rubbing against the barrier until it stopped. Post-collision inspection revealed minor scratches on the impact side and a shattered right front window. In the medium truck test, the collision resulted in damage to the right headlight and front bumper, with slight deformation observed on the right door. The deformations in all three vehicles did not affect the occupant compartments.

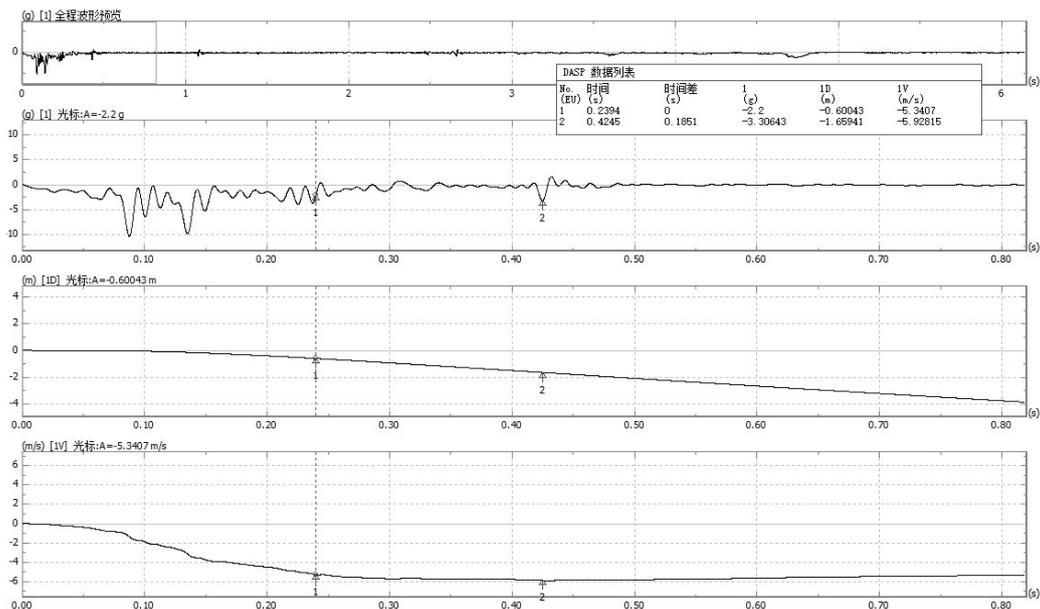
Figure 19. Buffering performance indicators curve: X-direction.

The hypothetical occupant's head collision time with the vehicle interior was determined to be 0.239 seconds when moving 0.6 meters along the longitudinal axis (Figure 19) of the occupant compartment and 0.241 seconds when moving 0.3 meters along the lateral axis (Figure 20). Therefore, the critical collision time was 0.239 seconds. Based on the collected acceleration curve at the vehicle's center of gravity and the derived occupant impact velocity curve, the buffering performance indicators for this test are shown in Table 4.

The barrier's buffering performance was evaluated using a passenger car. The test results showed occupant impact velocities of $V_x = 5.3 \text{ m} \cdot \text{s}^{-1}$ and $V_y = 3.0 \text{ m} \cdot \text{s}^{-1}$, both below the standard value of $12 \text{ m} \cdot \text{s}^{-1}$. The occupant ride-down accelerations were $a_x = 18.5 \text{ m} \cdot \text{s}^{-2}$ and $a_y = 26.3 \text{ m} \cdot \text{s}^{-2}$, both below the standard value of $200 \text{ m} \cdot \text{s}^{-2}$, demonstrating that the barrier's buffering performance met the required standards.

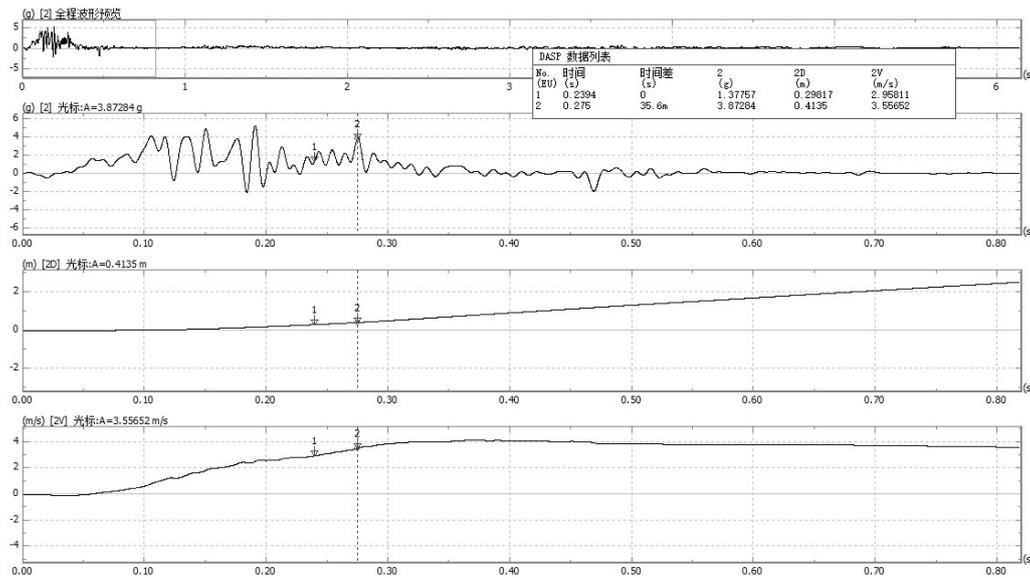
Figure 20. Buffering performance indicators curve: Y-direction.
