Identification and Mitigation of Subsidence in Karstic Areas with Sustainable Geotechnical Structures: A Case Study in Gallur (Spain)

Posted Date: 19 February 2024

Alberto Gracia ^{1,*}, Francisco Javier Torrijo ², Julio Garzón-Roca ³ and Miguel Pérez-Picallo ¹

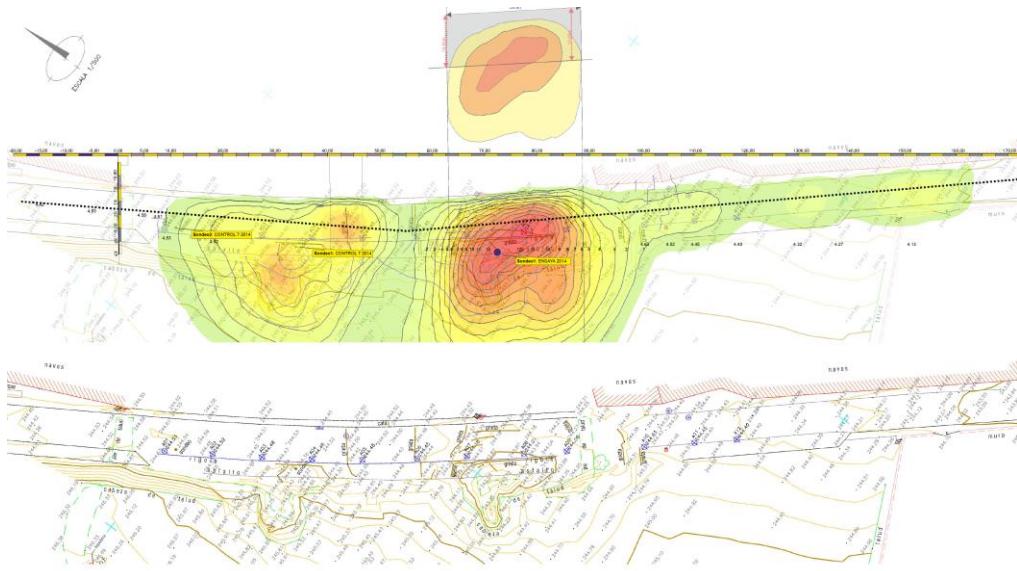
As a starting point, and based on data from previous works [21], boreholes and geophysical research of the existing detailed topography were located (Figure 2). The ground conditions facilitated the creation of a correlation model for the terrain, which was used to set the size and to delineate potential ground consolidation solutions (Figure 4).

Figure 4. Situation plan with positioning of the subsidence model defined based on the existing data.

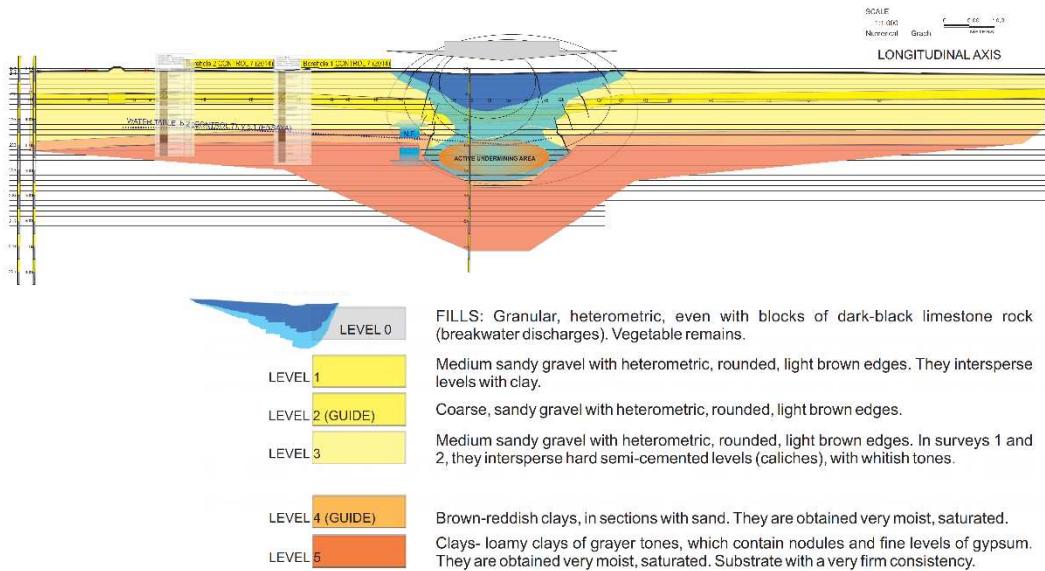
In the correlation conducted (Figure 5), two reference (guide) levels were obtained, serving to establish the relative decreases recorded in the subsidence zone affected by the sinkholes in this particular case. Level two (2), made up of coarse gravels with sand, showed a relative drop of around 3-4 metres in the sounding. Reference level 4 also showed a relative drop of another 4-5 metres, so that the accumulated result would be in the order of 7 to 9 metres. The thickness of level 3 reached more than 10 metres in the area that registers the subsidence process, while in the part where apparently that did not occur, the thickness was between 5 and 6.5 metres. One can interpret that the gravels with sands that form this defined level are very dense-compact ($N_{SPT} > 50$ /Rejection) in boreholes 1 and 2, and much looser, not very compact, in the borehole performed in the sinkhole, where the resistance to penetration ($N_{SPT} = 5-14$) is significantly lower.

Figure 5. Longitudinal geological-geotechnical profile established based on the existing data.
